**Presentation to the Building and Operating Committee
Meeting of August 21, 2025
Agenda Item No. 5**

Golden Gate Bridge Underwater Inspection

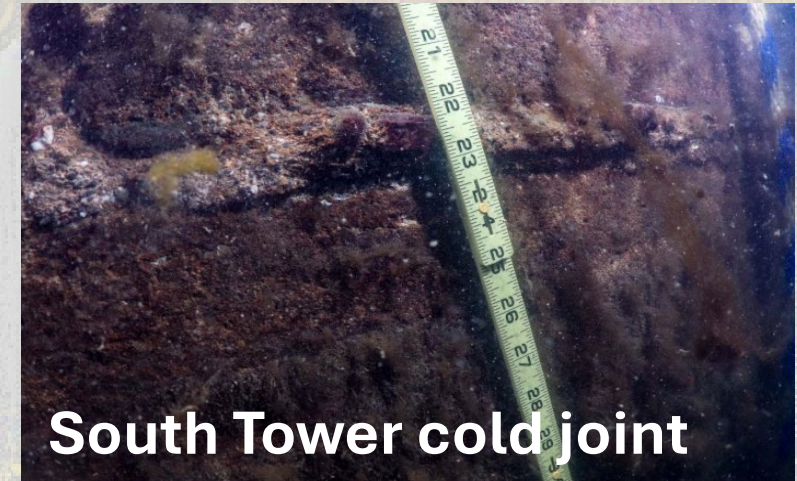
South Tower cold joint

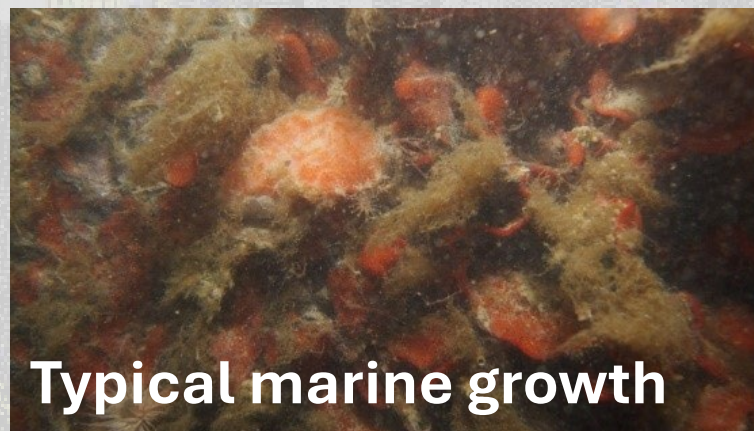
Typical marine growth

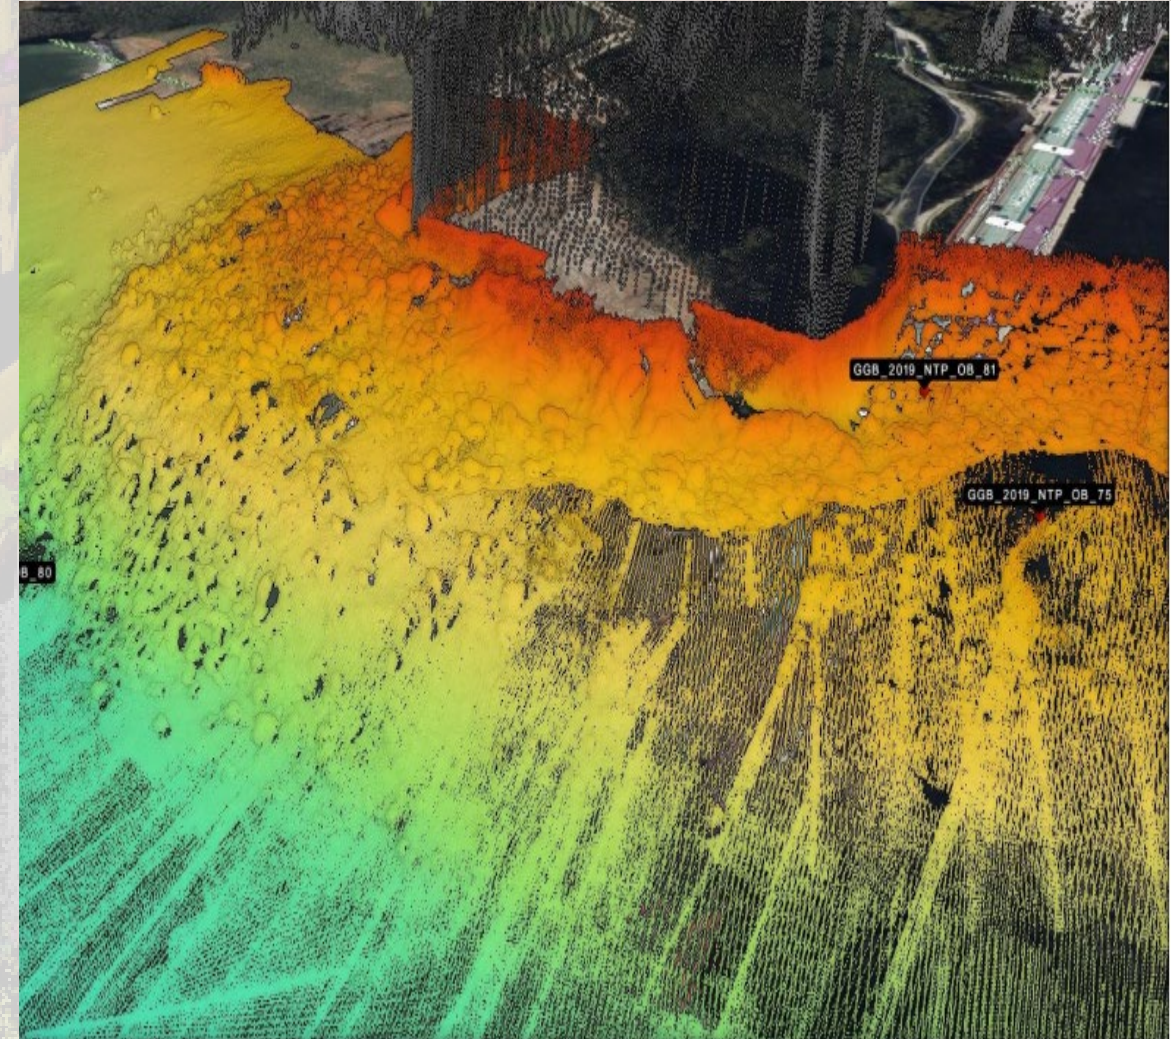
Figure 5-107 – South Tower Bathymetric Surface Change 2019 (red line) – 2025 (purple line)

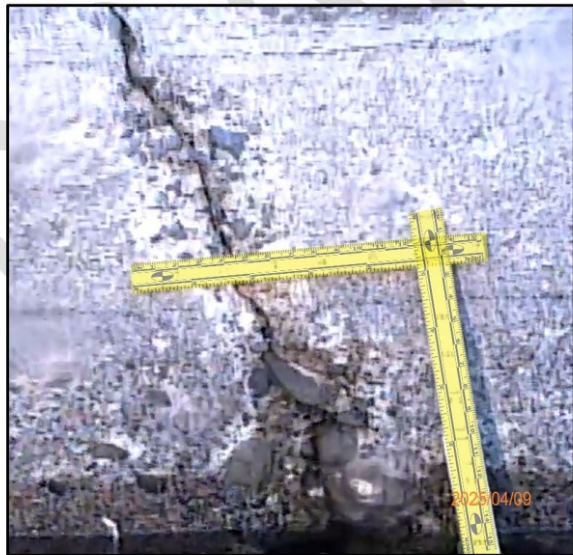
- South Tower and Fender: Satisfactory Condition
 - ✓ Cold joint at Elevation – 10.2
 - ✓ Hairline width vertical cracking in the splash zone.
 - ✓ Isolated 1/8-in wide vertical cracks, with edge spalling and isolated areas of light efflorescence in the splash zone.

Photo 12 – South Pier, West Face, 1/8-in wide Crack with Spalling

- ✓ South Tower Pier: Clean and seal cracks that are 1/16-in wide and larger with an epoxy suitable for marine applications
- ✓ South Tower Fender: Remove unsound concrete and patch areas of spalling that have exposed reinforcing steel
- ✓ North Tower Pier: Remove unsound concrete and patch the area of abrasion damage and spalling

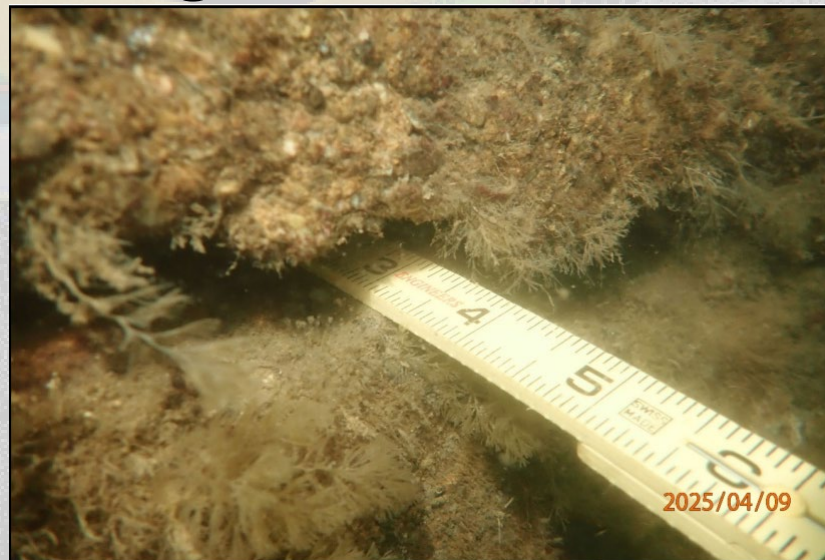
Photo 19 – South Tower Pier, Voiding at Cold Joint at ELEV. -10.2

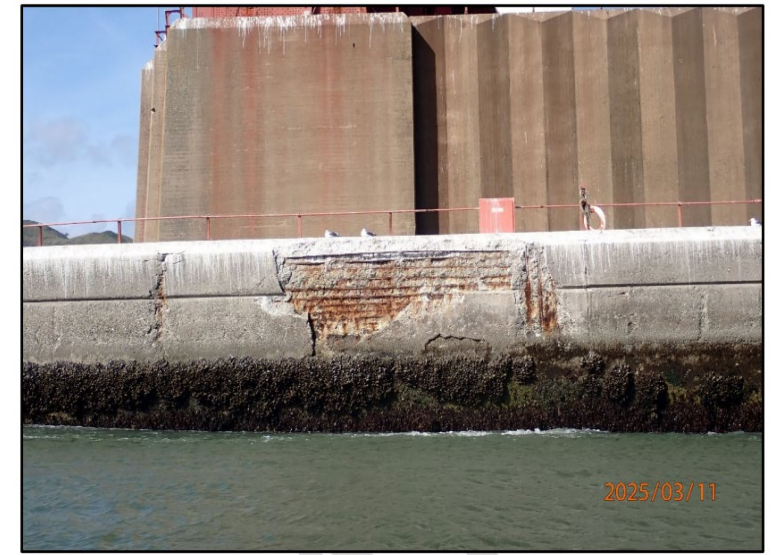
Photo 23 – South Tower Pier Fender, South Face, Spalling with Exposed Reinforcing

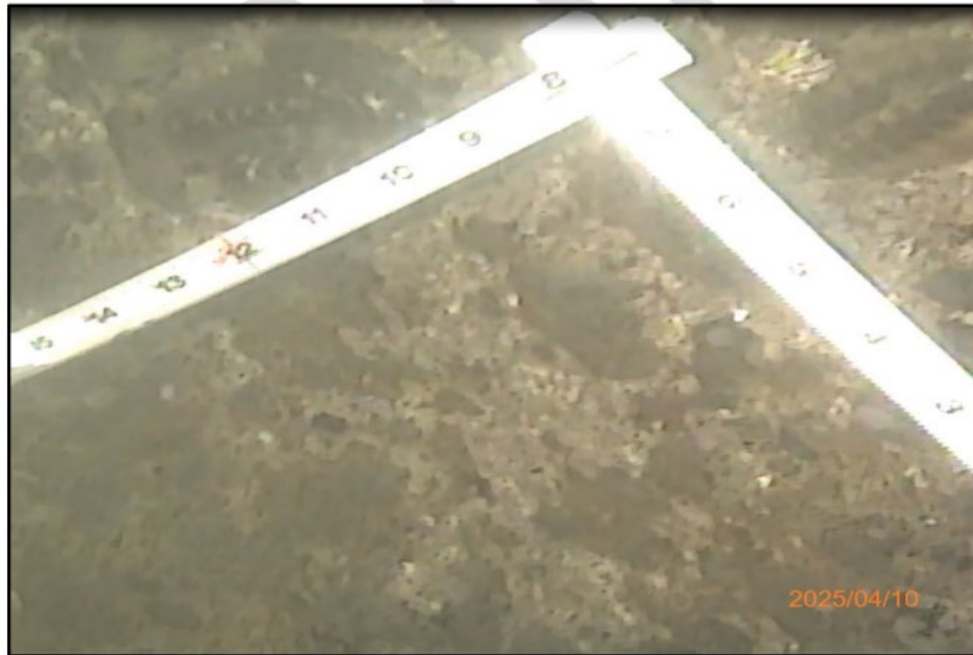
- North Tower Pier: Satisfactory Condition
 - ✓ The west end of the pier has abrasion, up to 6-in penetration, with one exposed reinforcing steel bar at the northwest corner.

Photo 28 – North Tower Pier, West Face, Abrasion, 3-in deep

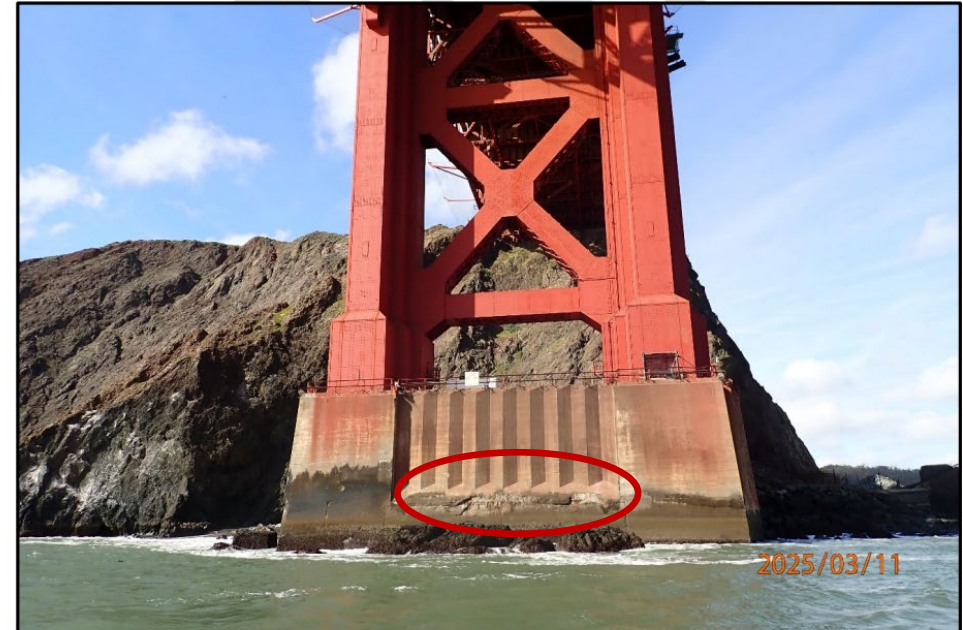
Photo 26 – North Tower Pier, South Face, Rock Outcropping to Left (West Face) and In Foreground (South Face), Spalling with Exposed Reinforcing Above MHHW
