# Larkspur Ferry Terminal Sea Level Rise Impact Assessment

Larkspur Ferry Service Expansion and Parking Project

Golden Gate Bridge, Highway and Transportation District

October 6, 2026

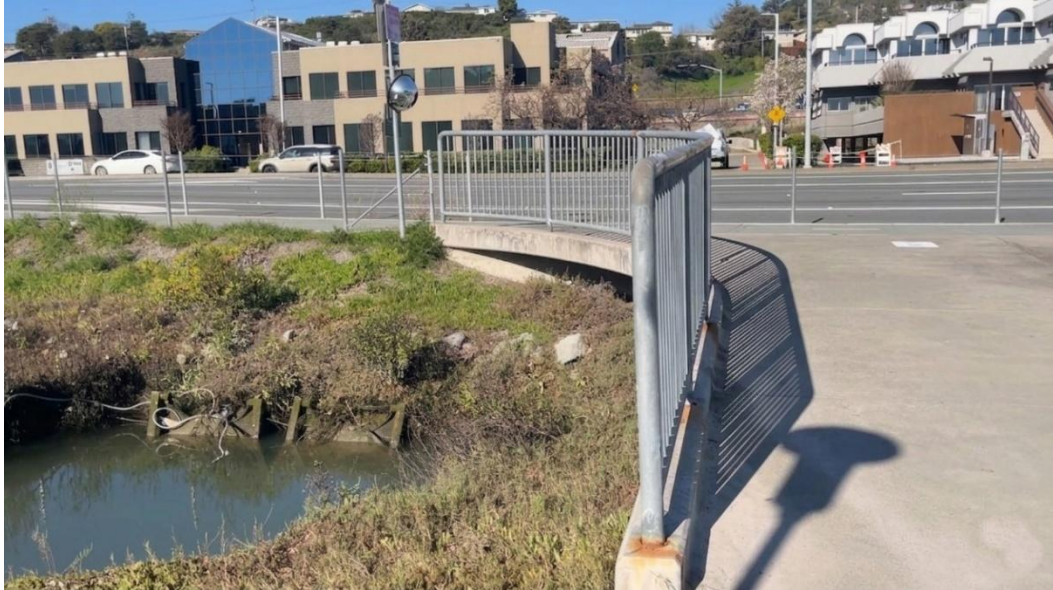
**Figure 6. Creek at the Sir Francis Drake Boulevard, gates semi-submerged**

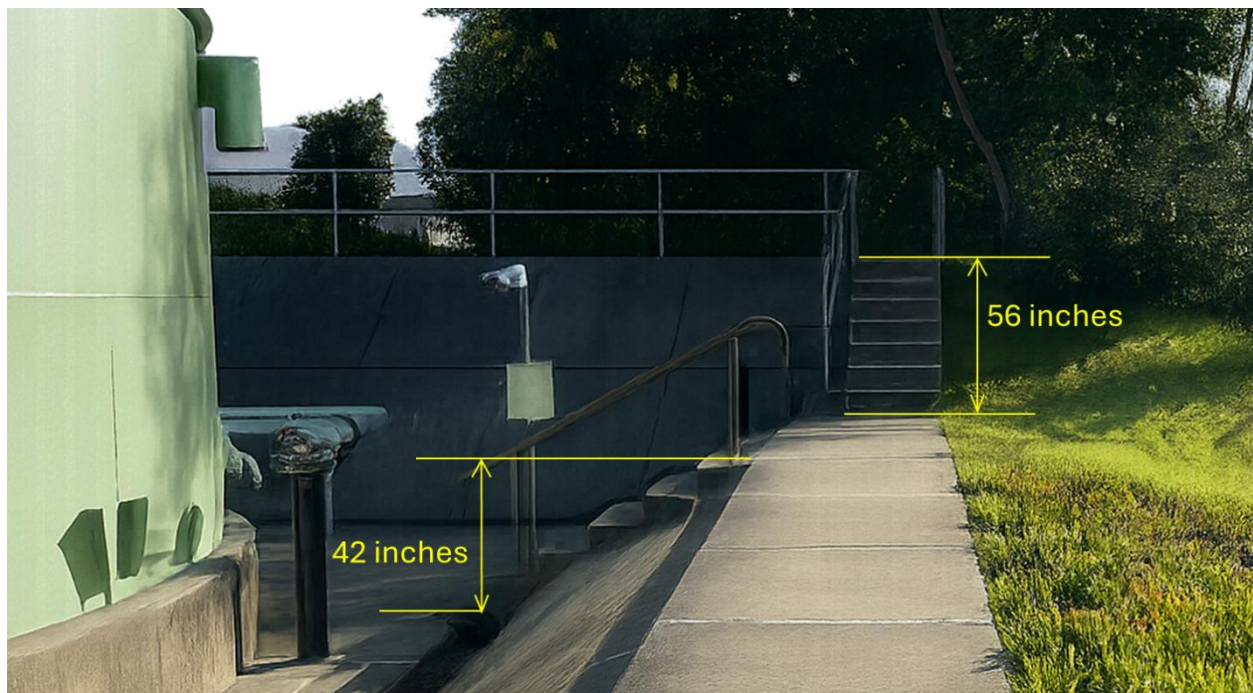
**Figure 17. Differences in elevations in the Fuel Tanks area**

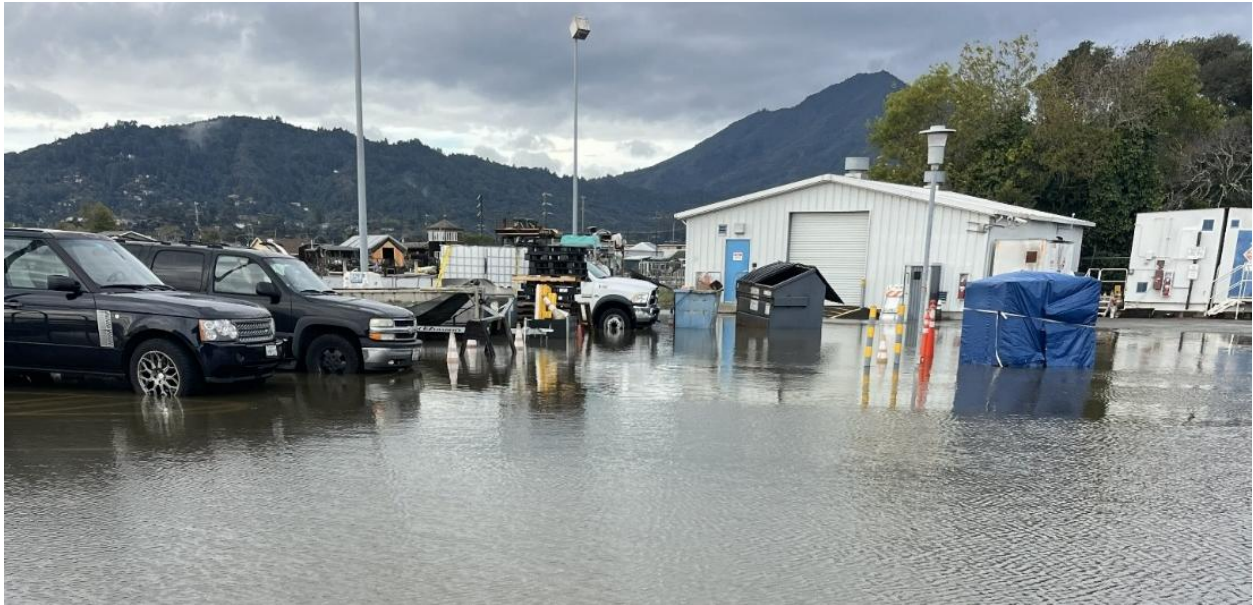
**Figure 18. Flooded area in front of the Butler Building on January 2, 2026, at 9:39 AM, TWL = 8.31 feet NAVD88 (NOAA 2025b)**

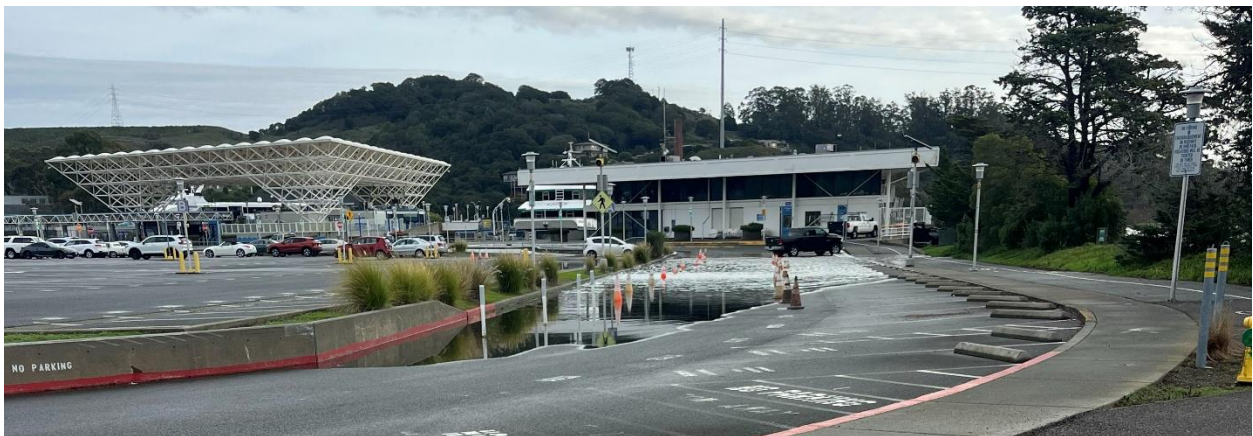
**Figure 19. Flooded area in the southern section of the Larkspur Ferry Terminal access road on January 2, 2026, at 9:39 AM, TWL = 8.31 feet NAVD88 (NOAA 2025b)**

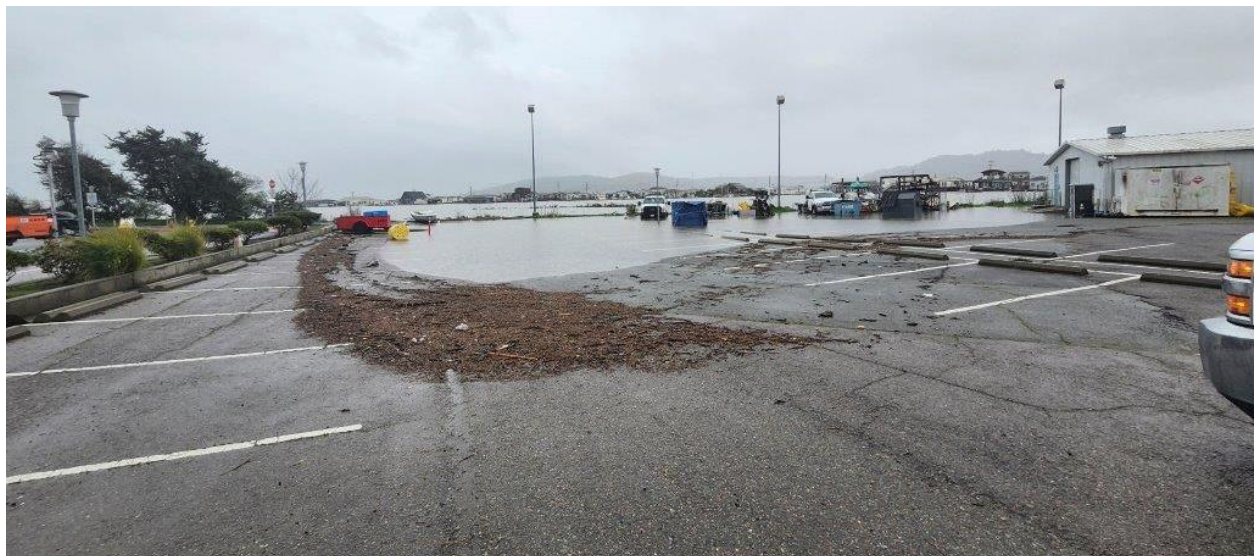
**Figure 21. Debris in the employee parking lot in the Butler Building area marking the edge of the highest floodwater elevation on January 3, 2026, at 10:36 AM, TWL = 8.73 feet NAVD88 (NOAA 2025b)**

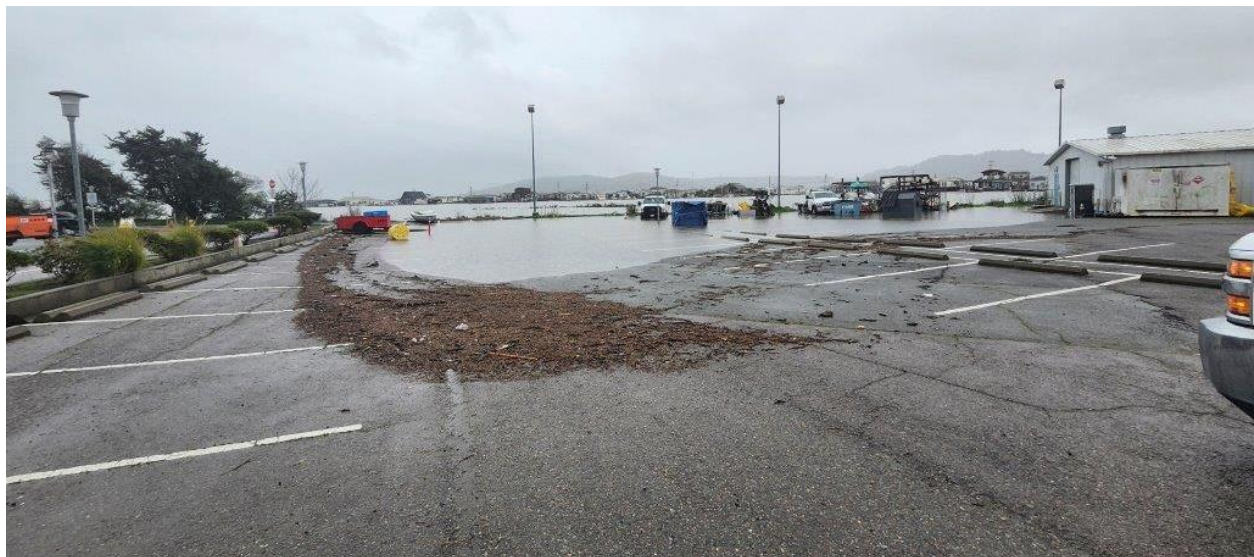
**Figure 23. Edge of the floodwater and flooded area in the employee parking lot in the Butler Building area on January 4, 2026, at 12:09 PM, TWL was 8.23 feet NAVD88 (NOAA 2025b)**

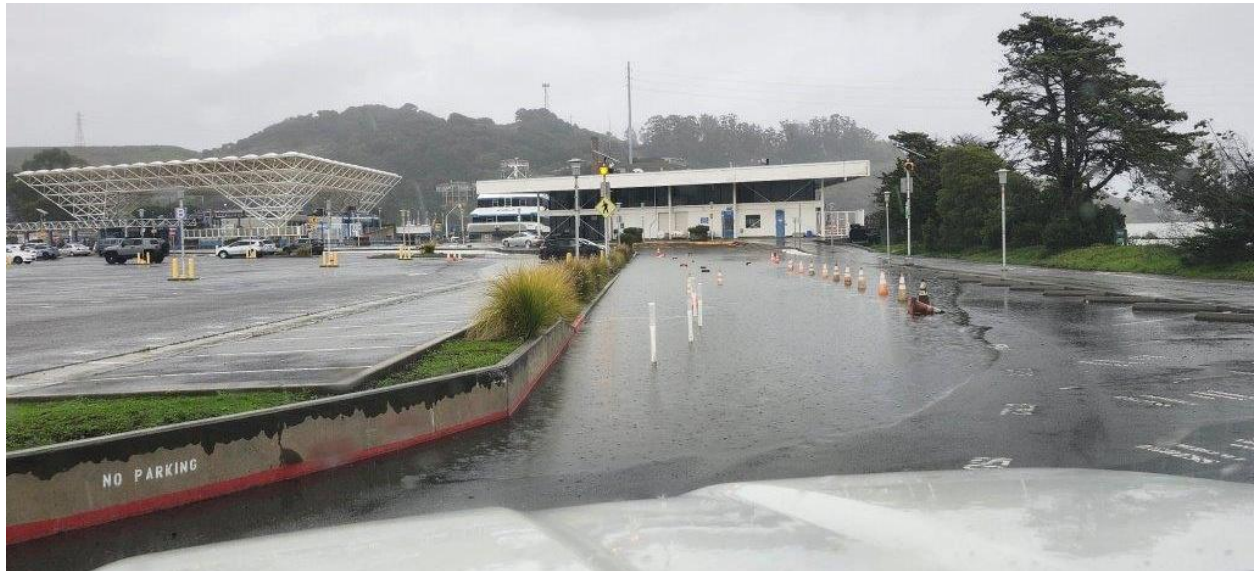
**Figure 24. Flooded area in the southern section of the Larkspur Ferry Terminal access road on January 4, 2026, at 12:12 PM, TWL = 8.23 feet NAVD88 (NOAA 2025b)**

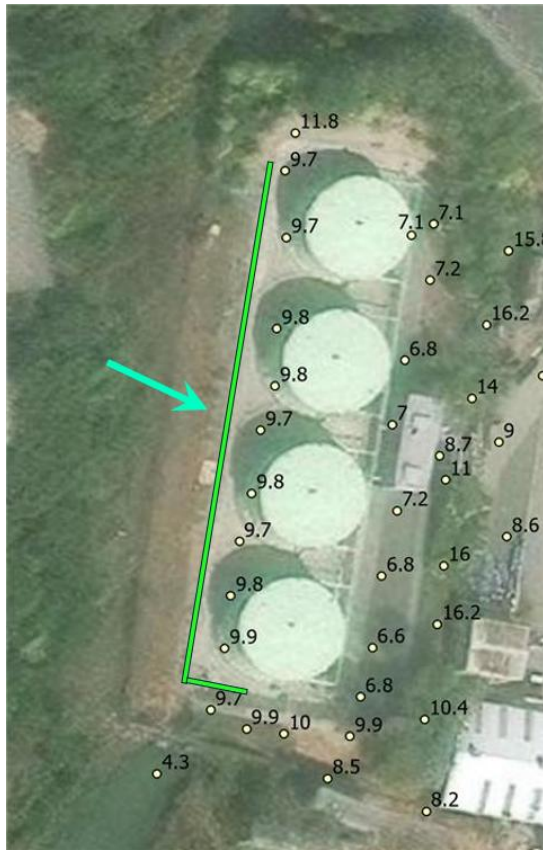
Figure 34. Location and elevation of the floodwater breaching section (red line) in the Fuel Tanks area on the top of the west side of the levee and elevations in the vicinity

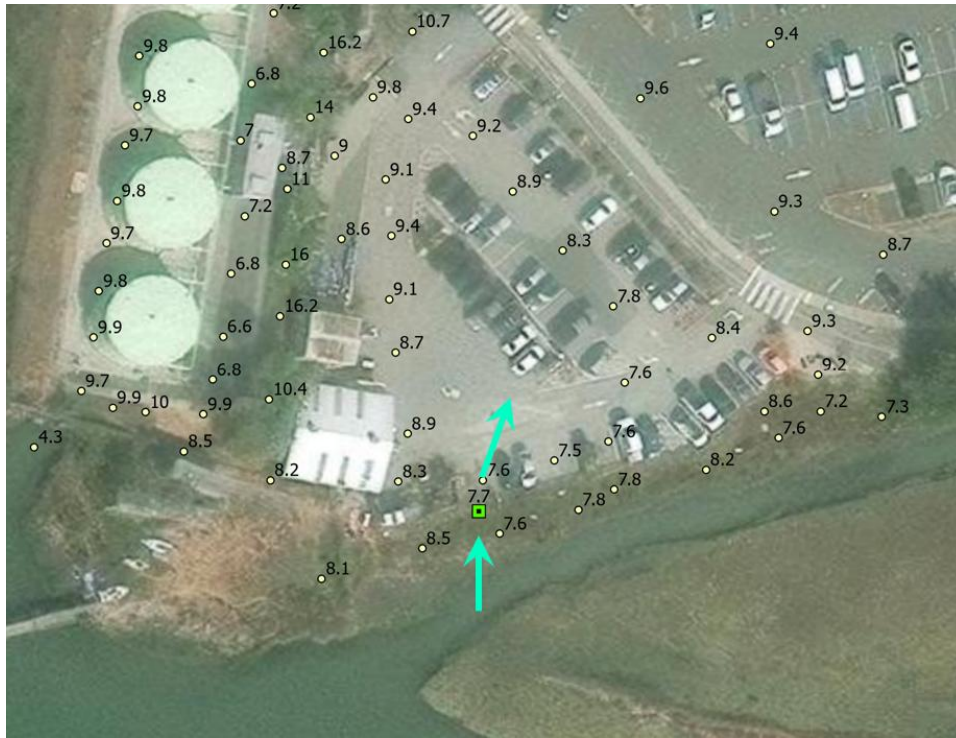
Figure 35. Location and elevation of the floodwater breaching point (7.7) in the Butler Building area at the western landward edge of the marsh close to the Butler Building and elevations in the vicinity.

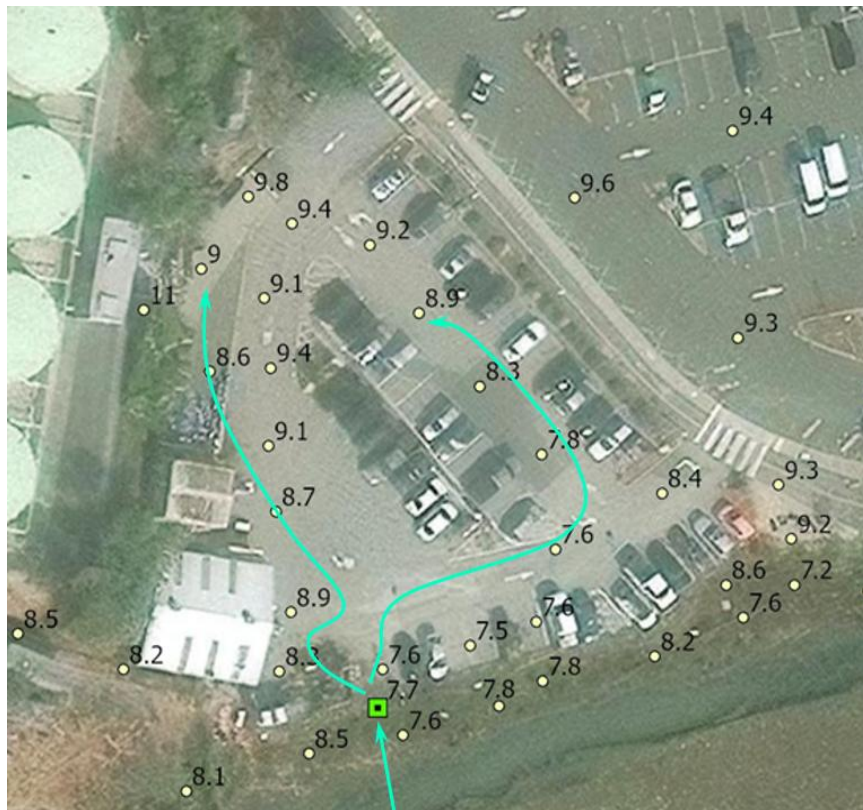
Figure 40. Schematic of potential floodwater pathways in the Butler Building area for the projected 8.9 feet NAVD88 TWL by 2030 (intermediate risk aversion) overtopping the 7.7 feet NAVD88 breaching point

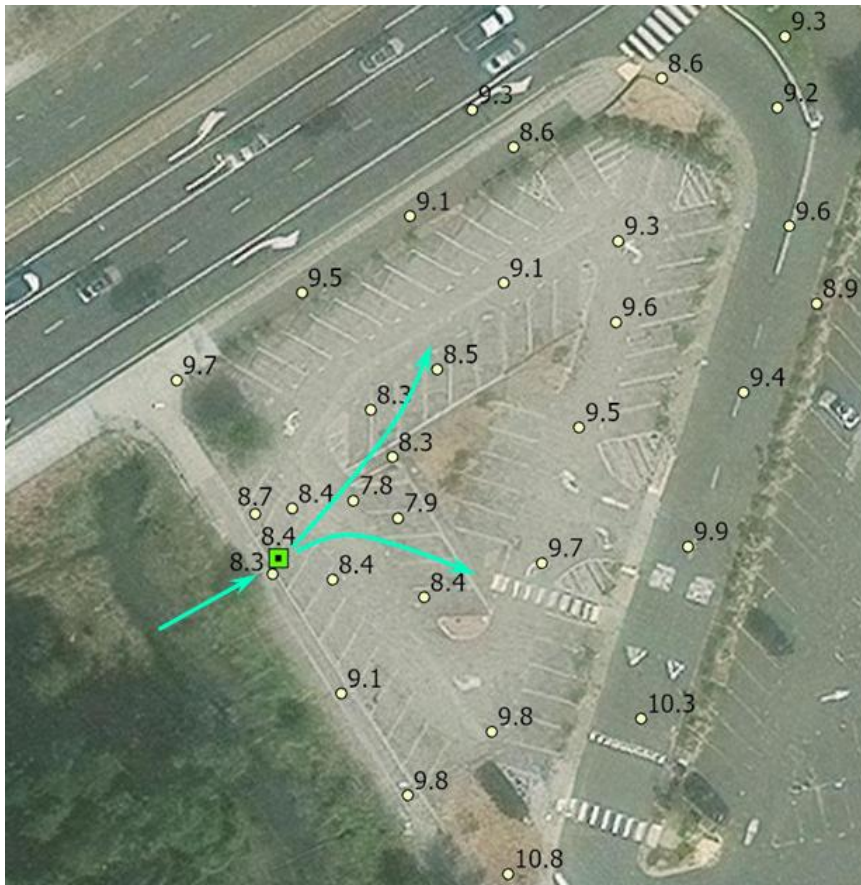
Figure 43. Schematic of potential floodwater pathways in the Creek area for the projected 8.9 feet NAVD88 TWL by 2030 (intermediate risk aversion) overtopping the 8.4 feet NAVD88 breaching point

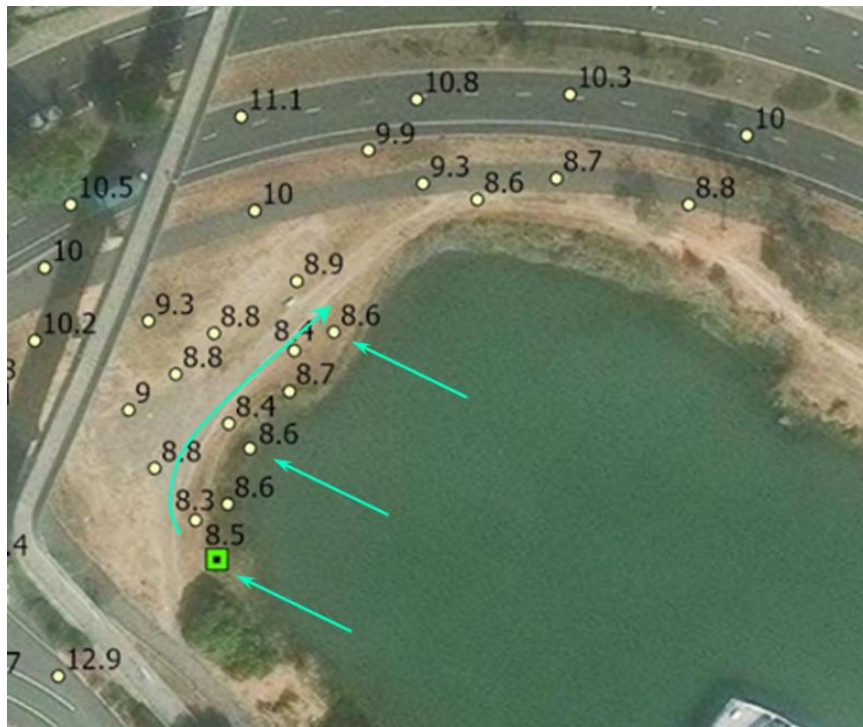
Figure 46. Schematic of potential floodwater pathways in the Undeveloped area for the projected 8.8 feet NAVD88 TWL by 2030 (low risk aversion) overtopping the 8.5 feet NAVD88 breaching point

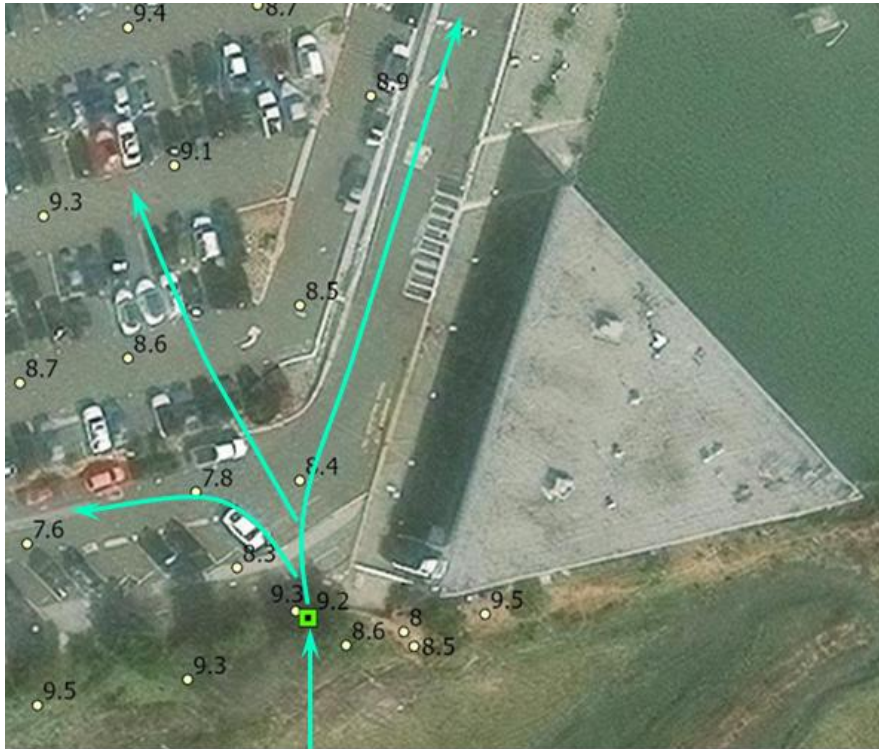
Figure 49. Schematic of potential floodwater pathways in the Marsh area for the projected 9.3 feet NAVD88 TWL by 2050 (intermediate risk aversion) overtopping the 9.2 feet NAVD88 breaching point

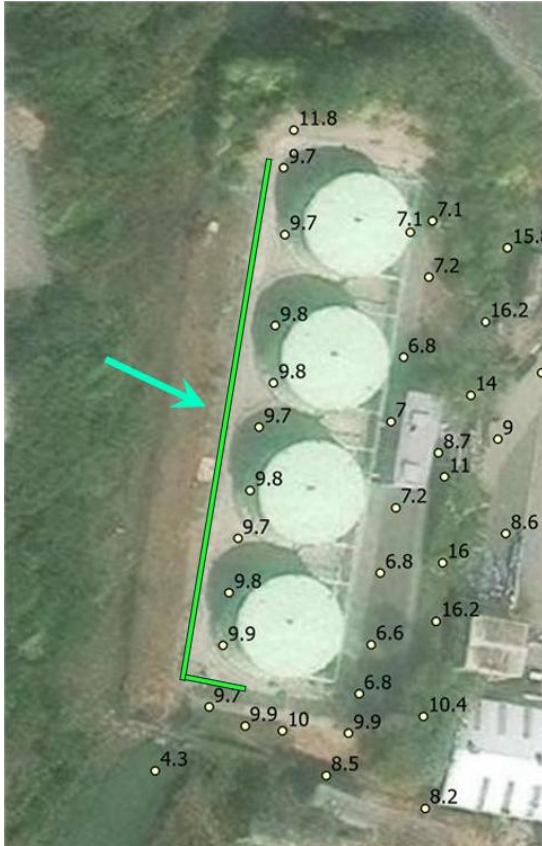
Figure 52. Schematic of potential floodwater pathways in the Fuel Tanks area for the projected 9.8 feet NAVD88 TWL by 2070 (intermediate risk aversion) overtopping the 9.7-foot NAVD88 high engineered levee

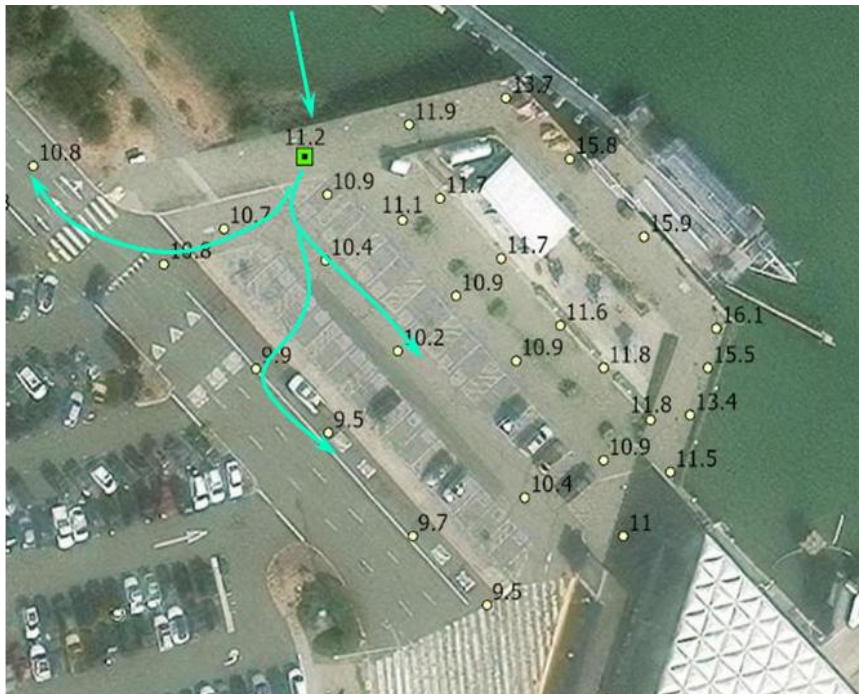
Figure 55. Schematic of potential floodwater pathways in the Larkspur Ferry Terminal Buildings Berth 3 for the projected 11.3 feet NAVD88 TWL by 2070 (high risk aversion) overtopping the 11.2 feet NAVD88 breaching point

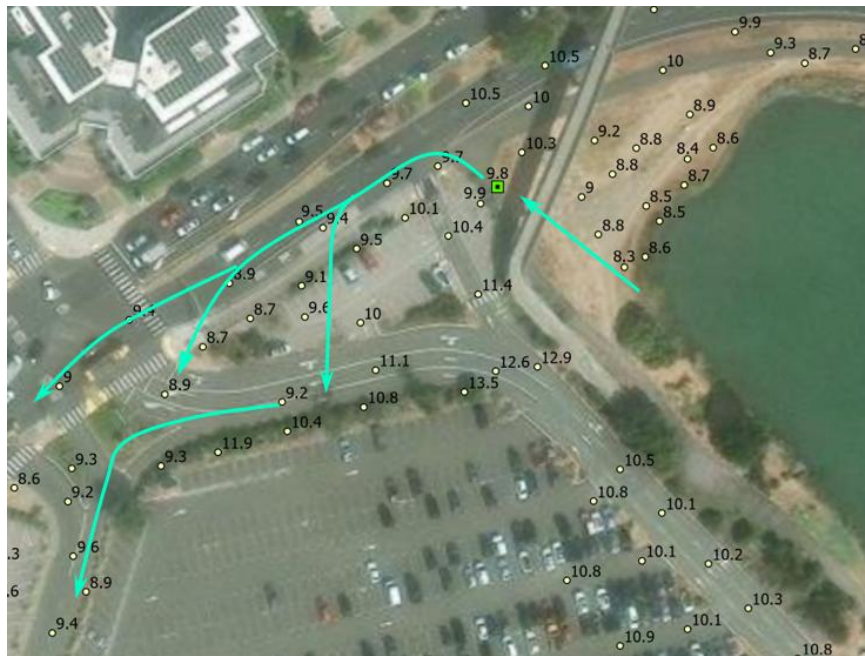
**Figure 58. Schematic of potential floodwater pathways in the Sir Francis Drake Boulevard area for the projected 10.2 feet NAVD88 TWL by 2080 (intermediate risk aversion) overtopping the 9.8 feet NAVD88 breaching point**
