## Corte Madera Four-Acre Tidal Marsh Restoration Project

### Year 2 (2022) Annual Monitoring Report

Corte Madera, Marin County, California

January 2023

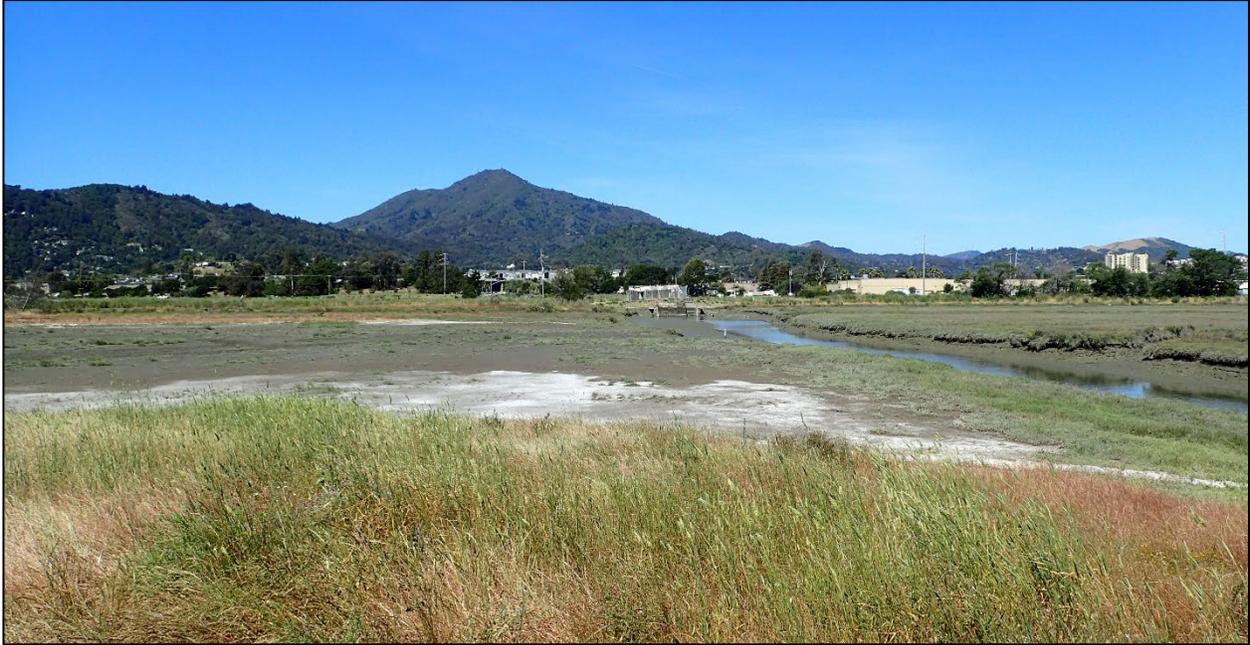
**Photograph 1.** Photo-monitoring Location 1. View of transition zone and tidal marsh, facing west. Photo taken May 20, 2022.

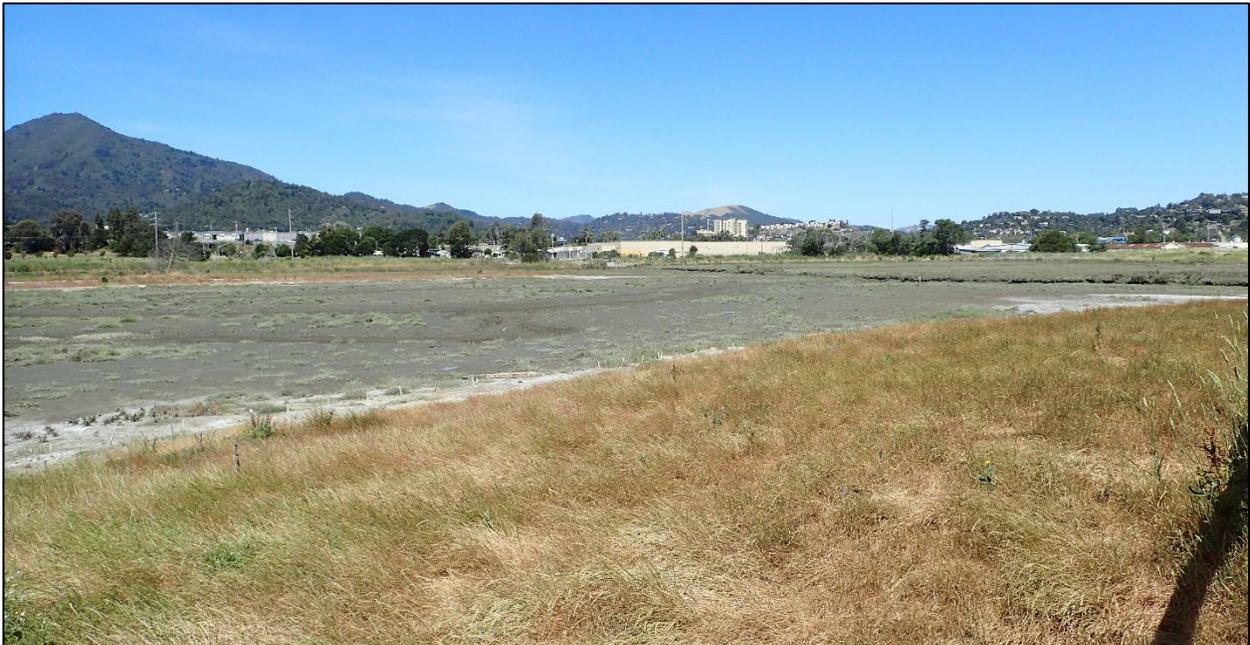
**Photograph 2.** Photo-monitoring Location 2. View of tidal marsh (background), transition zone (a narrow band adjacent to the tidal marsh), and uplands (foreground), facing northwest. Photo taken May 20, 2022.

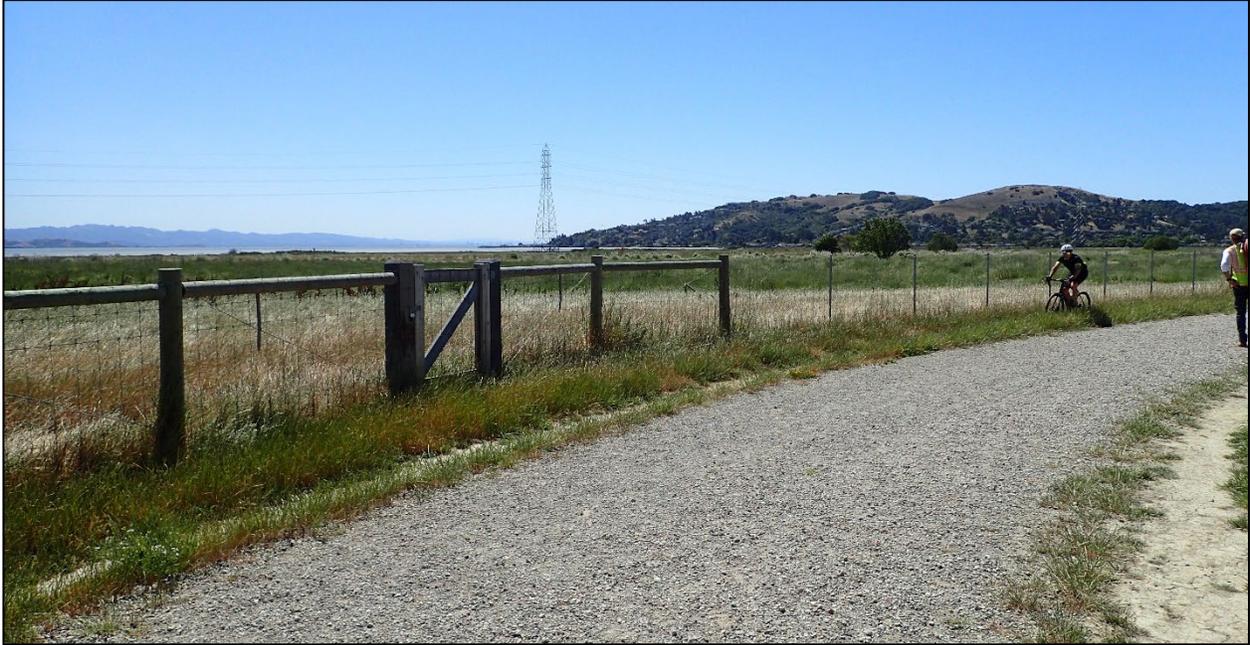
**Photograph 3.** Photo-monitoring Location 3. View of trail and exclusion fence, facing southeast. Photo taken May 20, 2022.

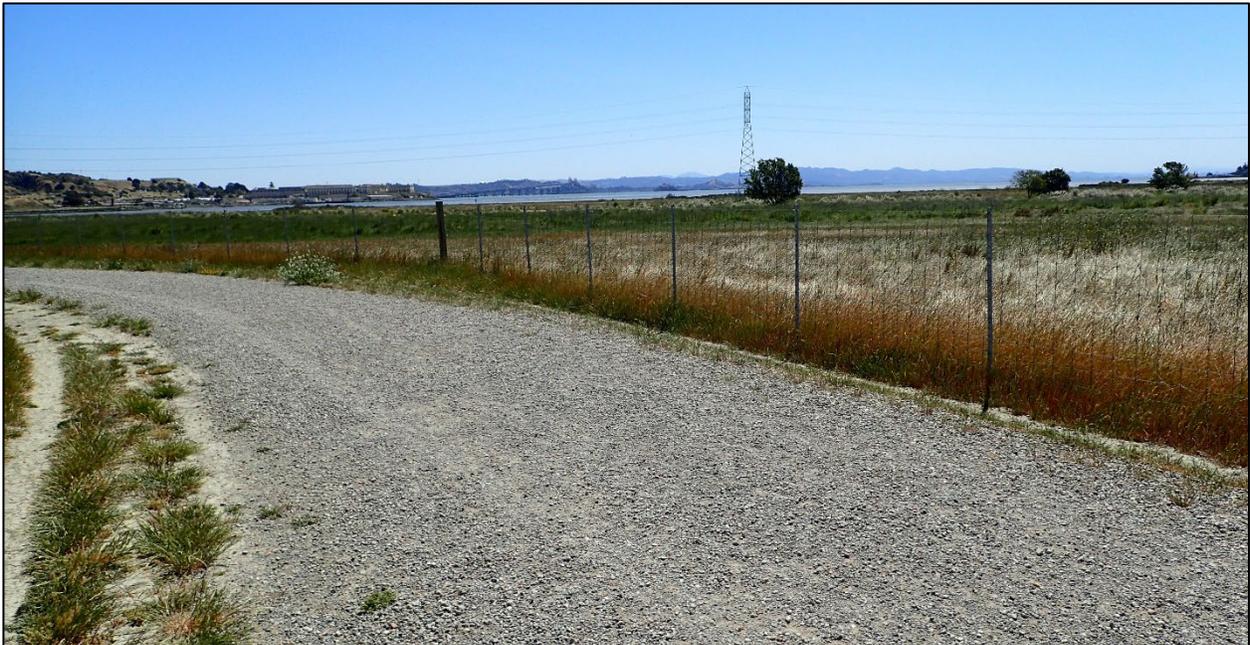
**Photograph 4.** Photo-monitoring Location 4. View of trail and exclusion fence, facing east. Photo taken May 20, 2022.

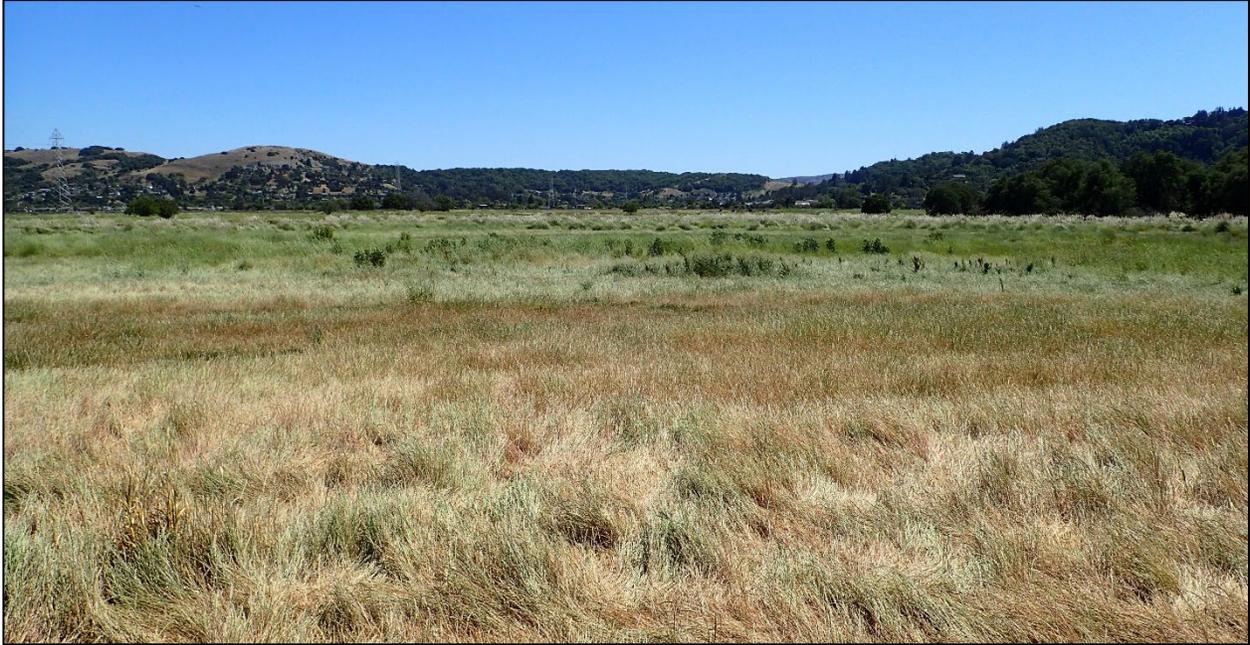
**Photograph 5.** Photo-monitoring Location 5. View of upland disposal area with seasonal wetland in background, facing south. Photo taken May 20, 2022

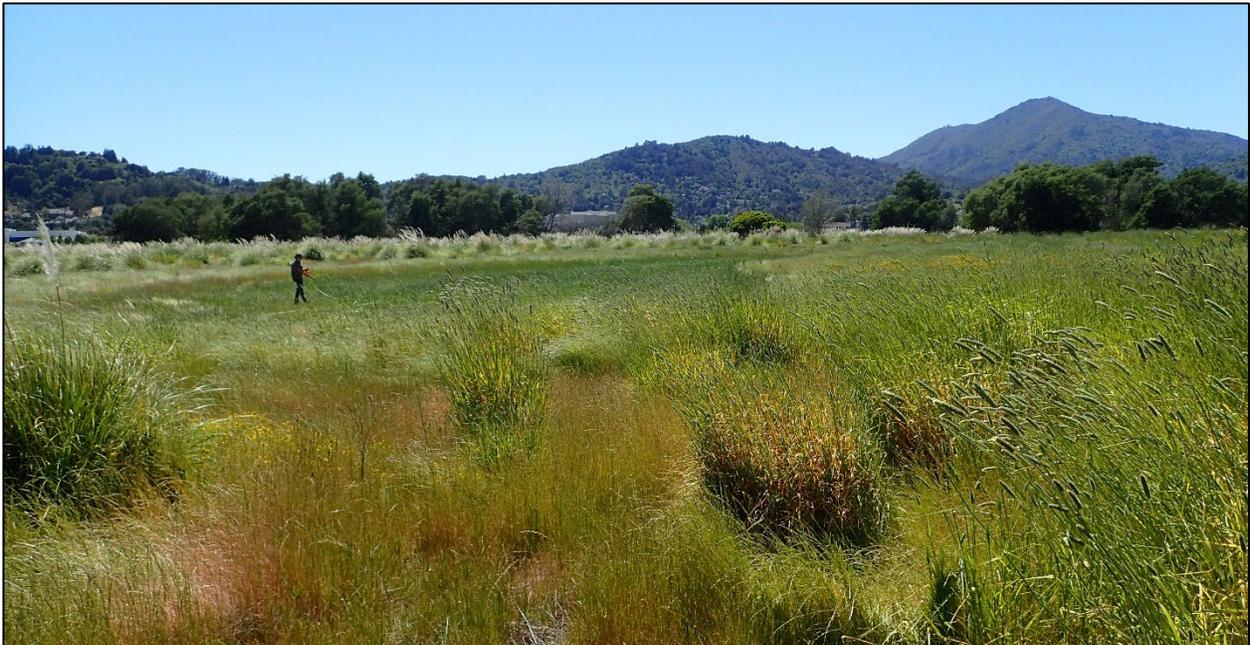
**Photograph 6.** Photo-monitoring Location 6. View of restored seasonal wetland, facing west. Photo taken May 20, 2022.

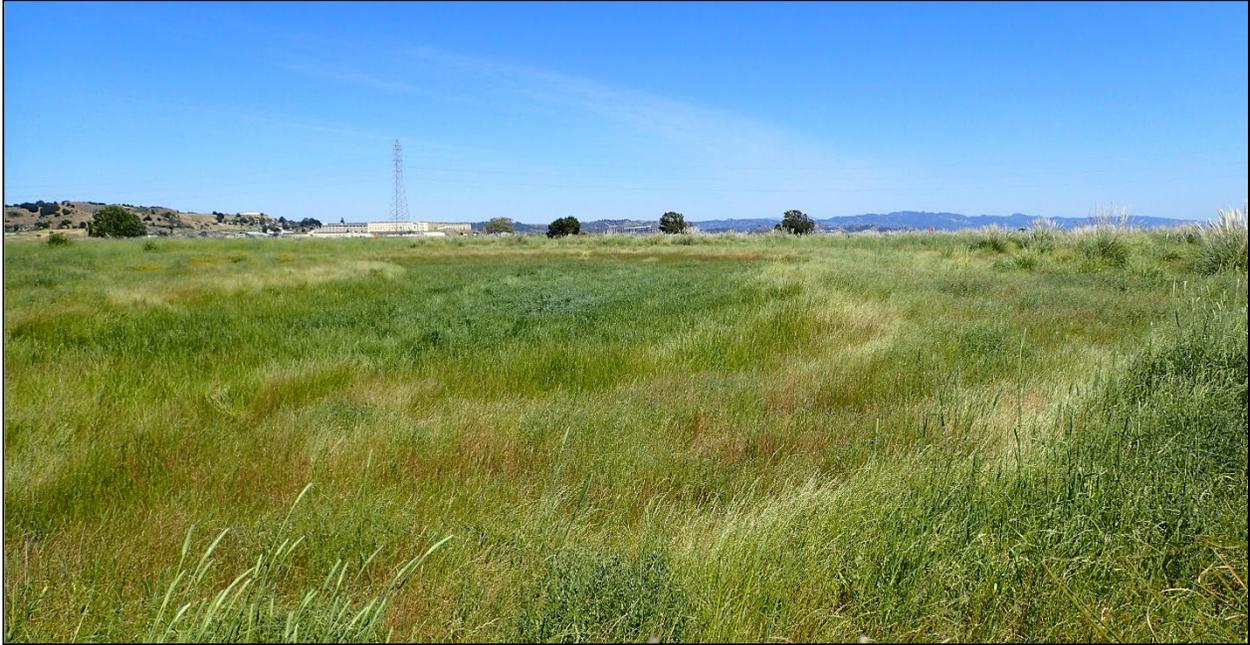
**Photograph 7.** Photo-monitoring Location 7. View of restored seasonal wetland, facing east. Photo taken May 20, 2022.

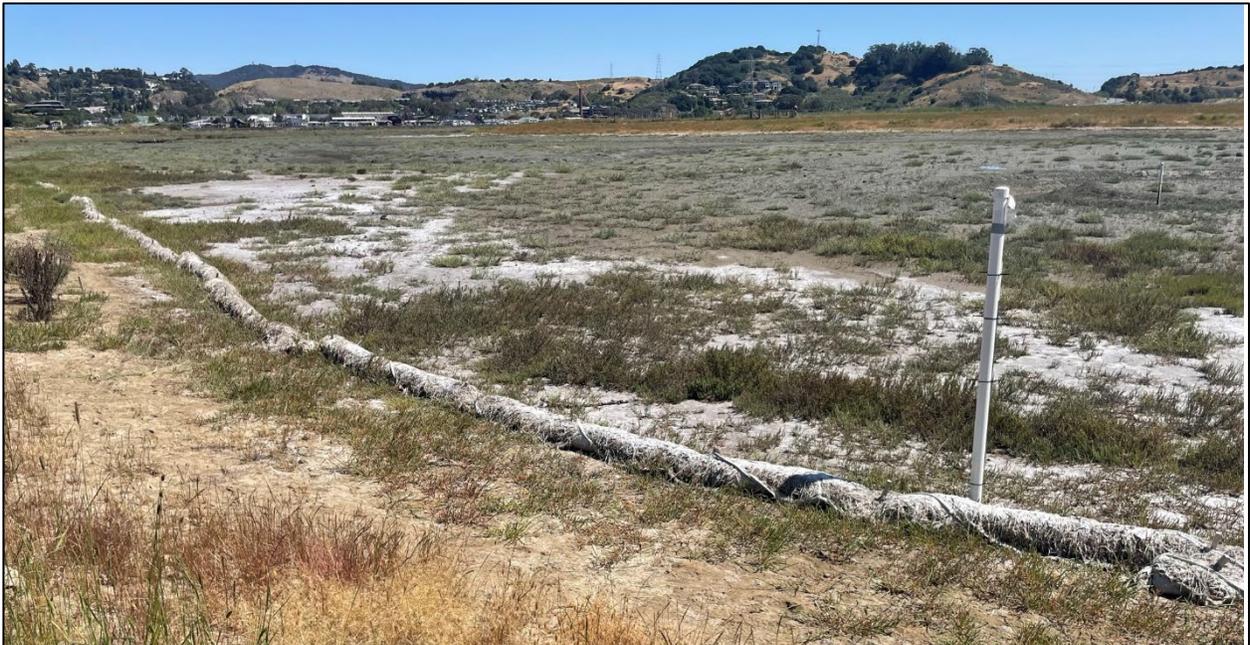
**Photograph 8.** Photo-monitoring Location 8. View of transition zone and tidal marsh, facing northeast. The tidal marsh vegetation in view is pickleweed (*Salicornia pacifica*). Photo taken May 20, 2022.

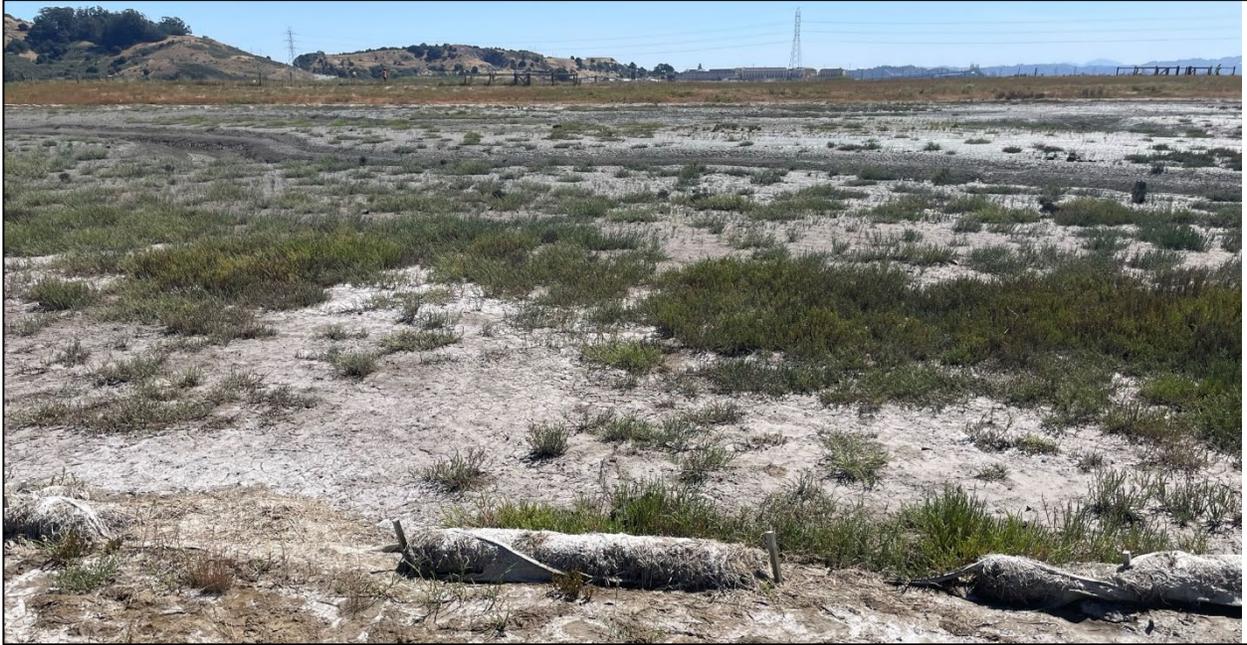
**Photograph 9.** Photo-monitoring Location 9. View of tidal marsh, facing east. Tidal marsh vegetation in view is dominated by pickleweed. Photo taken May 20, 2022.

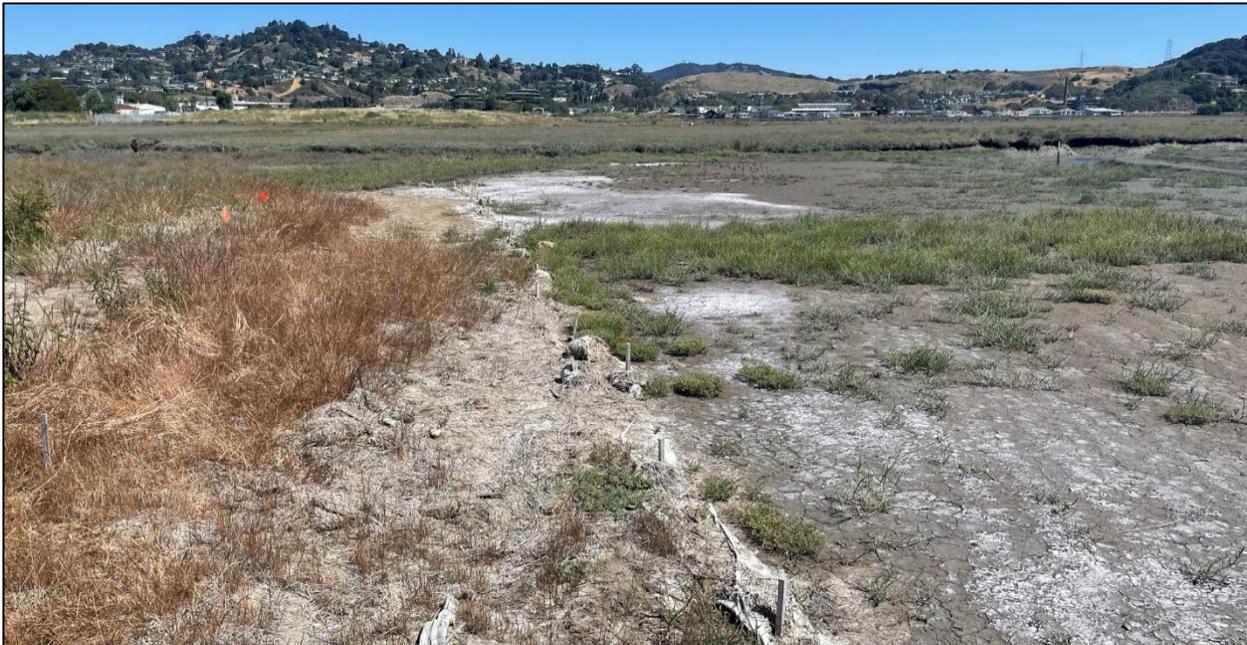
**Photograph 10.** Photo-monitoring Location 10. View of restored tidal marsh and adjacent previously existing marsh, facing north. Tidal marsh vegetation in view on the right is dominated by pickleweed. Vegetation in view on the left is a mix of Italian rye grass (*Festuca perennis*) and salt marsh baccharis (*Baccharis glutinosa*). Photo taken May 20, 2022.

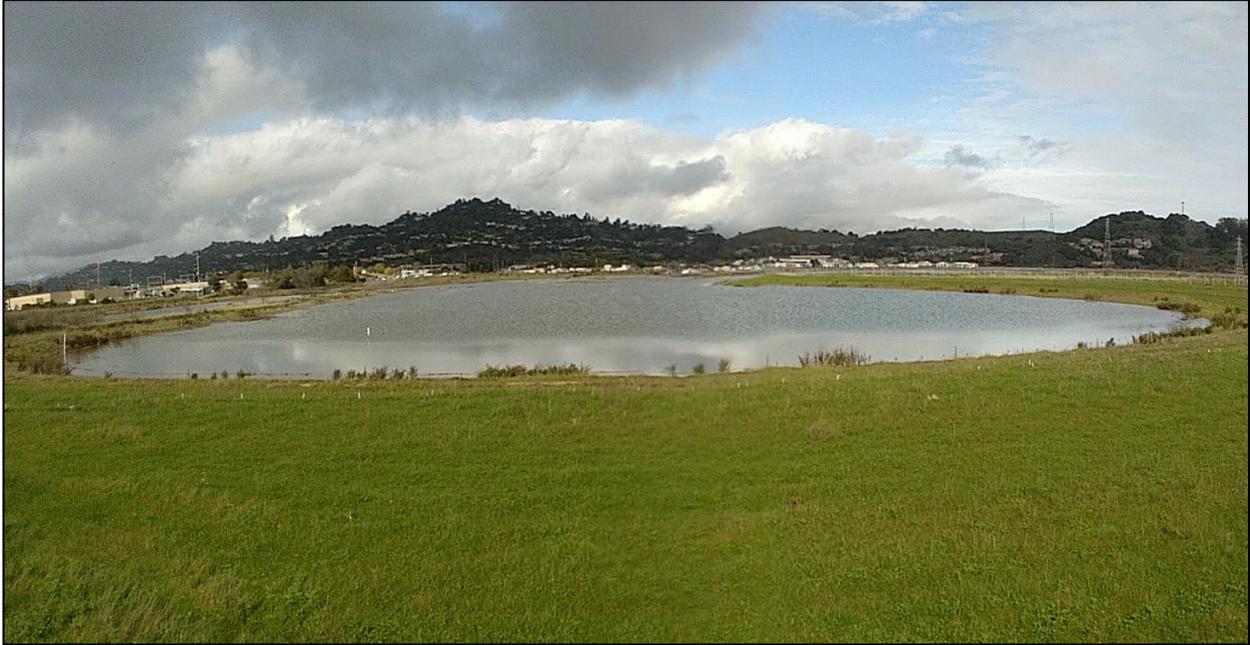
The as-built elevation for full tidal inundation of the restored tidal area is 6.5 feet NAVD88. Photographs were taken on January 4 and February 1, 2022 (Appendix C), that depict the restored tidal area fully inundated at high tide. The predicted highest tides on those dates (NOAA 2021) were 6.8 feet NAVD88 and 6.7 feet NAVD88, respectively, which corroborates the photographs. The photographs and corroborating tide predictions demonstrate that the restored tidal area is hydrologically functioning as designed for the second consecutive year since it was constructed. Because tidal hydrographs and tidal datums were compared, the Year 2 success criterion was met.

**Photograph 11.** View north of the restored tidal area fully inundated at high tide. The predicted high tide elevation was 6.7 feet mean lower low water. Photo taken January 4, 2022.

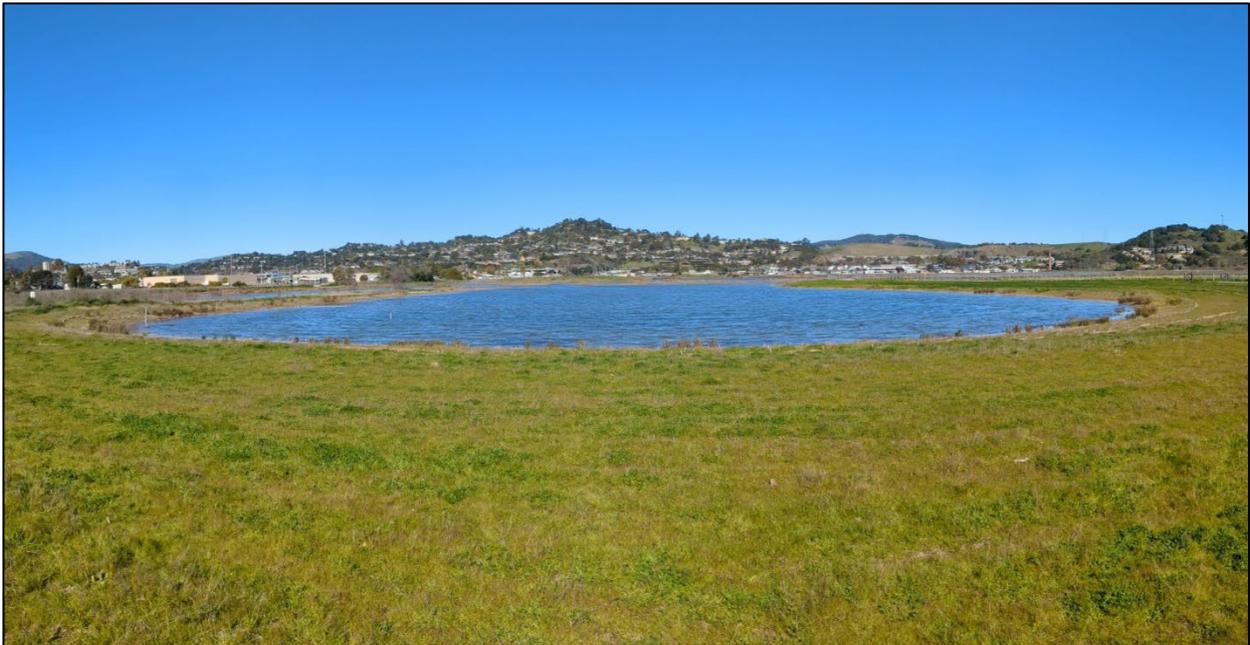
**Photograph 12.** View north of the restored tidal area fully inundated at high tide. The predicted high tide elevation was 6.6 feet mean lower low water. Photo taken February 1, 2022.

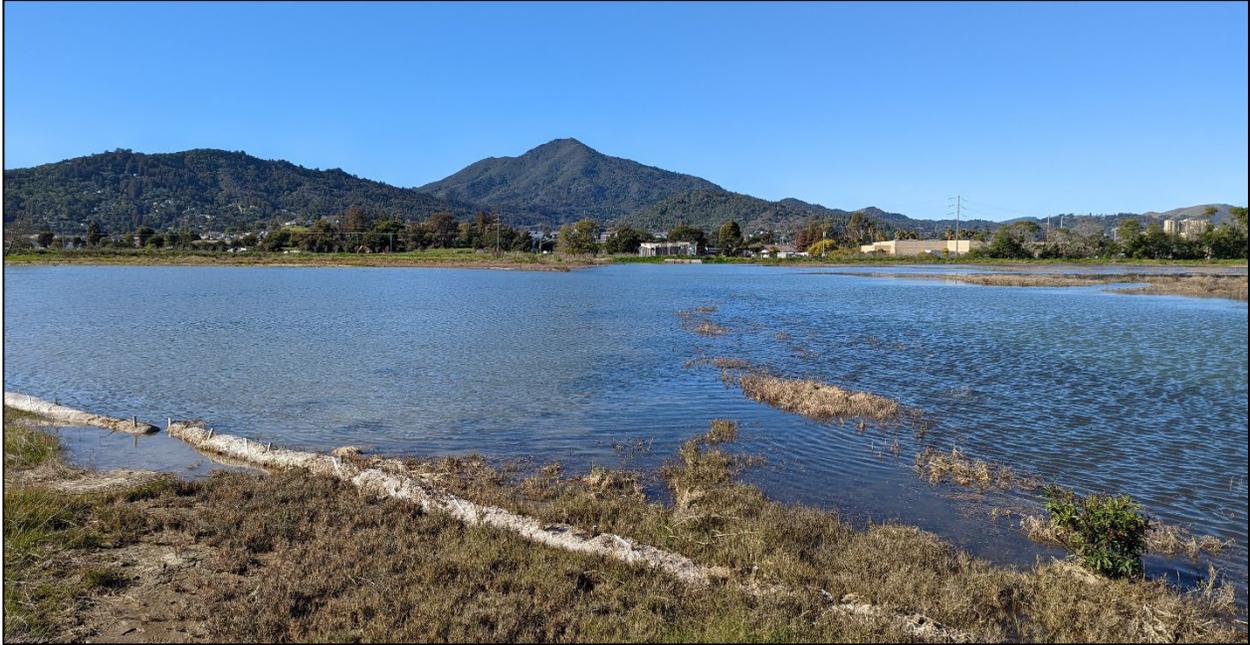
**Photograph 13.** View west of the restored tidal area fully inundated at high tide at the boundary with the Northern Drainage Channel. Emergent salt grass (*Distichlis spicata*), pickleweed, and marsh gumplant (*Grindelia stricta*) are visible. The predicted high tide elevation was 6.6 feet mean lower low water. Photo taken February 1, 2022.

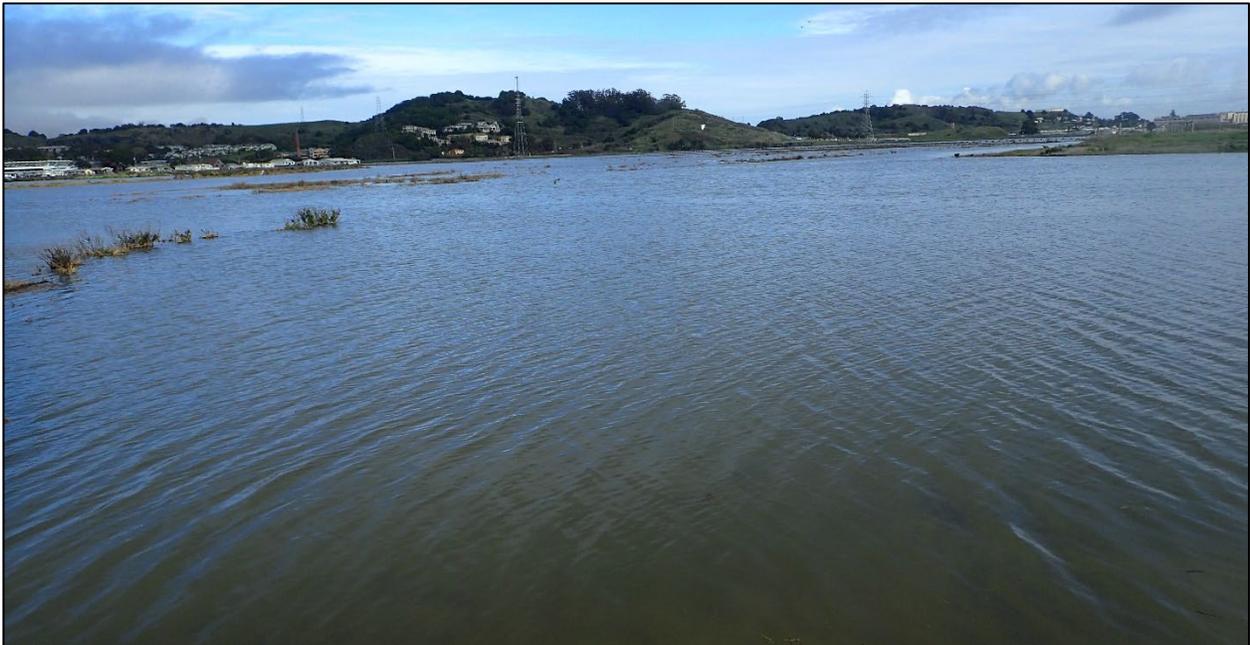
**Photograph 14.** View northeast of the restored tidal area fully inundated at high tide near the boundary with the Northern Drainage Channel. The predicted high tide elevation was 6.7 feet mean lower low water. Photo taken January 4, 2022.

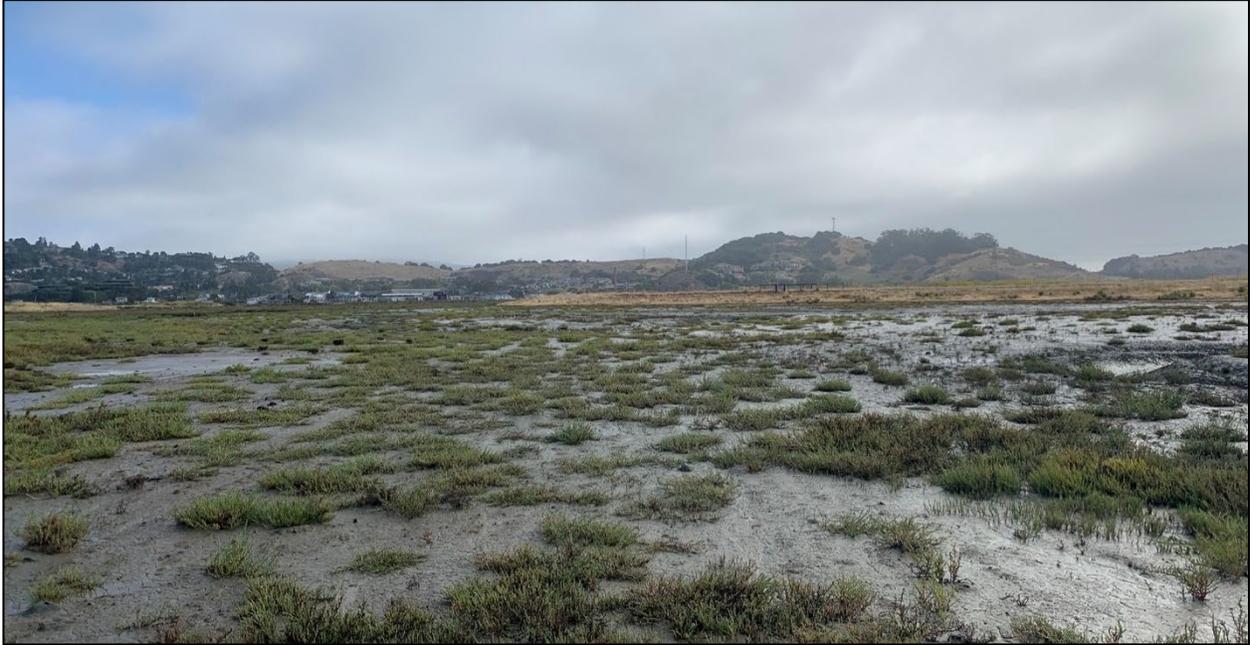
Vegetation in the high marsh is expanding more rapidly than anticipated. Planted individuals have expanded, and natural recruits have also established beyond planted areas. Pickleweed (*Salicornia pacifica*) recruits were the most abundant, but other species were observed, including alkali heath (*Frankenia salina*), marsh jaumea (*Jaumea carnosa*), and salt grass (*Distichlis spicata*). Photographs showing tidal marsh species recruitment are provided in Appendix C, and the vegetated areas are depicted in Appendix A, Figure 5. No non-native species were observed in high marsh. A total of 1.26 acres of the 3.80 acres of high marsh (33 percent) were vegetated by native plant species. Therefore, absolute native plant cover within the high marsh was greater than 15 percent, and the Year 2 high marsh success criterion was met.

**Photograph 15.** View of the high marsh in the restored tidal marsh. Image shows expanding native plantings, primarily pickleweed, as well as natural native species recruits. Photo taken July 14, 2022.

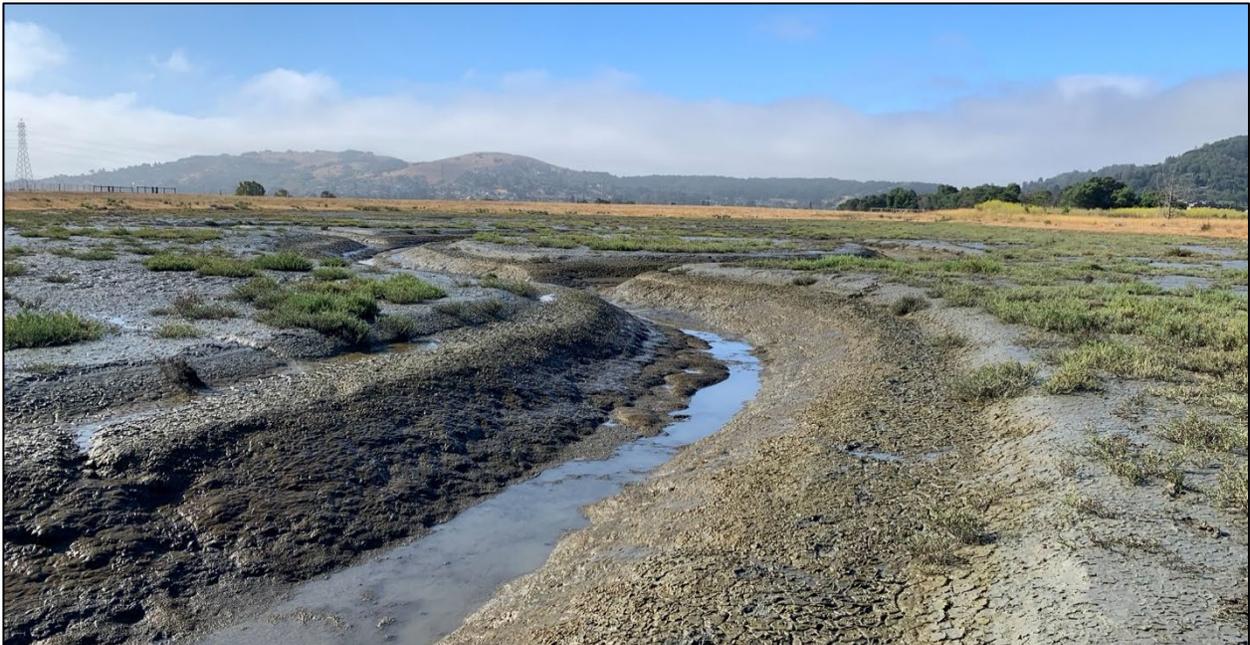
The tidal marsh, transition zone, upland refugia, and seasonal wetland are performing well, and are meeting all applicable Year 2 success criteria. Cordgrass has not yet established at low marsh elevations, and so the low marsh vegetation criterion is not yet applicable. Low marsh vegetation cannot be planted because of ISP recommendations, so the vegetation will have to develop naturally, and no management actions can be taken to improve colonization.

**Photograph 16.** View of the low marsh (center) and high marsh (sides and background) in the restored tidal marsh, looking south from the northern boundary of the marsh. Image shows expanding native plantings as well as natural native species recruits, primarily pickleweed. Photo taken July 14, 2022.

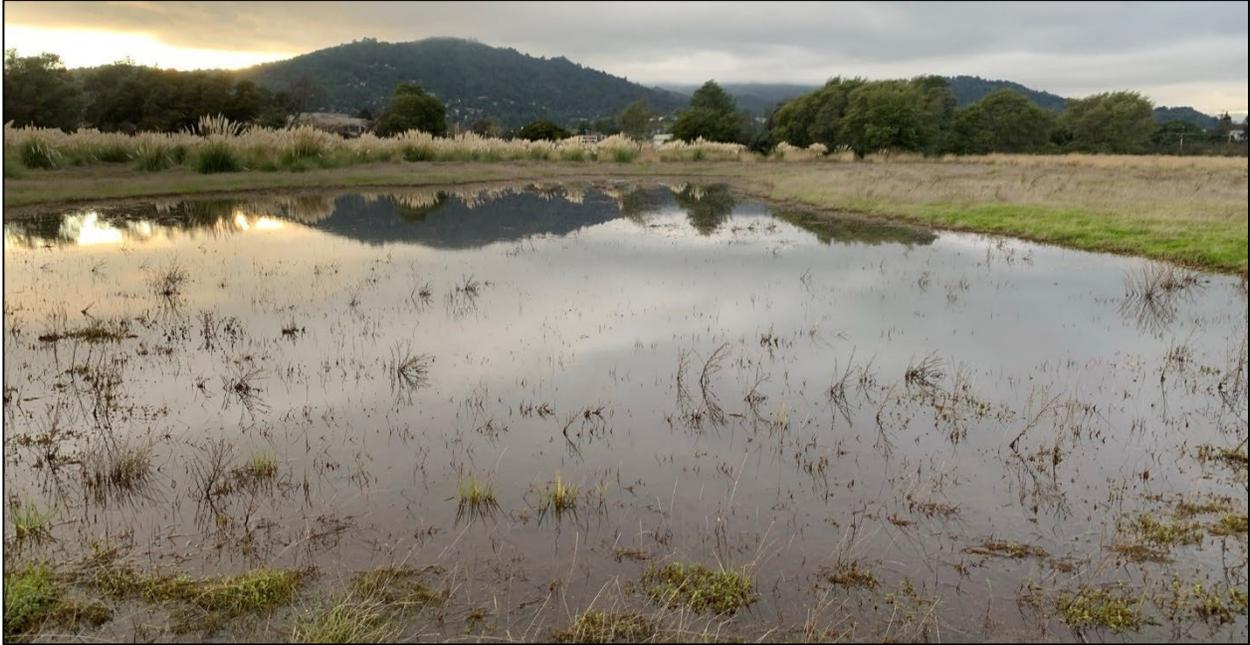
The restored seasonal wetland was directly observed on the ground on November 18 and December 3, 2021, and January 4 and February 1, 2022. On November 18 and December 3, 2021, and January 4, 2022, the wetland was completely full. On February 1, 2022, it had a narrow, saturated fringe but was otherwise inundated. The observations demonstrate that the wetland was inundated and/or saturated for more than 14 days during the Year 2 monitoring period. Therefore, the Year 2 success criterion was met.

**Photograph 17.** View of the restored seasonal wetland, facing west. Image shows the wetland fully inundated. Photo taken November 19, 2021.

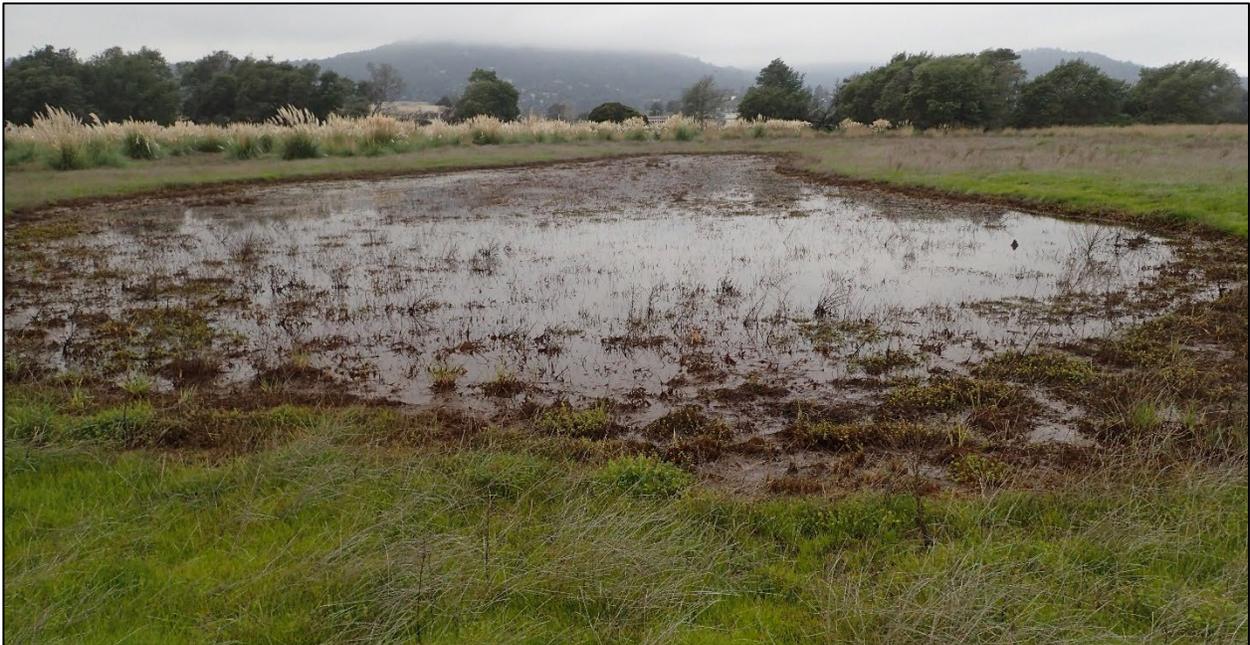
**Photograph 18.** View of the restored seasonal wetland, facing west. Image shows the wetland fully inundated. Image shows inundation and/or surface saturation throughout the wetland. Photo taken December 3, 2021.

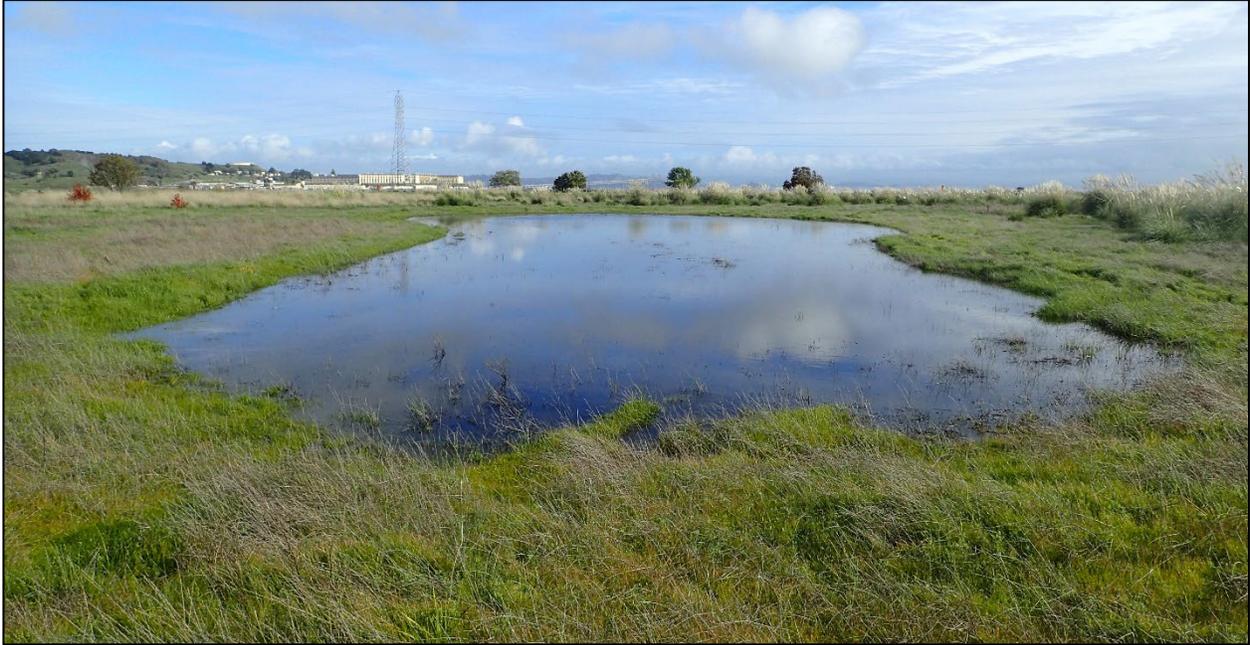
**Photograph 19.** View of the restored seasonal wetland, facing east. Image shows the wetland fully inundated. Photo taken January 4, 2022.

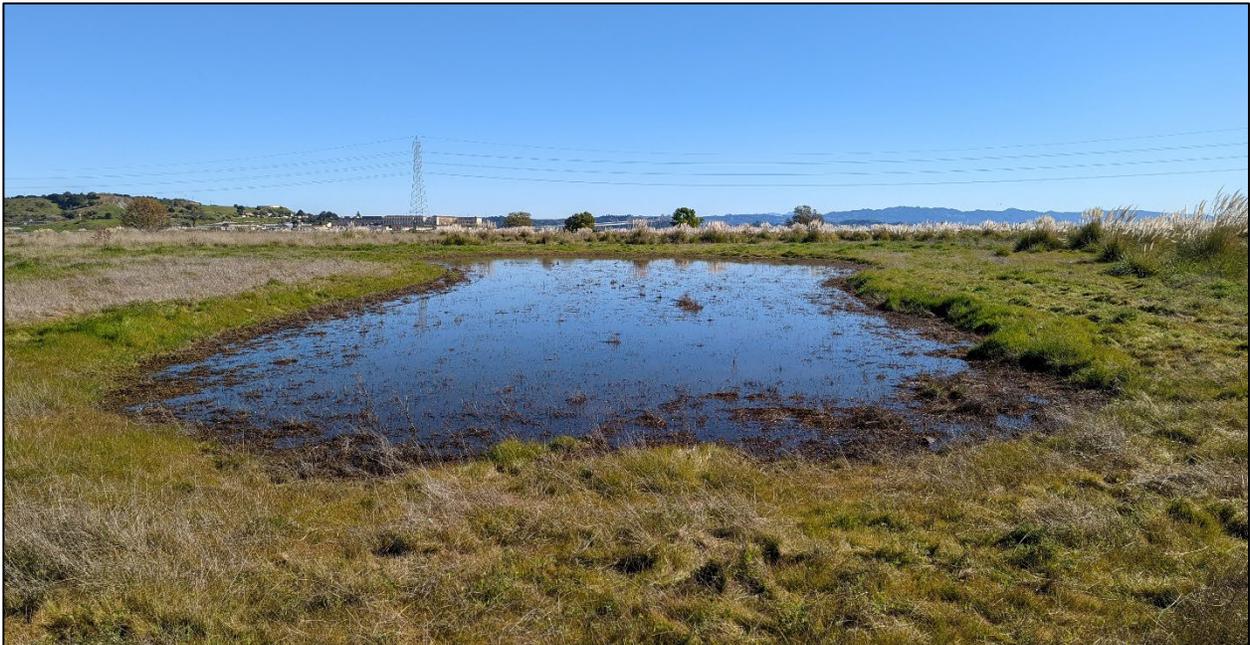
**Photograph 20.** View of the restored seasonal wetland, facing east. Image shows the wetland entirely inundated or saturated. Photo taken February 1, 2022.

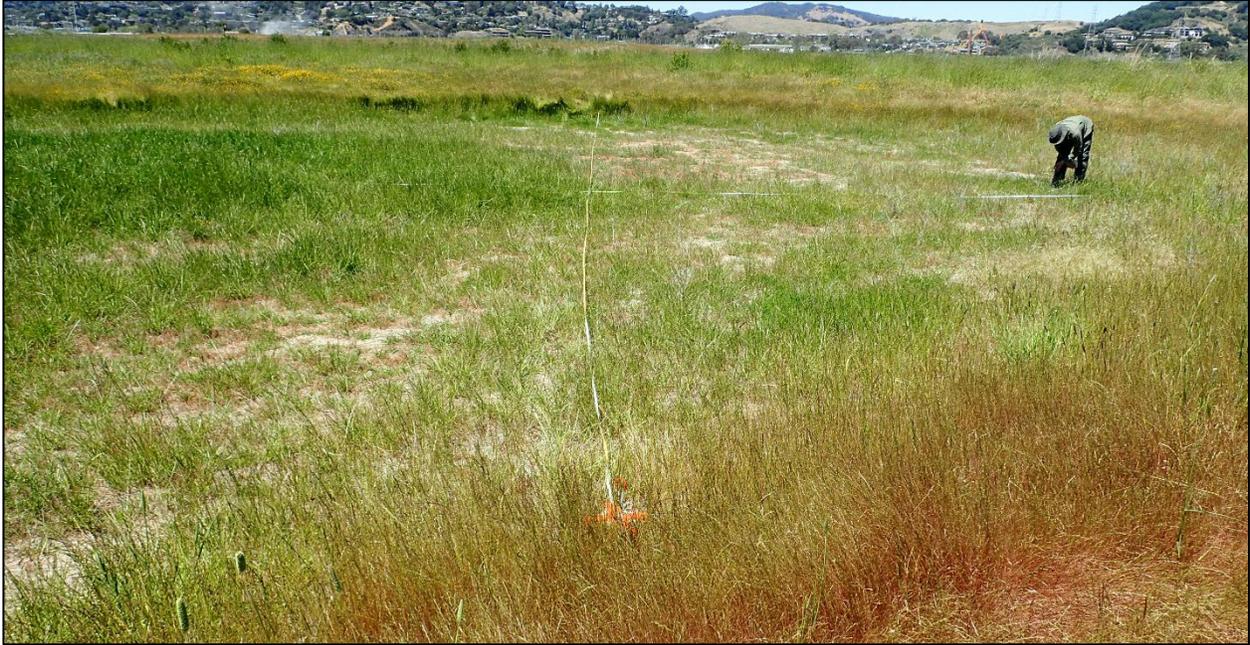
**Photograph 21.** View facing north of the eastern end of the restored seasonal wetland during annual vegetation monitoring. The more sparsely vegetated areas are naturally occurring as a result of the combination of more prolonged inundation in slightly deeper areas as well as higher salinity soils. Photo taken May 20, 2022.

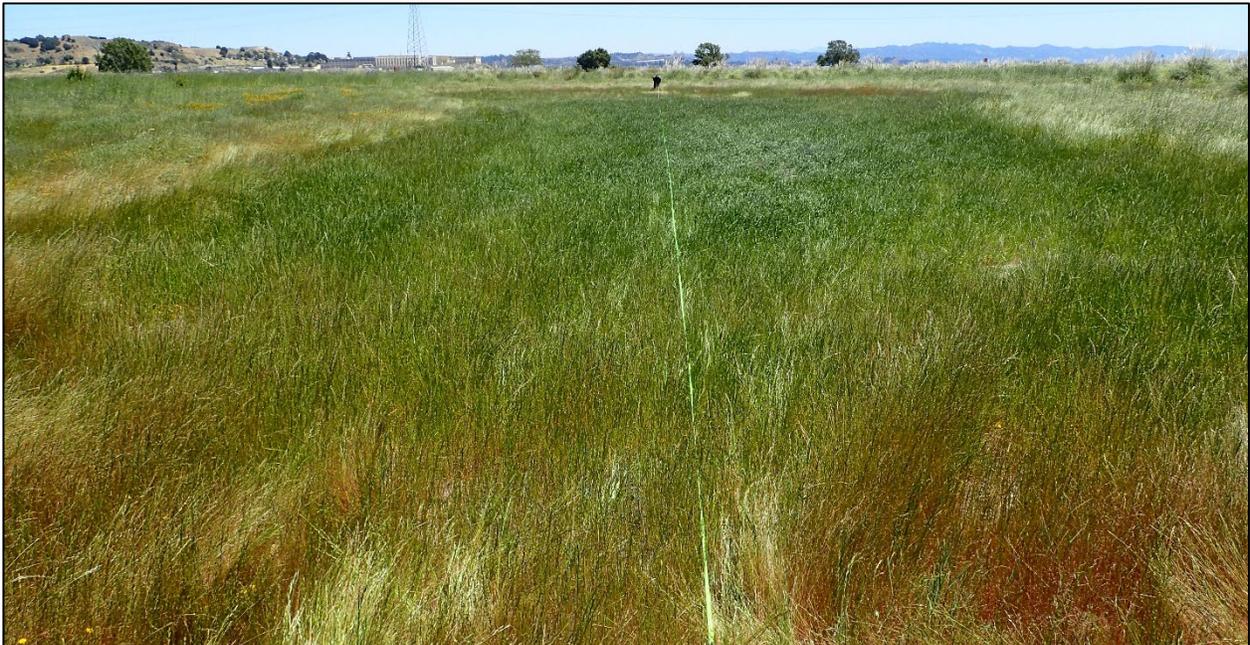
**Photograph 22.** View facing east of the restored seasonal wetland with dense vegetation during annual vegetation monitoring. Photo taken May 20, 2022.
