Corte Madera Four-Acre Tidal Marsh Restoration Project

Year 3 (2023) Annual Monitoring Report

Corte Madera, Marin County, California

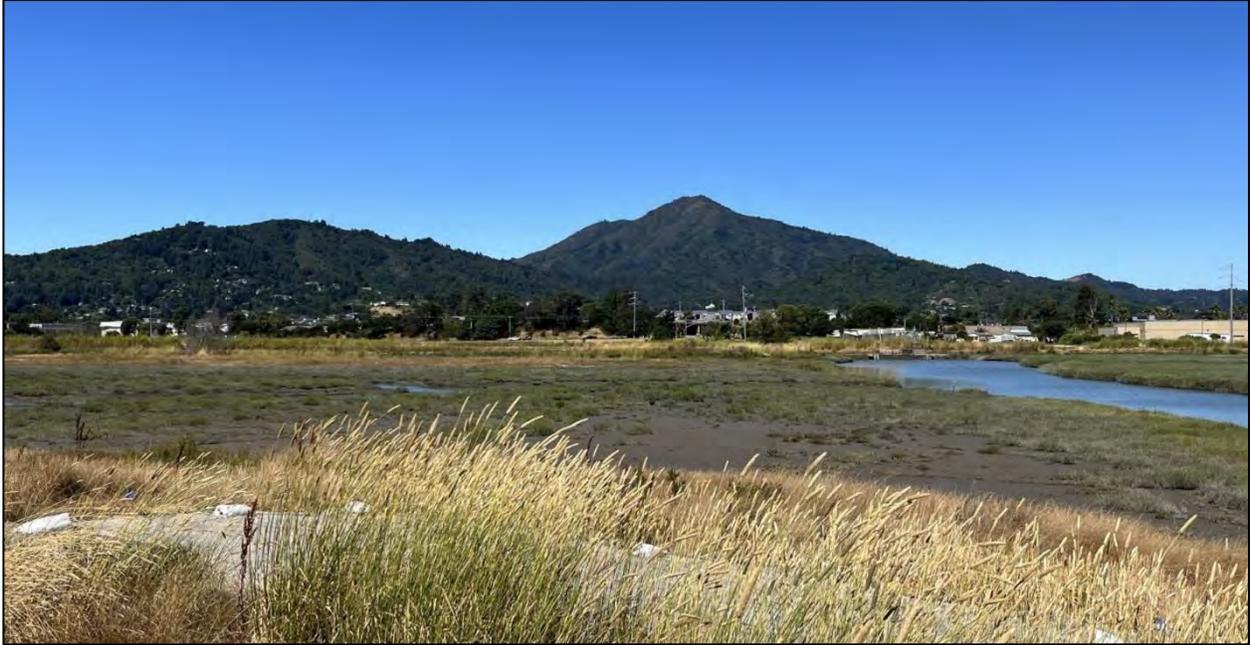
Photograph 1. Photo-monitoring Location 1. View of transition zone and tidal marsh, facing west. Photo taken July 12, 2023.

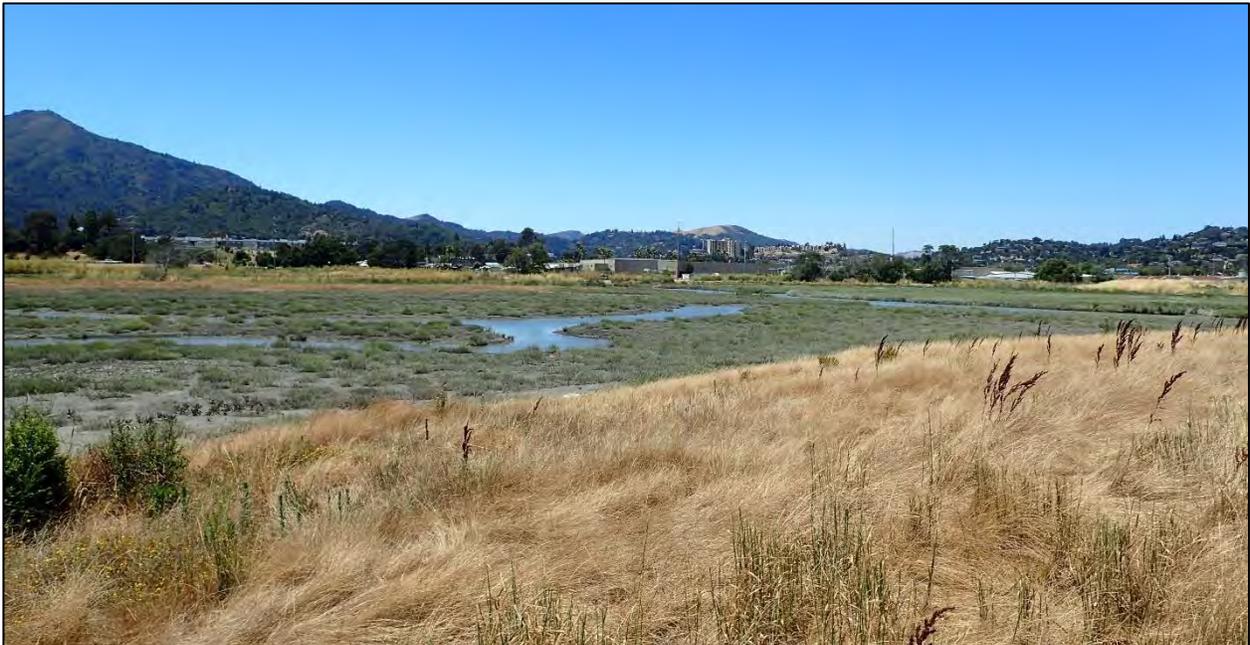
Photograph 2. Photo-monitoring Location 2. View of tidal marsh (background), transition zone (a narrow band adjacent to the tidal marsh), and uplands (foreground), facing northwest. Photo taken July 14, 2023.

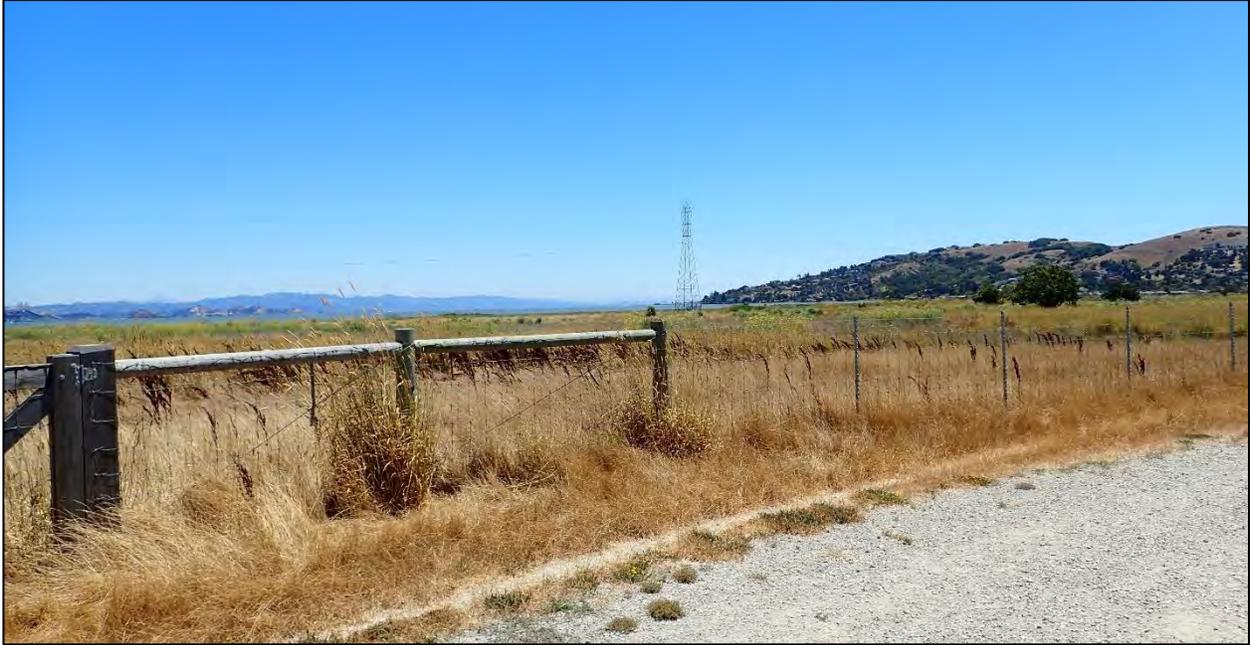
Photograph 3. Photo-monitoring Location 3. View of trail and exclusion fence, facing southeast. Photo taken July 14, 2023.

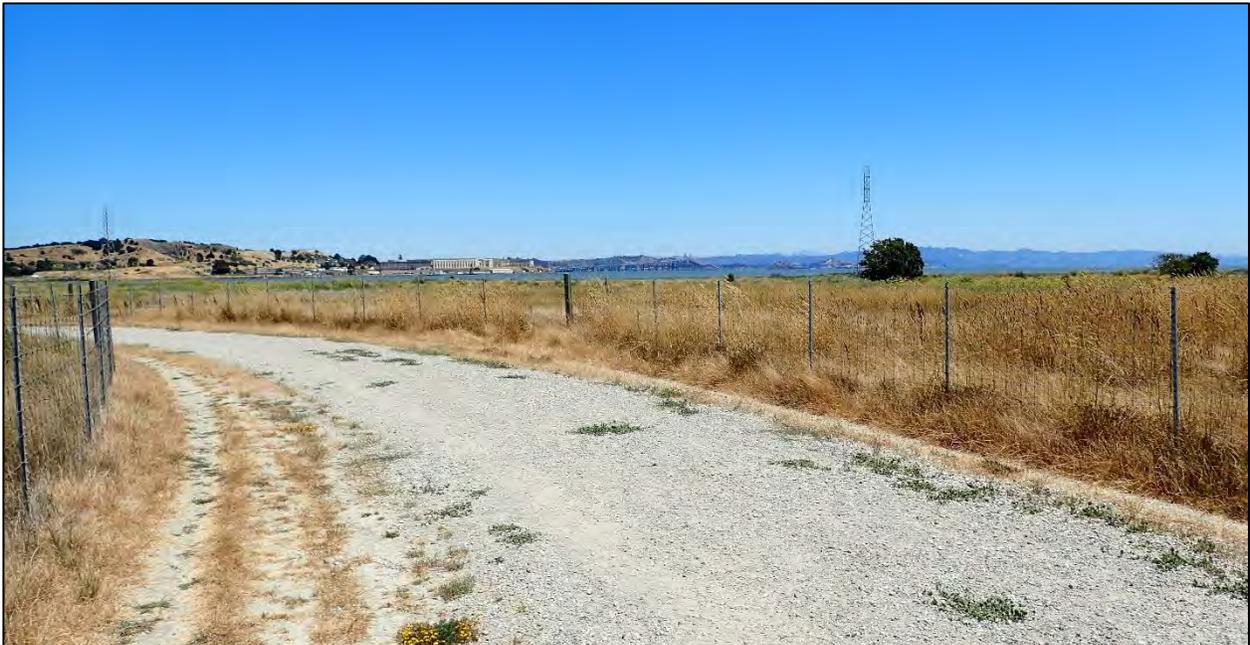
Photograph 4. Photo-monitoring Location 4. View of trail and exclusion fence, facing east. Photo taken July 14, 2023.

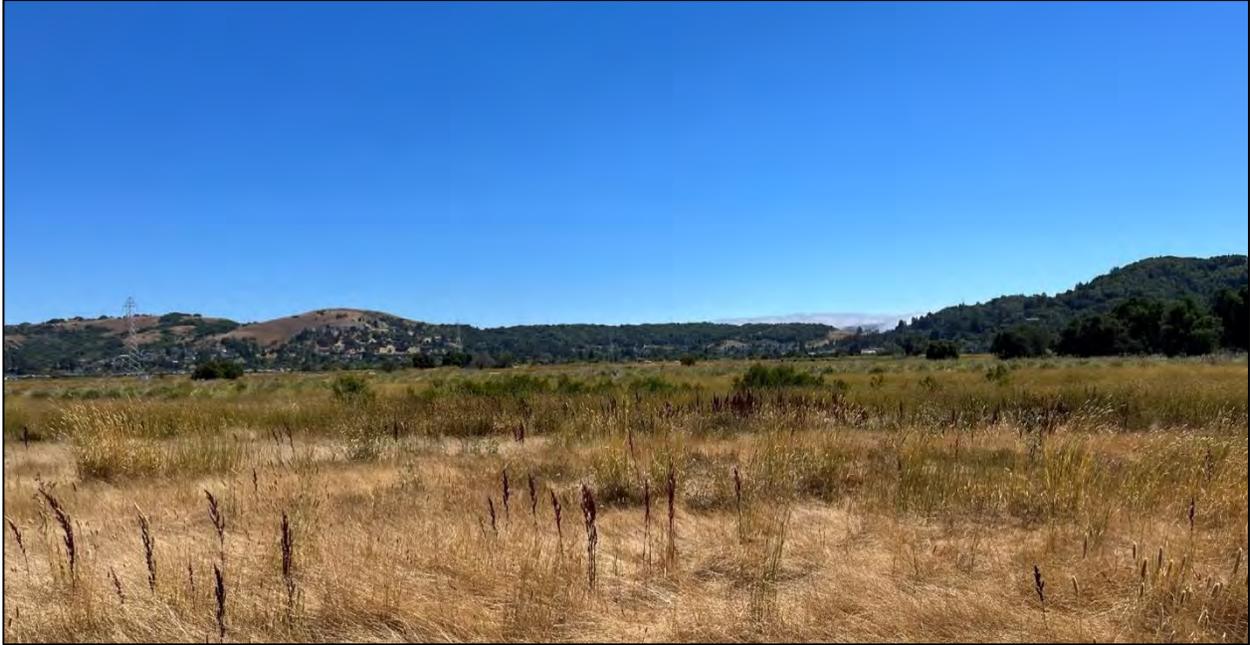
Photograph 5. Photo-monitoring Location 5. View of upland disposal area with seasonal wetland in background, facing south. Photo taken July 12, 2023.

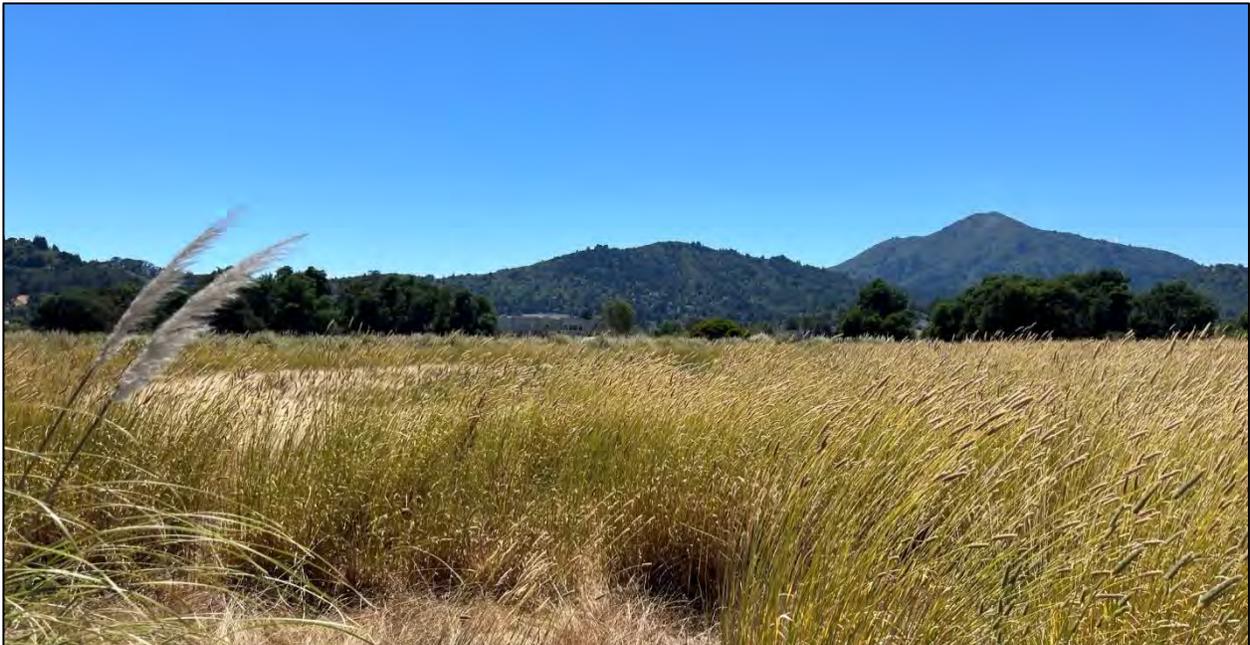
Photograph 6. Photo-monitoring Location 6. View of restored seasonal wetland, facing west. Photo taken July 12, 2023.

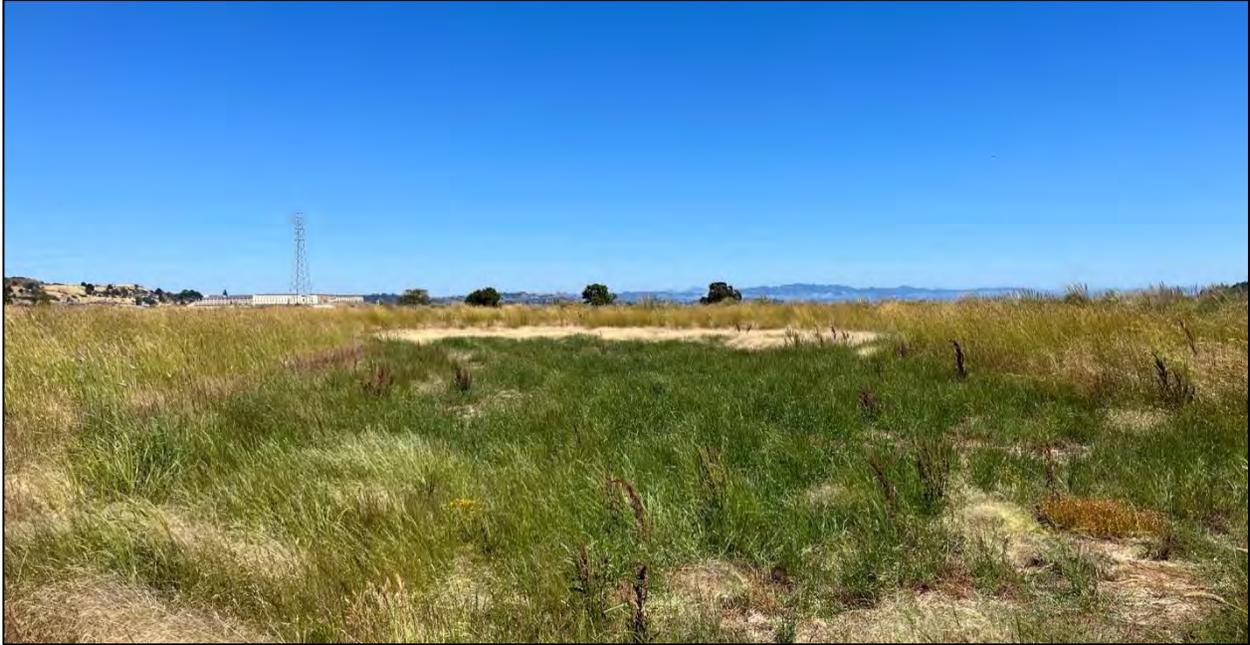
Photograph 7. Photo-monitoring Location 7. View of restored seasonal wetland, facing east. Photo taken July 12, 2023.

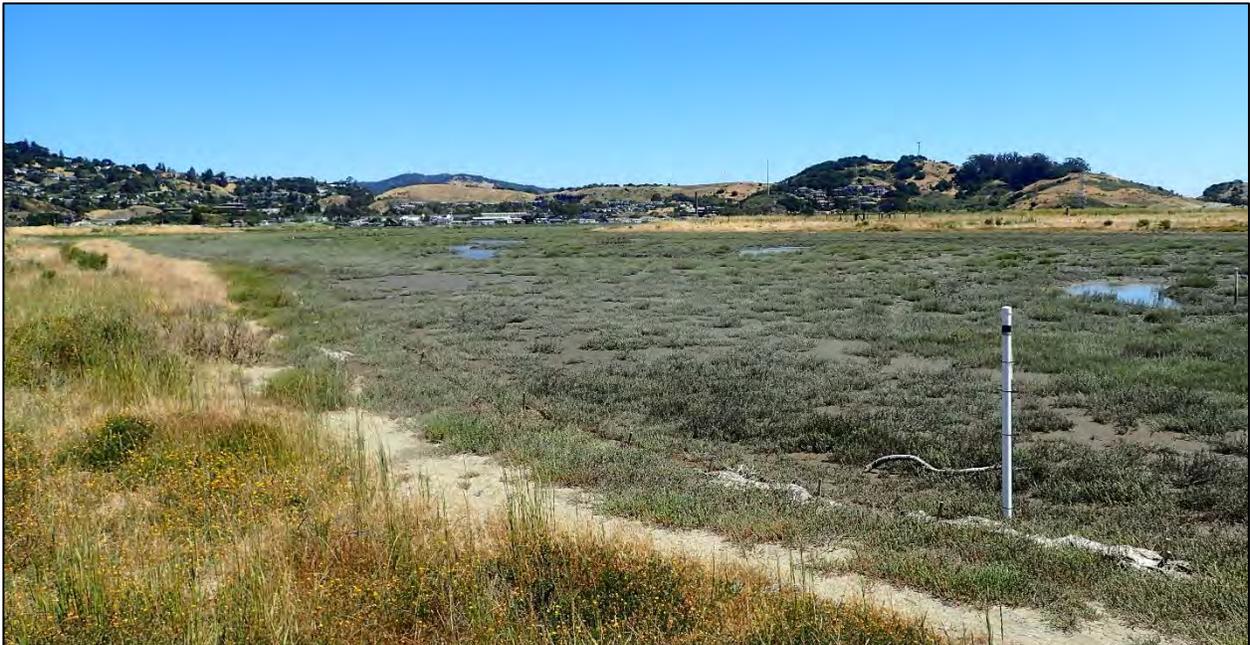
Photograph 8. Photo-monitoring Location 8. View of transition zone and tidal marsh, facing northeast. The tidal marsh vegetation in view is pickleweed (*Salicornia pacifica*). Photo taken July 14, 2023.

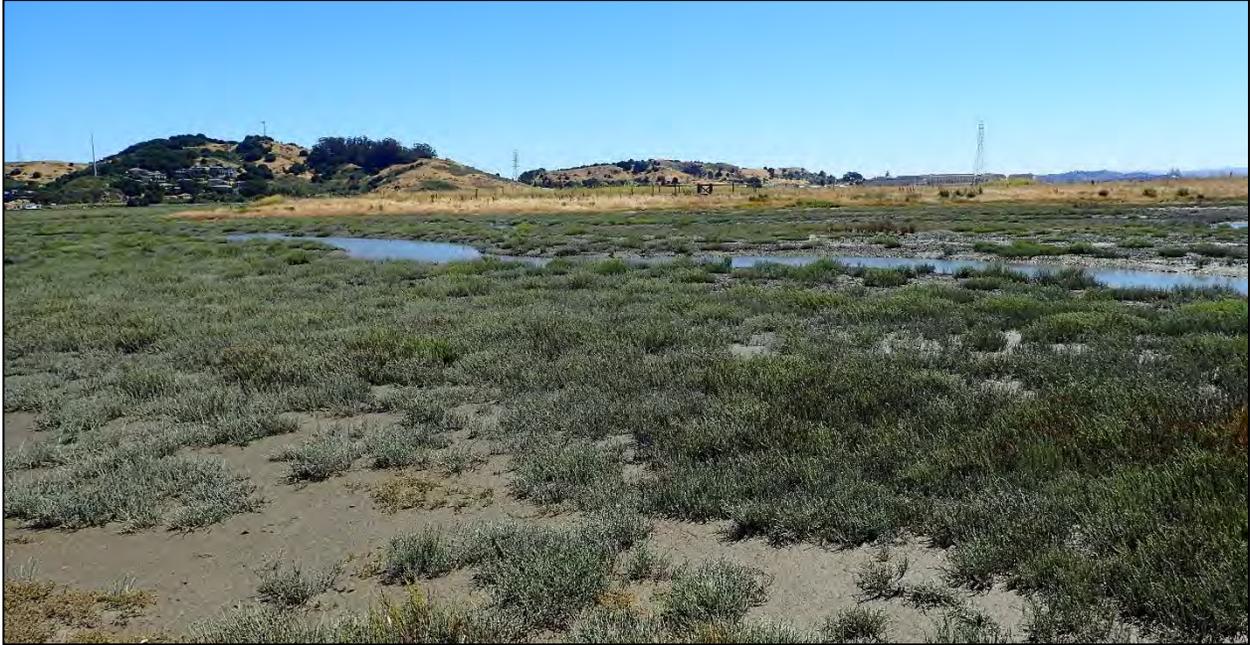
Photograph 9. Photo-monitoring Location 9. View of tidal marsh, facing east. Tidal marsh vegetation in view is dominated by pickleweed. Photo taken July 14, 2023.

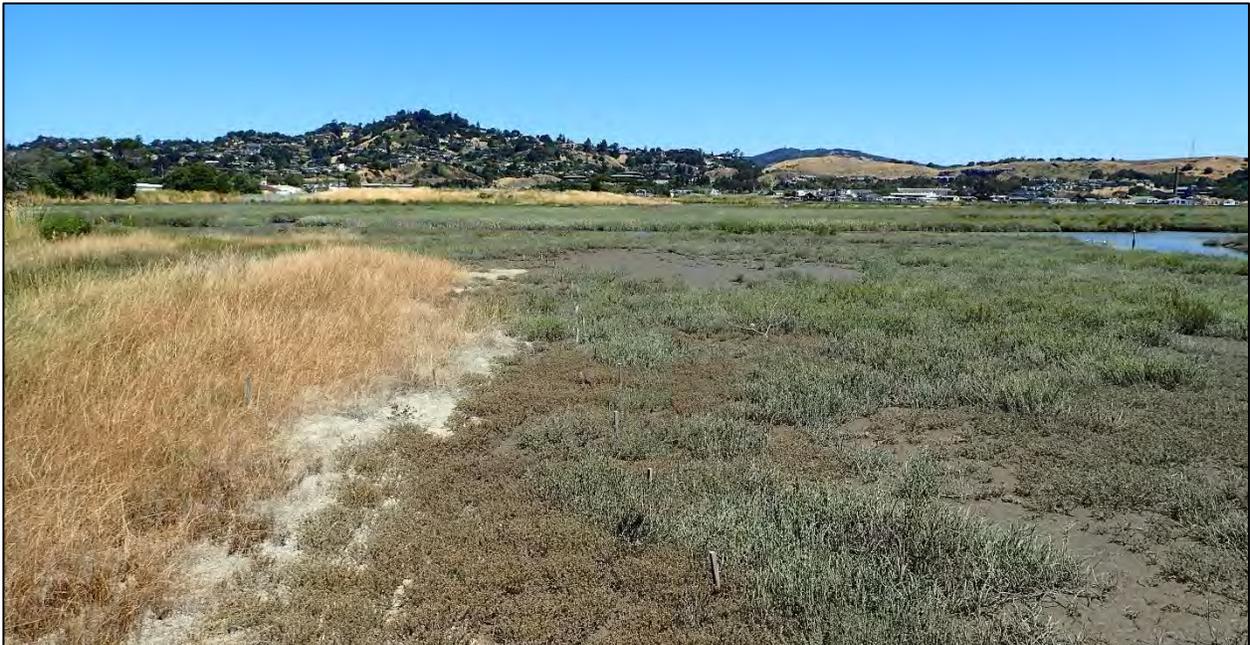
Photograph 10. Photo-monitoring Location 10. View of restored tidal marsh and adjacent previously existing marsh, facing north. Tidal marsh vegetation in view on the right is dominated by pickleweed. Vegetation in view on the left is dominated by Italian rye grass (*Festuca perennis*). Photo taken July 14, 2023.

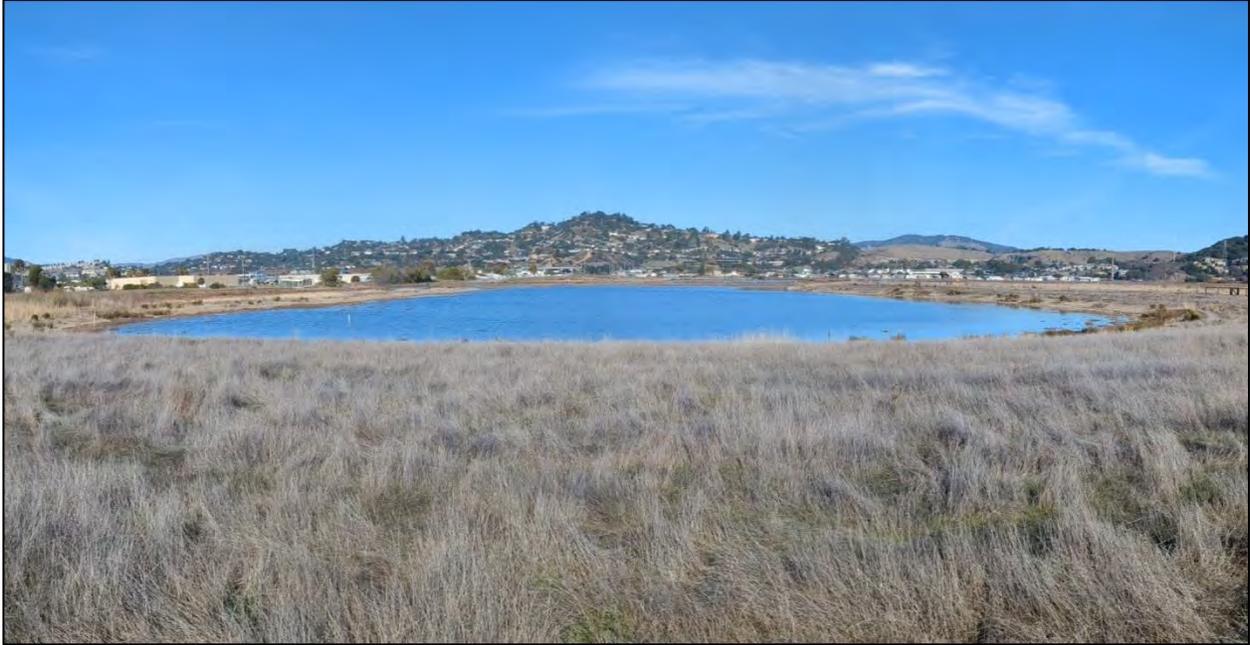
Photograph 11. View north of the restored tidal area fully inundated at high tide. The predicted high tide elevation was 6.5 feet mean lower low water. Photo taken November 23, 2022.

The as-built elevation for full tidal inundation of the restored tidal area is 6.5 feet NAVD88. Photographs were taken on November 23, 2022, and January 3, 2023 (Appendix C), that depict the restored tidal area fully inundated at high tide. The predicted highest tides on those dates (NOAA 2021, 2022) were 6.8 feet NAVD88 and 6.5 feet NAVD88, respectively, which corroborates the photographs. The photographs and corroborating tide predictions demonstrate that the restored tidal area is hydrologically functioning as designed for the second consecutive year since it was constructed. Because tidal hydrographs and tidal datums were compared, the Year 3 success criterion was met.

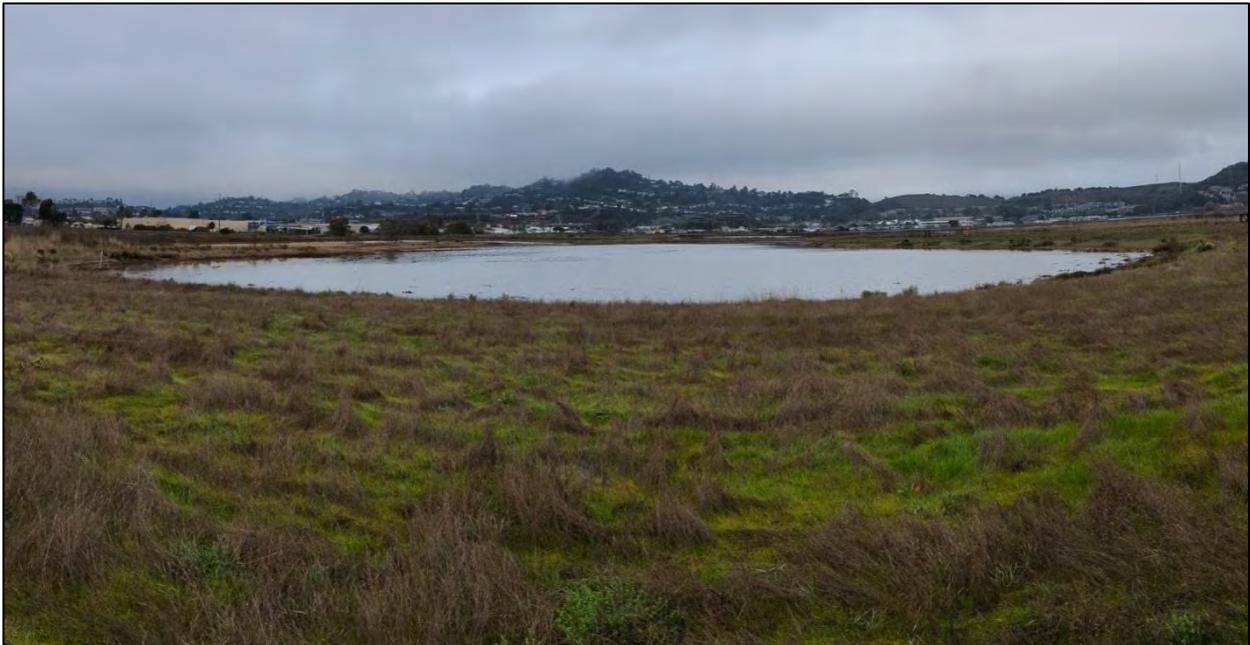
Photograph 12. View north of the restored tidal area fully inundated at high tide. The predicted high tide elevation was 6.2 feet mean lower low water. Photo taken January 3, 2023.

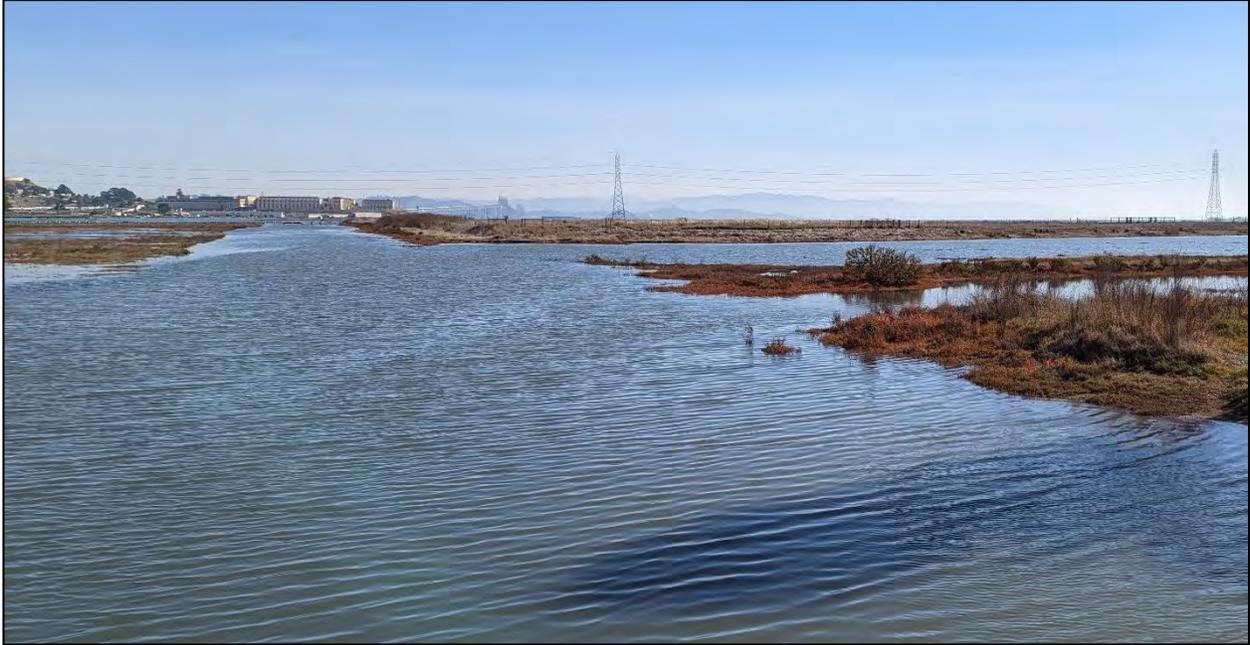
Photograph 13. View southeast of the restored tidal area (upper center and upper right), Northern Drainage Channel, and adjacent tidal marsh fully inundated at high tide. The predicted high tide elevation was 6.5 feet mean lower low water. Photo taken from the public path at the pump station. Photo taken November 23, 2022.

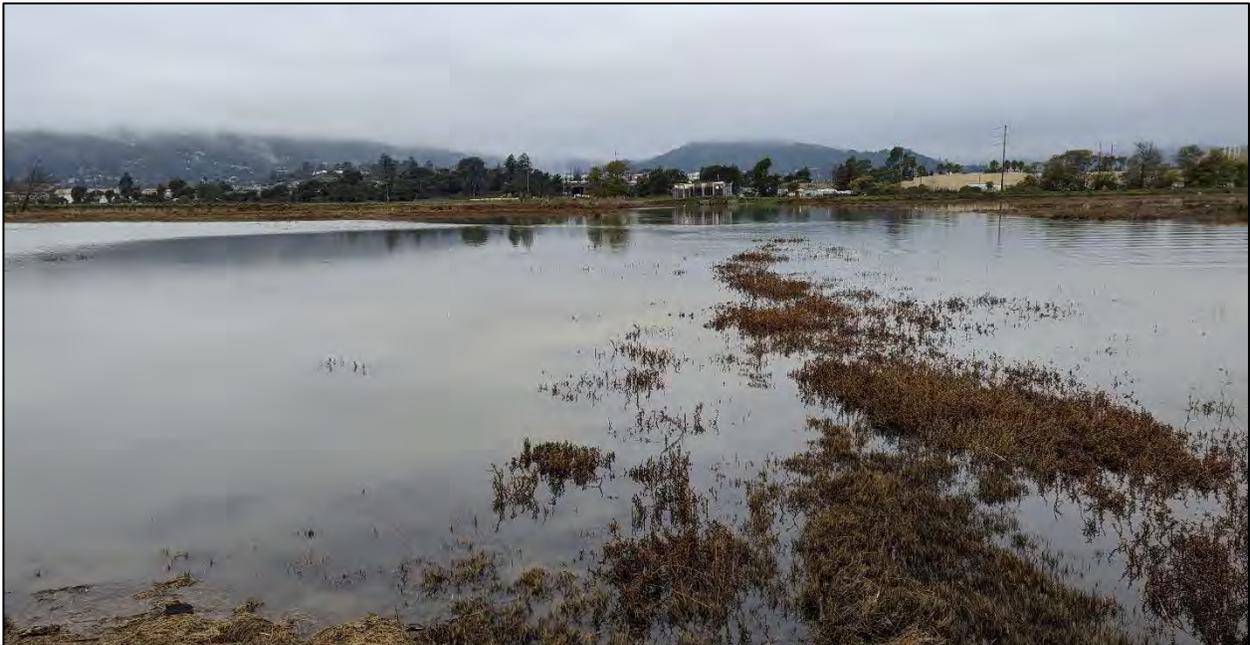
Photograph 14. View west of the restored tidal area fully inundated at high tide near the boundary with the Northern Drainage Channel. The predicted high tide elevation was 6.2 feet mean lower low water. Photo taken January 3, 2023.

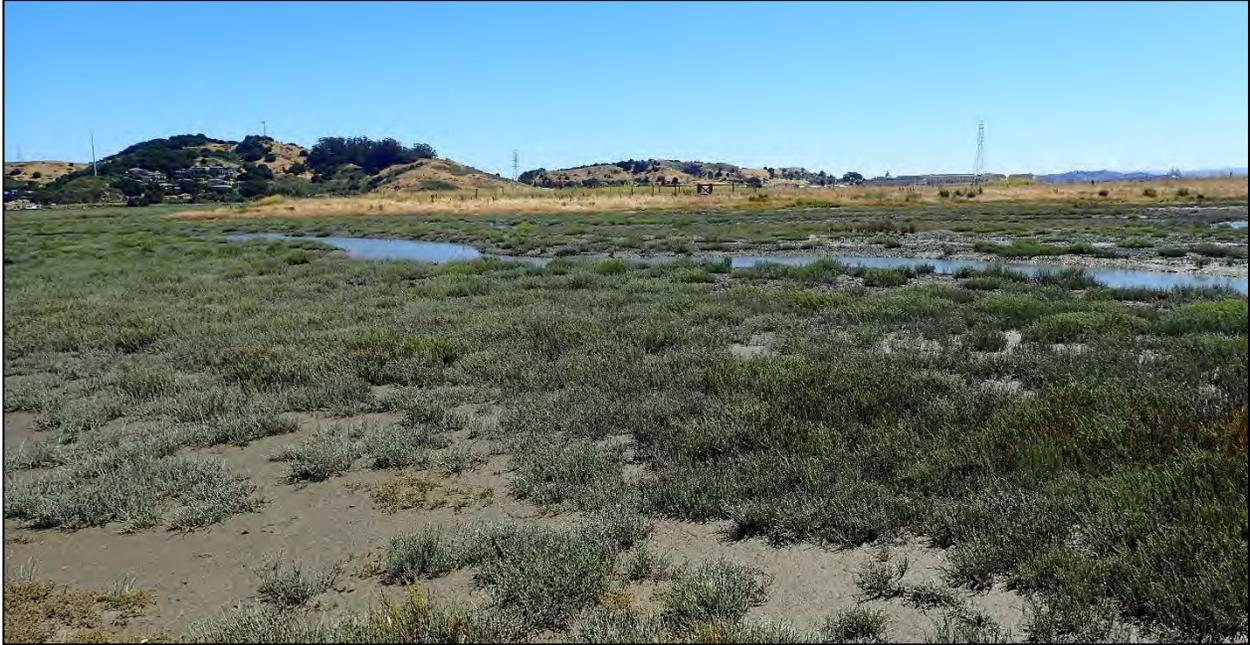
Photograph 15. View of the high marsh in the restored tidal marsh. Image shows expanding native plantings, primarily pickleweed, as well as natural native species recruits. Photo taken July 14, 2023.

Vegetation in the high marsh continues to expand. Planted individuals have expanded, and natural recruits have also established beyond planted areas. Pickleweed (*Salicornia pacifica*) recruits were the most abundant, but other species were observed, including alkali heath (*Frankenia salina*), marsh jaumea (*Jaumea carnosa*), and salt grass (*Distichlis spicata*). Photographs showing tidal marsh species recruitment are provided in Appendix C, and the vegetated areas are depicted in Appendix A, Figure 5. No non-native species were observed in high marsh. A total of 1.43 acres of the 3.80 acres of high marsh (38 percent) were vegetated by native plant species. Therefore, absolute native plant cover within the high marsh was greater than 22.5 percent, and the Year 3 high marsh success criterion was met.

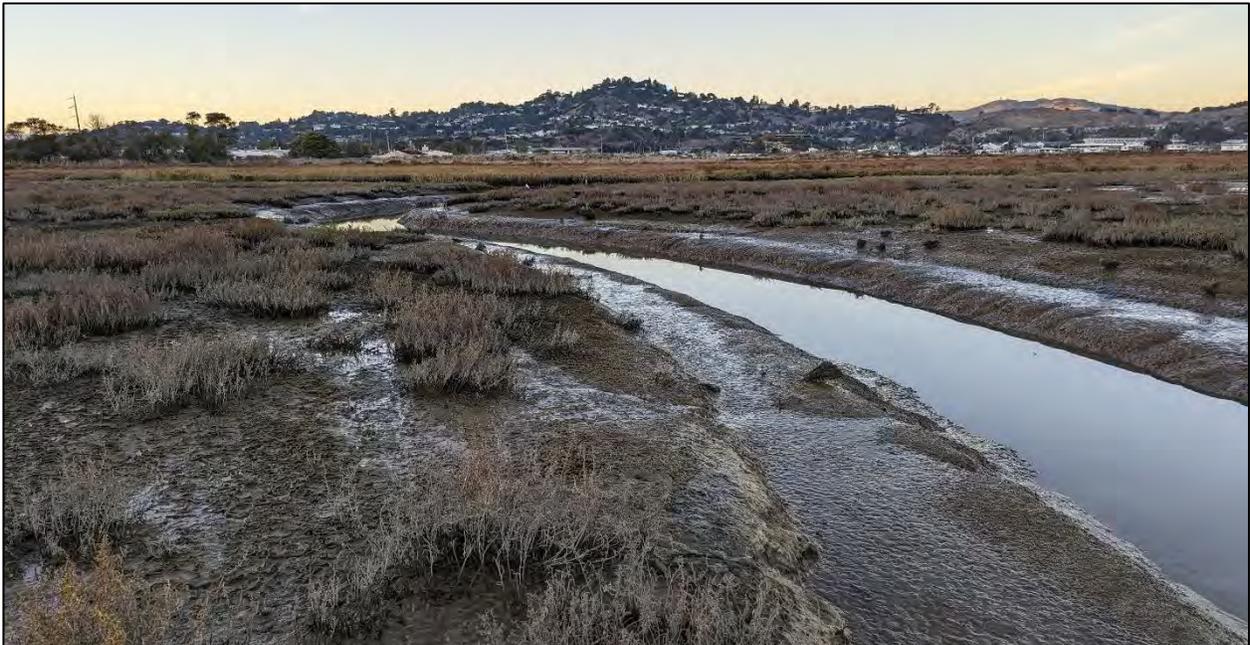
Photograph 16. View of the low marsh (channel) and high marsh in the restored tidal marsh, looking north toward the mouth of the marsh. Image shows expanding native plantings as well as natural native species recruits, primarily pickleweed. Photo taken November 1, 2023.

The Year 3 low marsh cover success criterion (“Following native cordgrass establishment, low marsh cover will increase 5 percent annually”) is not yet applicable because Year 3 is the first year that cordgrass established in low marsh elevations within the restoration area. A single, small clump was observed approximately 100 feet south of the boundary between the restoration area and the Northern Drainage Channel, on the east side of the main low marsh channel. The native cordgrass present at the mouth of the restoration area was there prior to restoration.

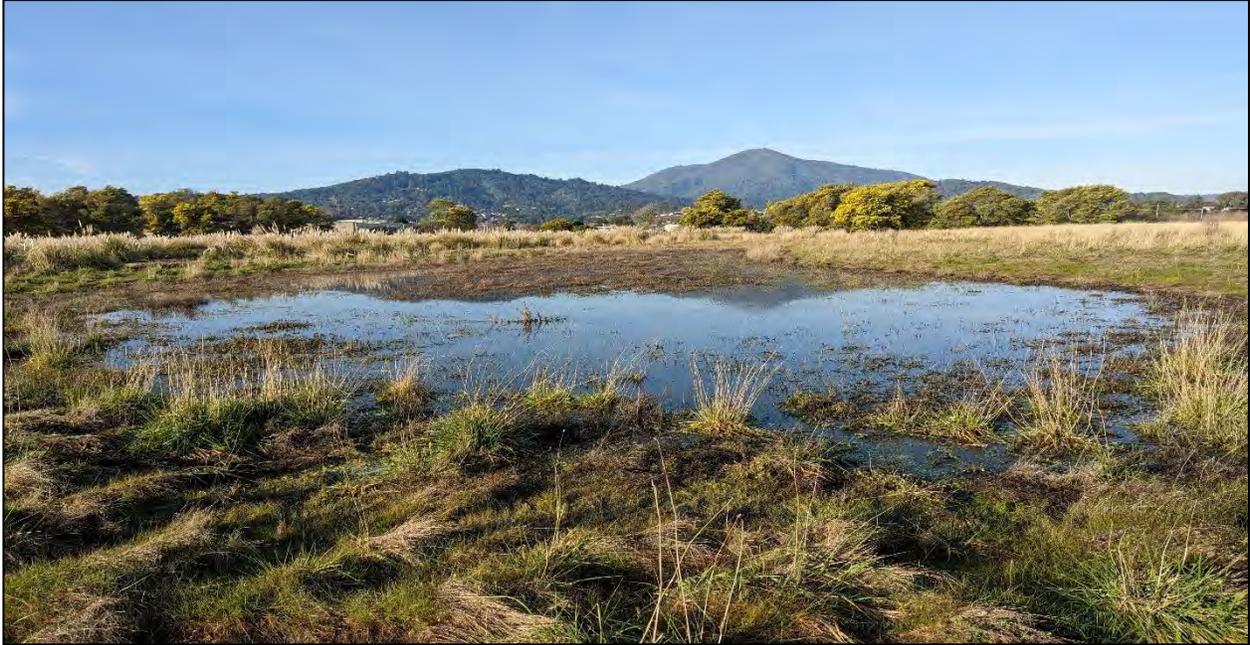
Photograph 17. View of the restored seasonal wetland, facing west. Image shows the wetland fully inundated. Photo taken February 1, 2023.

The restored seasonal wetland was directly observed on the ground on January 3, February 1, March 23, and May 5, 2023. On all dates, the restored seasonal wetland was fully inundated and/or saturated. The observations demonstrate that the wetland was inundated and/or saturated for more than 14 days during the Year 3 monitoring period. Therefore, the Year 3 success criterion was met.

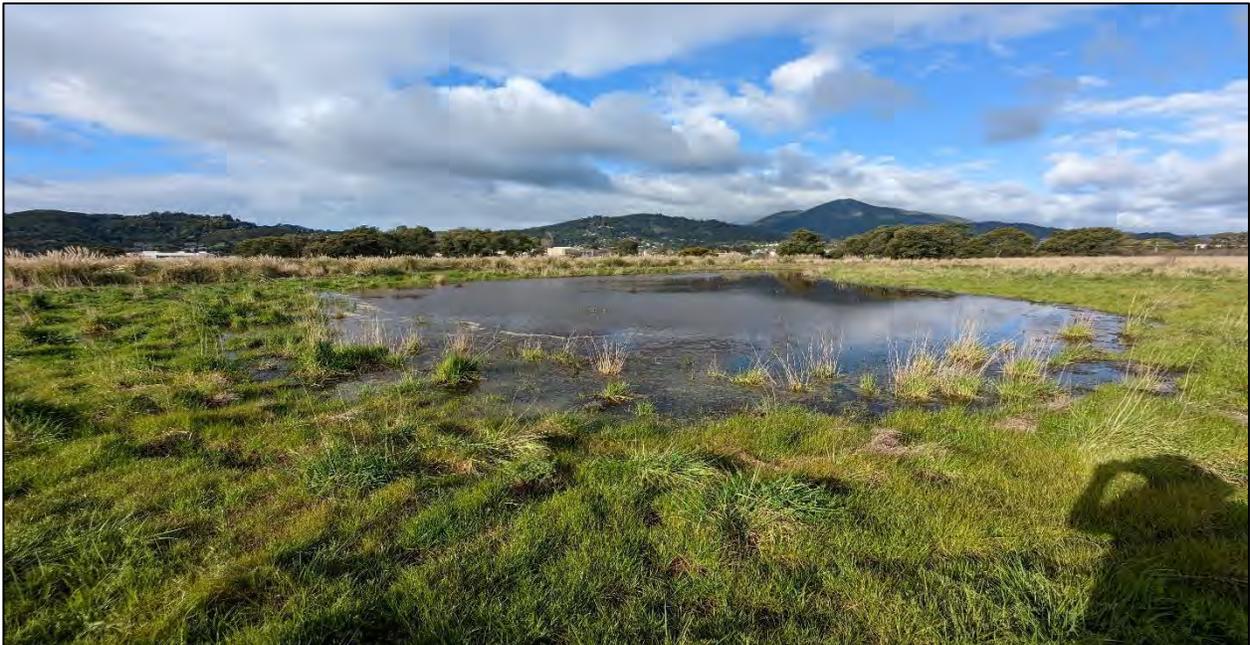
Photograph 18. View of the restored seasonal wetland, facing west. Image shows the wetland fully inundated. Photo taken March 23, 2023.

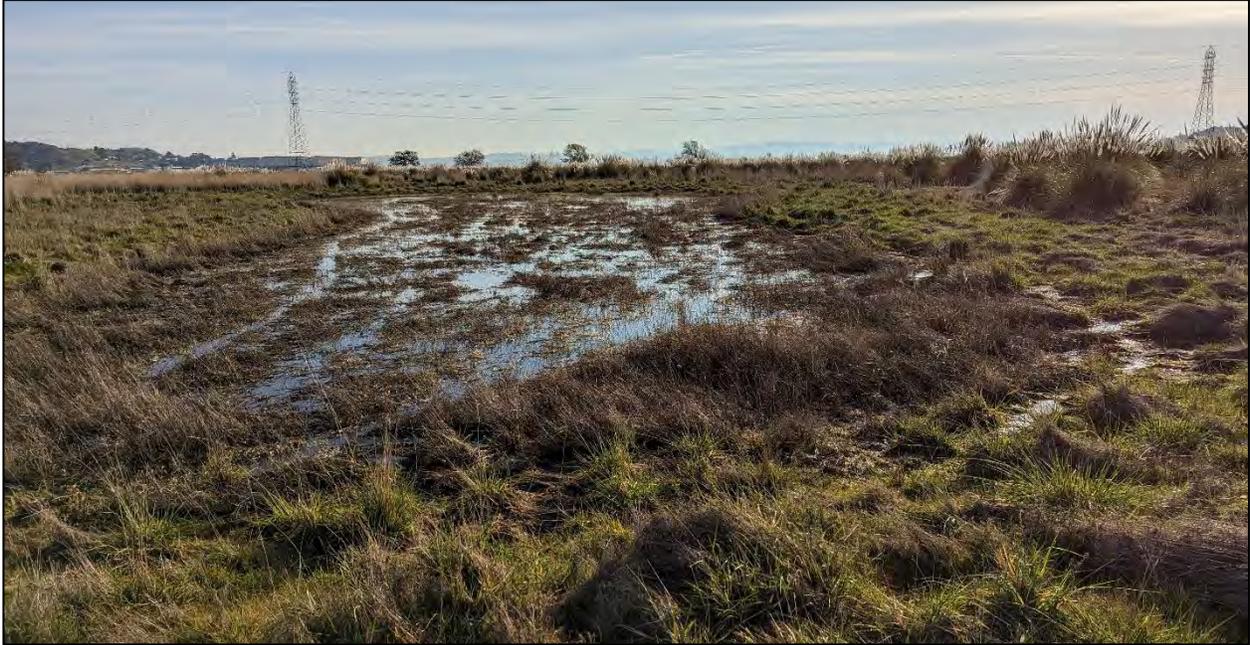
Photograph 19. View of the restored seasonal wetland, facing east. Image shows the wetland fully inundated. Photo taken February 1, 2023.

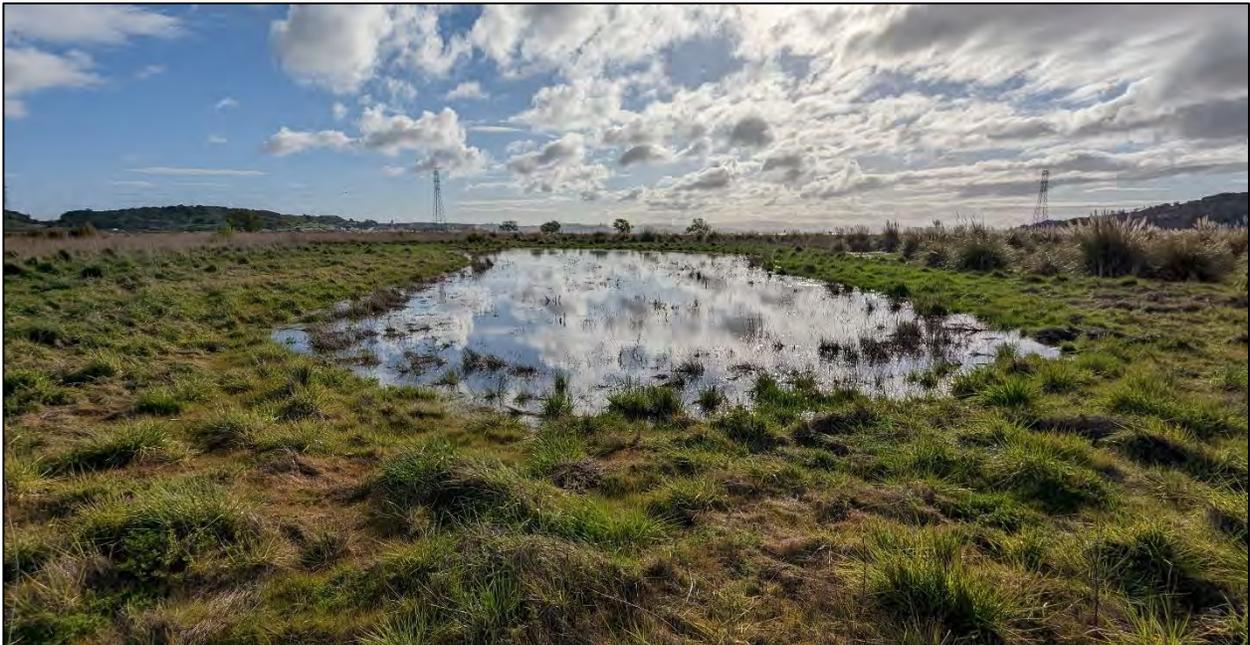
Photograph 20. View of the restored seasonal wetland, facing east. Image shows the wetland fully inundated. Photo taken March 23, 2023.

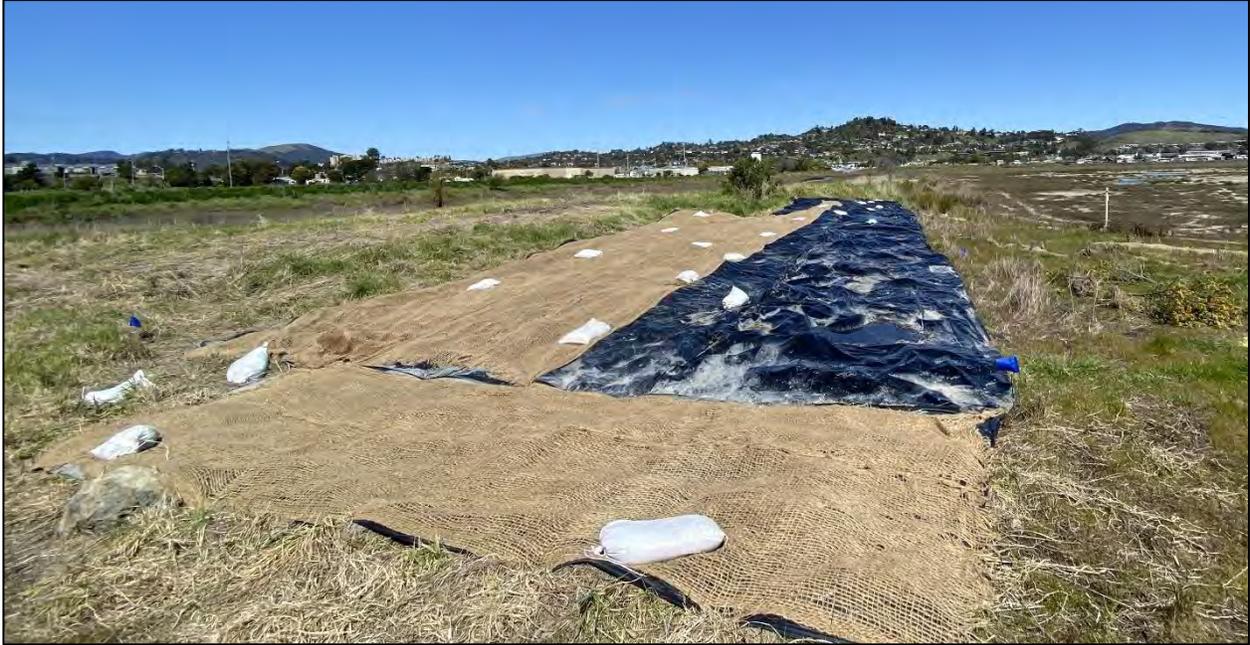
Photograph 21. Harding grass (*Phalaris aquatica*) plastic solarization sheeting at the southwest end of the tidal marsh restoration area. Jute netting and sandbags were placed on top of the plastic sheeting to help hold it in place and reduce damage from wind and coyotes (*Canis latrans*). View facing north. Photo taken April 4, 2023.

Following recommendations made in the Year 2 Annual Monitoring Report (WRA 2023), on March 3 and 27, 2023, patches of Harding grass were treated in parts of the upland refugia area on the west, south, and east sides of the restored marsh using the solarization method. In the treatment areas, the Harding grass was first cut to the ground, then 6-millimeter-thick black plastic sheeting was placed on the ground surface and affixed using 18-inch metal pins. Sand bags and jute netting were also placed to weigh the sheeting down and help keep it in place against wind, rain, and disturbance by wildlife. The sheeting was left in place until mid-November 2023, and the Harding grass had been successfully suppressed.

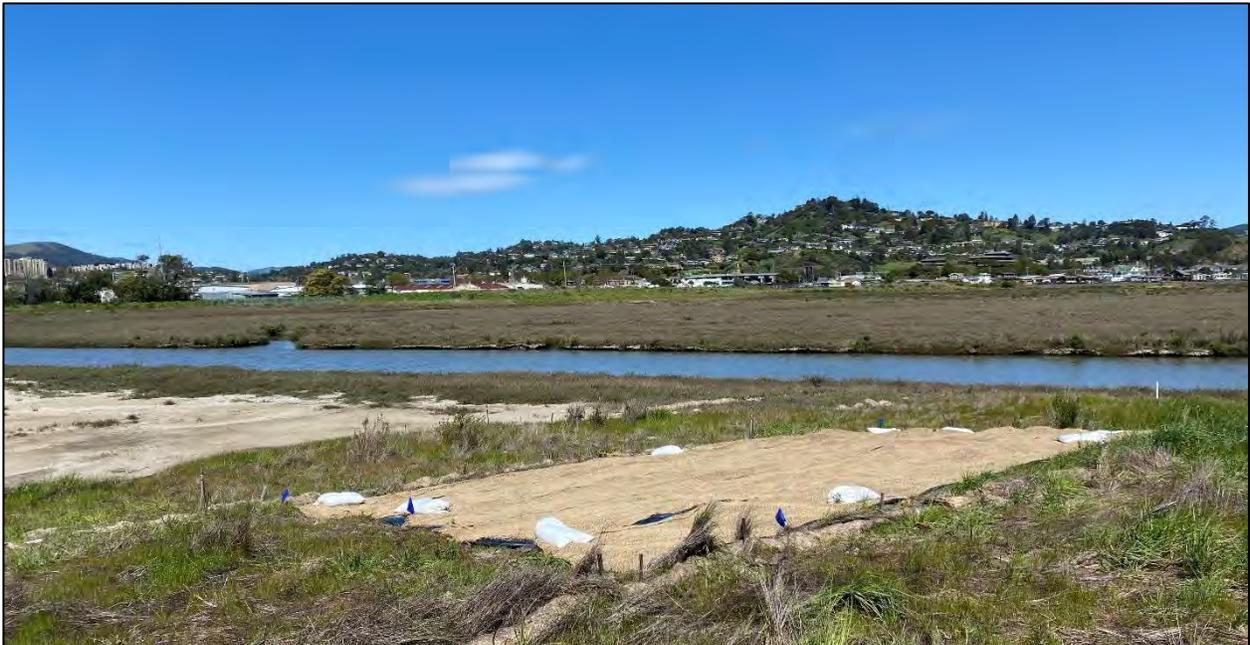
Photograph 22. Harding grass plastic solarization sheeting at the northeast end of the tidal marsh restoration area. Jute netting and sandbags were placed on top of the plastic sheeting to help hold it in place and reduce damage from wind and coyotes. View facing northwest. Photo taken April 4, 2023.

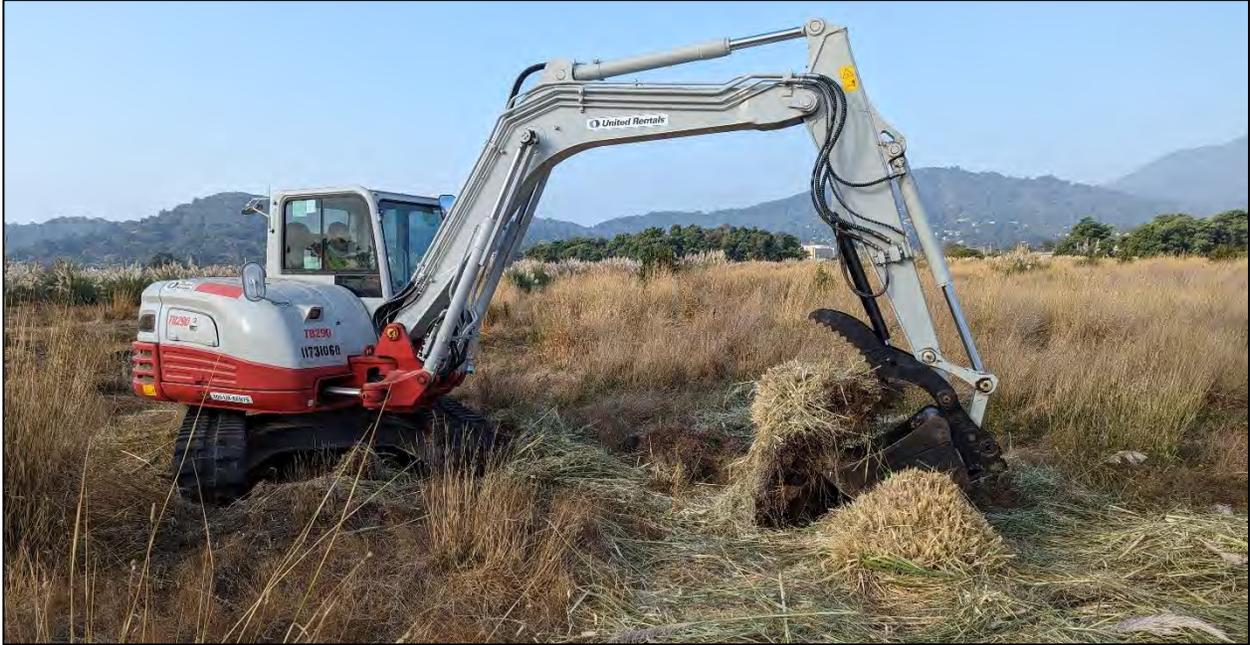
Photograph 23. Excavator digging up pampas grass (*Cortaderia selloana*) east and outside of the tidal restoration area as part of the first phase of the project to eradicate pampas grass adjacent to the restoration areas. One of the goals is to prevent pampas grass from invading the restoration area. Photo taken September 21, 2023.

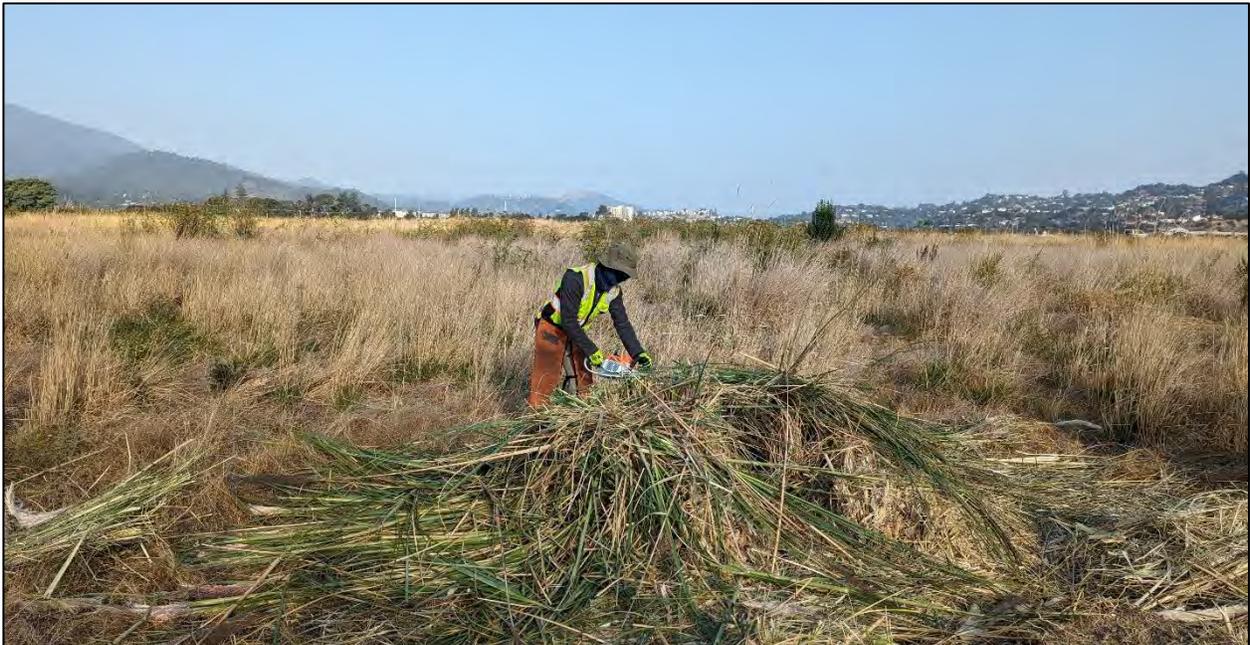
Photograph 24. Trimming leaves from pampas grass to prep it for excavation, east and outside of the tidal restoration area. Part of the first phase of the project to eradicate pampas grass adjacent to the restoration areas. One of the goals is to prevent pampas grass from invading the restoration area. Photo taken September 21, 2023.
