Corte Madera Four-Acre Tidal Marsh Restoration Project

Year 5 (2025) Annual Monitoring Report

Corte Madera, Marin County, California

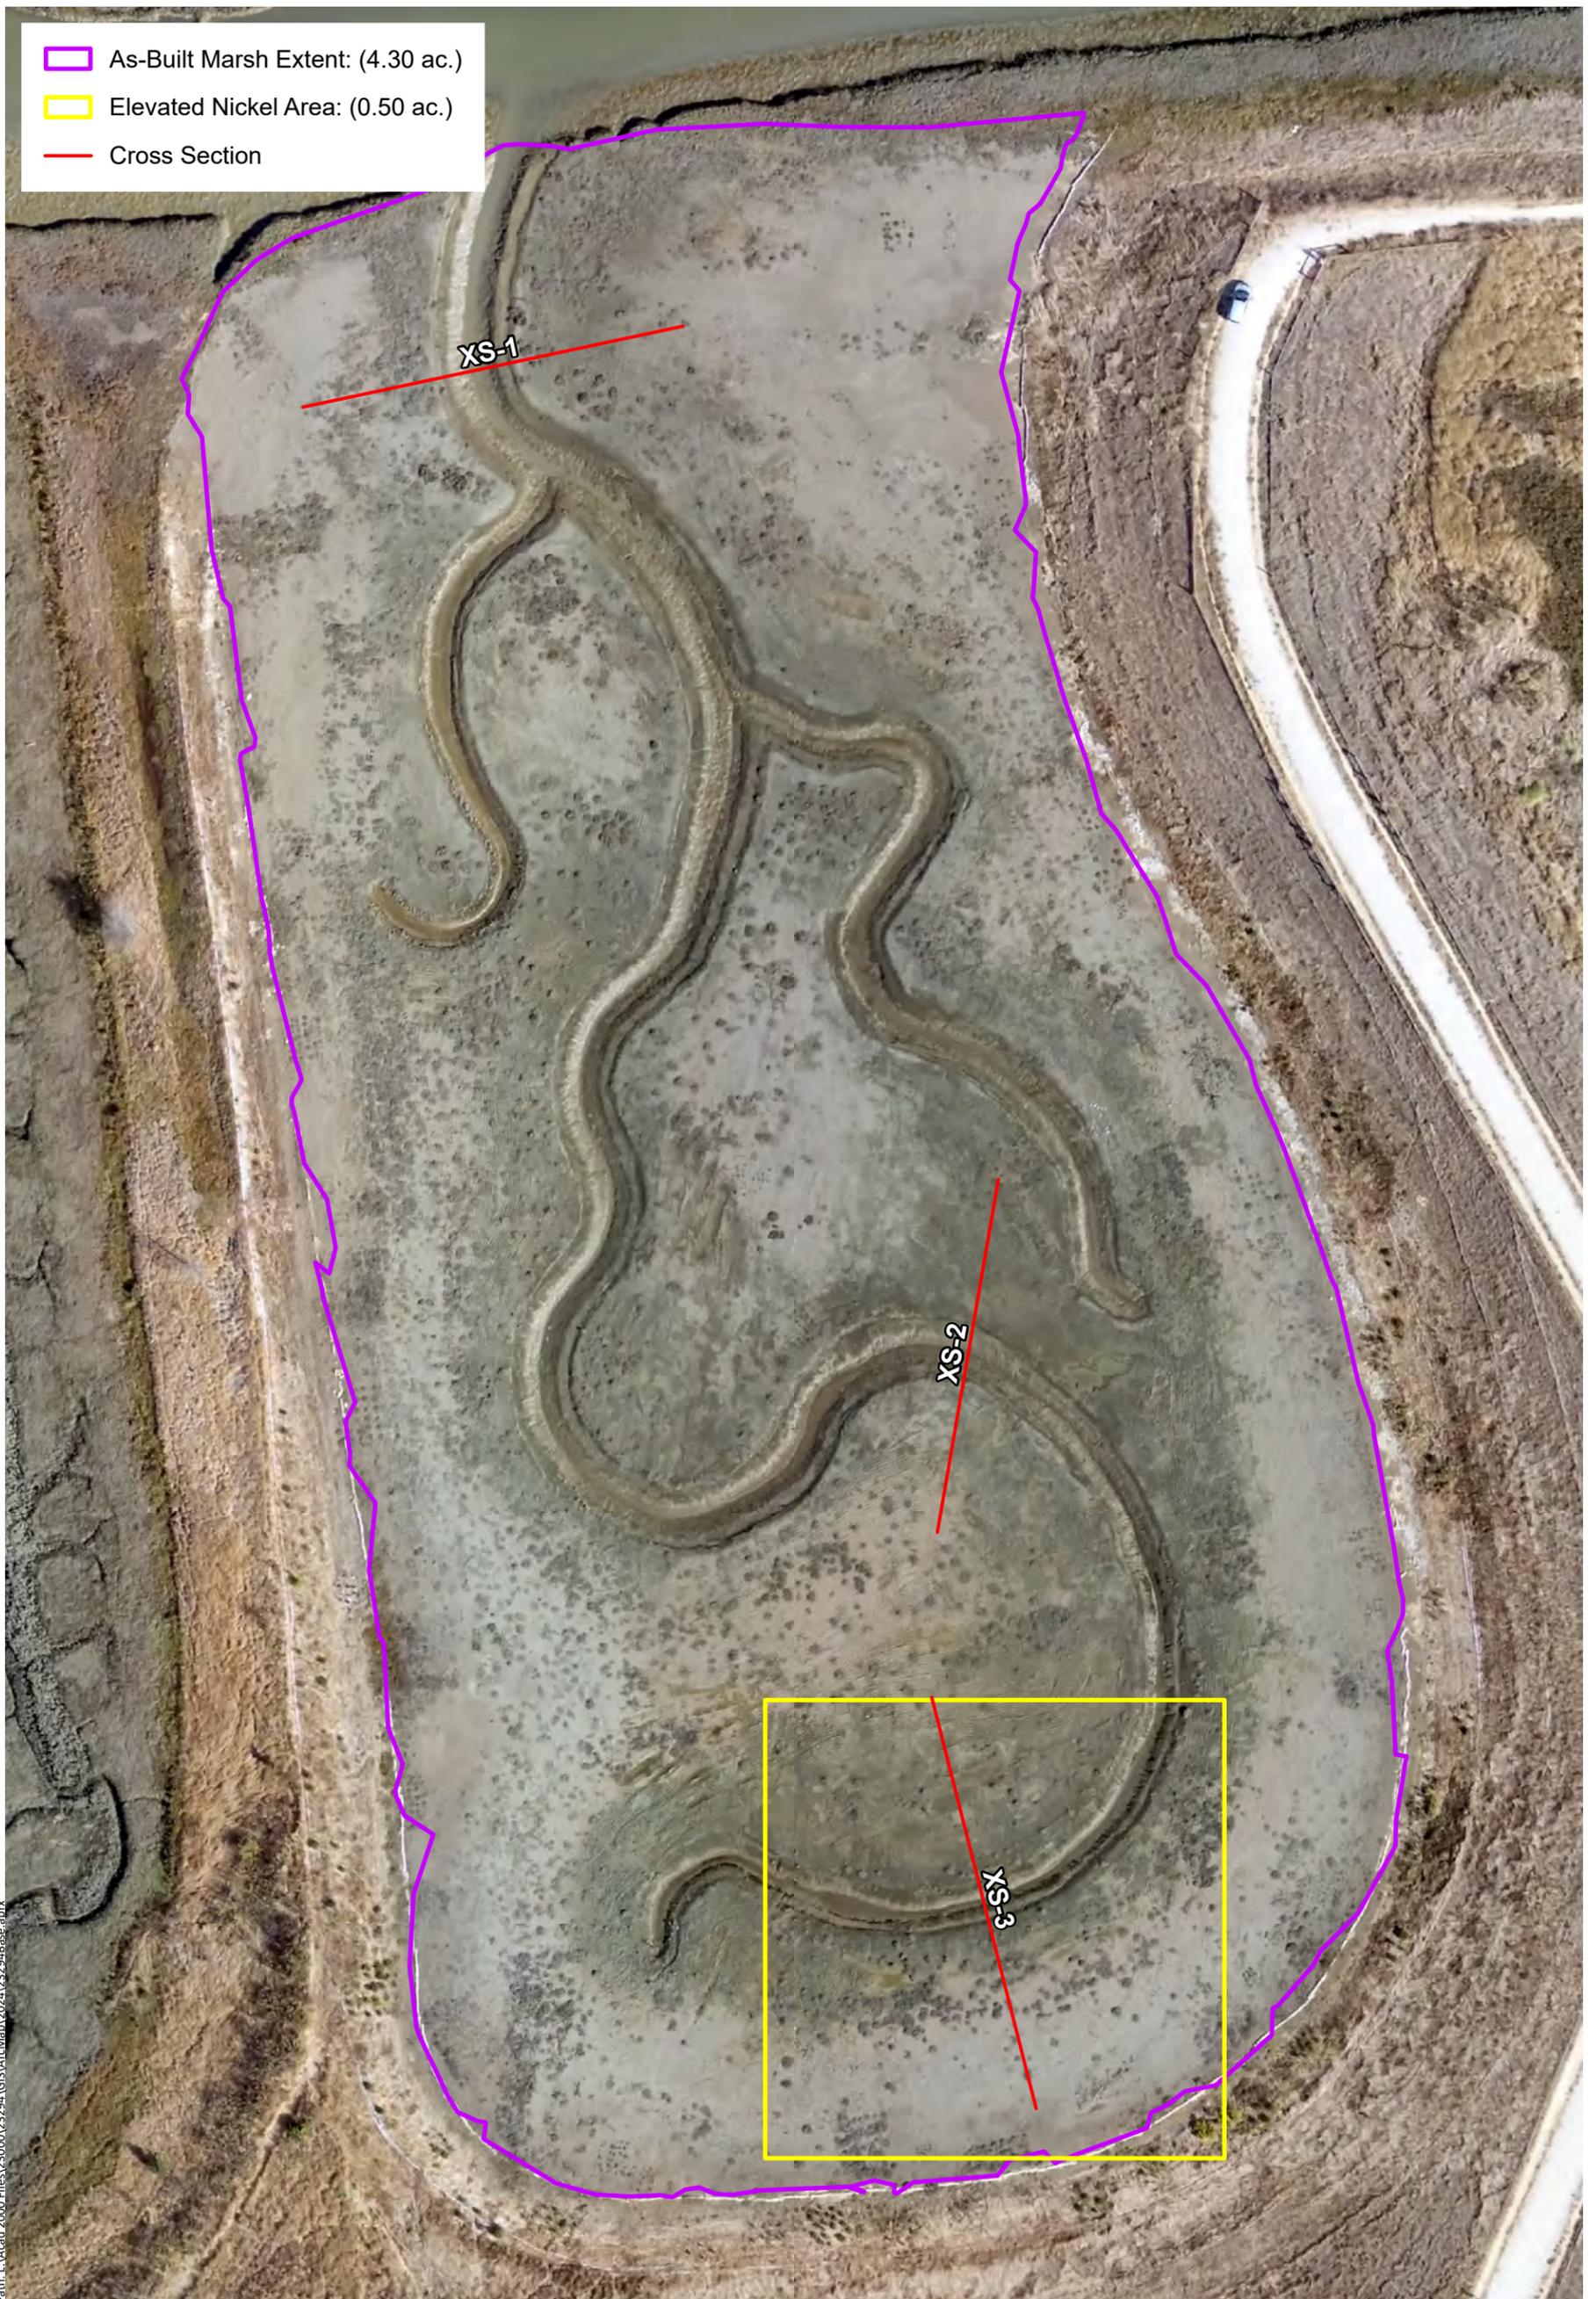
Figure 3. Cross Section Overview

▭ As-Built Marsh Extent: (4.30 ac.)
▭ Elevated Nickel Area: (0.50 ac.)
— Cross Section

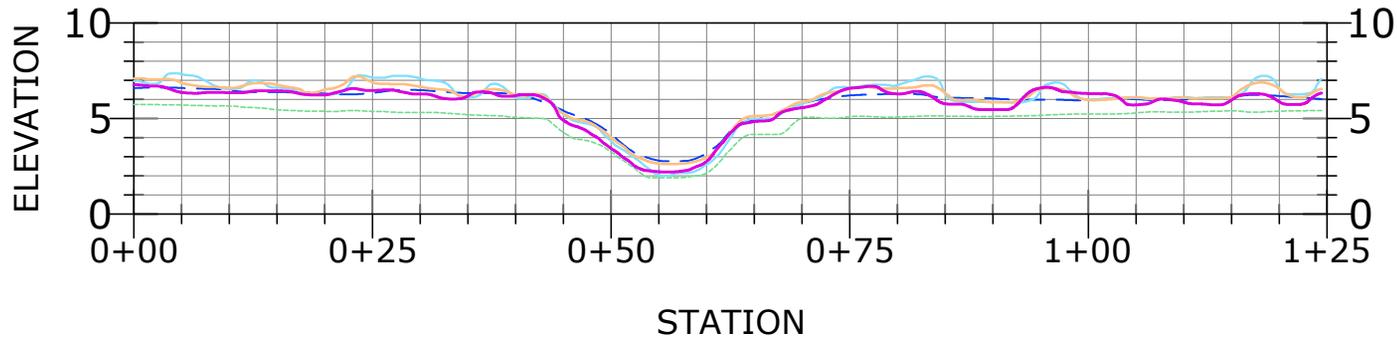
① CROSS SECTION 1
2H:1V

FIGURE 4.
CHANNEL CROSS SECTIONS

Baseline topography taken in December of 2020 was compared to current topography in 2025. Year 5 monitoring data shows slight variations in surface elevations as compared to the baseline conditions and all other years, which is typical for dynamic tidal marsh systems, but the elevations are within the 0.3-foot threshold in the final Year 5 performance criterion. This indicates that sedimentation does not contribute to reduction in MHHW by more than 0.3 feet depth. Additionally, the topographic comparison indicates no detrimental erosion in the area of elevated nickel, with at least 0.5 feet of cover over that area throughout the monitoring period. The site meets the success criteria for erosion and sedimentation.

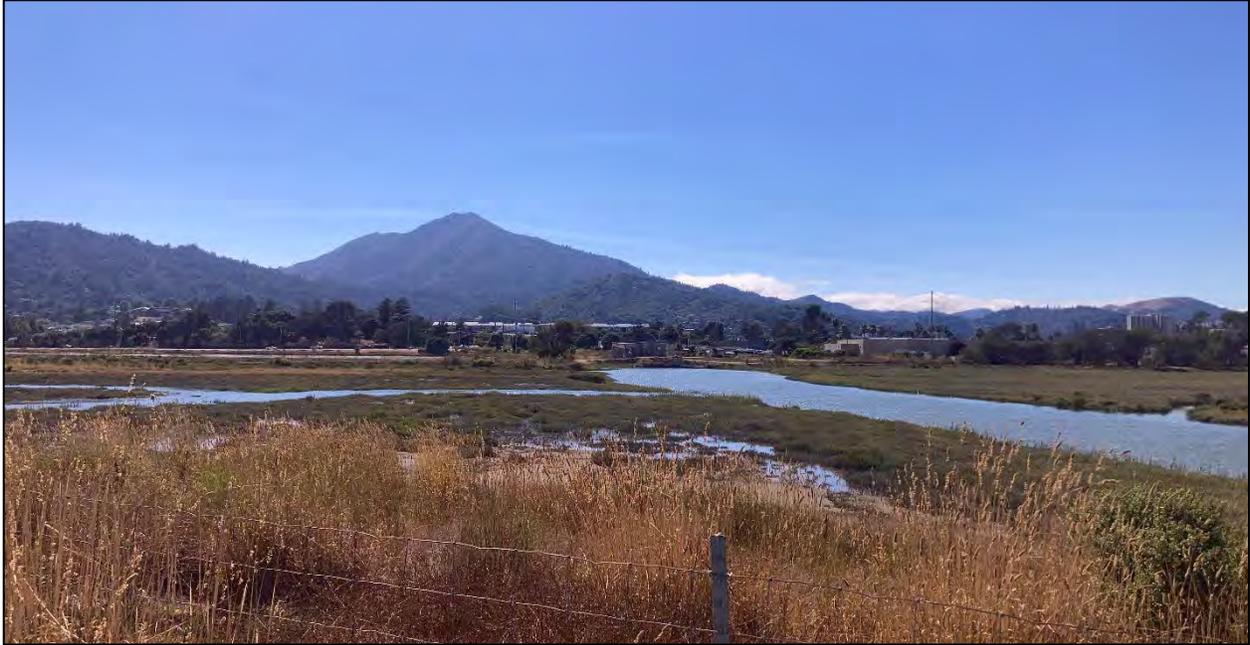
Photograph 1. Photo-monitoring Location 1. View of transition zone and tidal marsh, facing west. Photo was taken at high tide – predicted at 5.82 ft MLLW at 4:05 pm. Photo taken August 13, 2025.

Photographs were taken on August 13, 2025 (Appendix C) that depict the restored tidal area mostly inundated at high tide. The predicted highest tides on that date (NOAA 2025) were 5.82 feet MLLW (mean lower low water datum), which is slightly lower than the as-built target elevation of 6.5 feet MHHW as the outer boundary of the restored marsh area; therefore, this photo accurately depicts anticipated tidal inundation. The photographs and corroborating tide predictions demonstrate that the restored tidal area is hydrologically functioning as designed for the fifth consecutive year since it was constructed. Additionally, the difference in MHHW at the Northern (Main) Channel versus the Lower Channel was 0.18 feet, as recorded during the Year 5 tidal data collection period, below the threshold of the performance criteria. Because the difference in MHHW at the tidal marsh compared to the Northern Drainage Channel is within the 0.3-foot threshold of the performance criteria, the Year 5 success criterion was met.

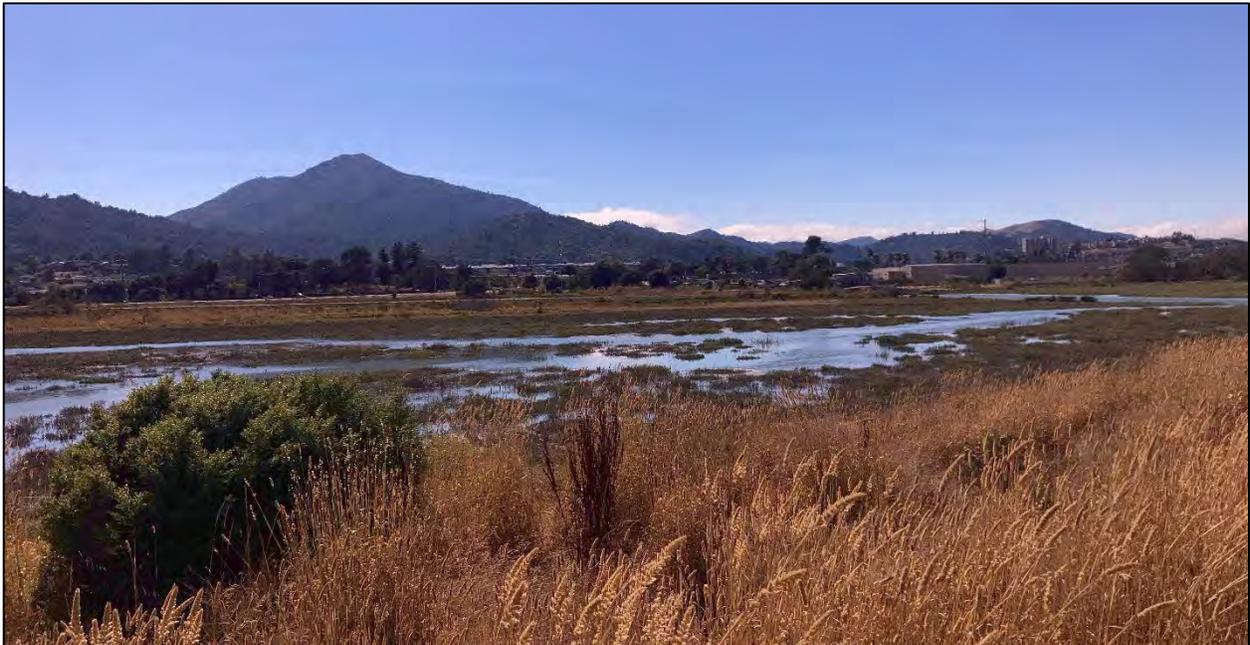
Photograph 2. Photo-monitoring Location 2. View of tidal marsh (background), transition zone (a narrow band adjacent to the tidal marsh), and uplands (foreground), facing northwest. Photo was taken at high tide – predicted at 5.82 ft MLLW at 4:05 pm. Photo taken August 13, 2025.

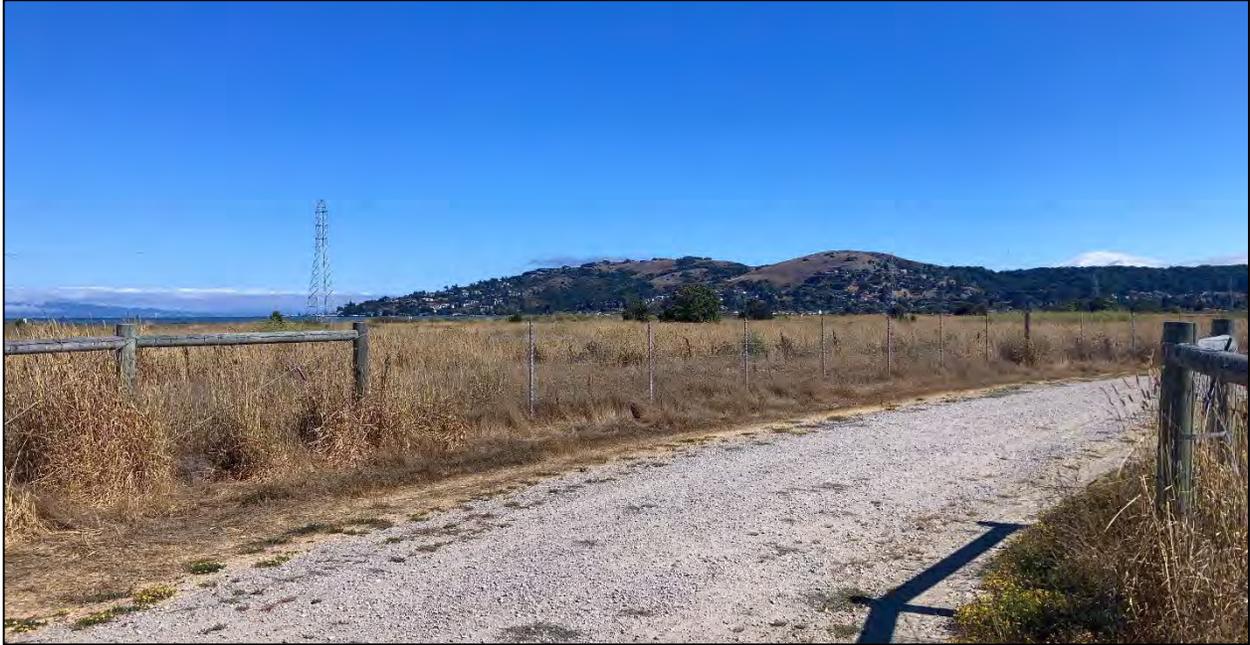
Photograph 3. Photo-monitoring Location 3. View of trail and exclusion fence, facing southeast. Photo taken August 13, 2025.

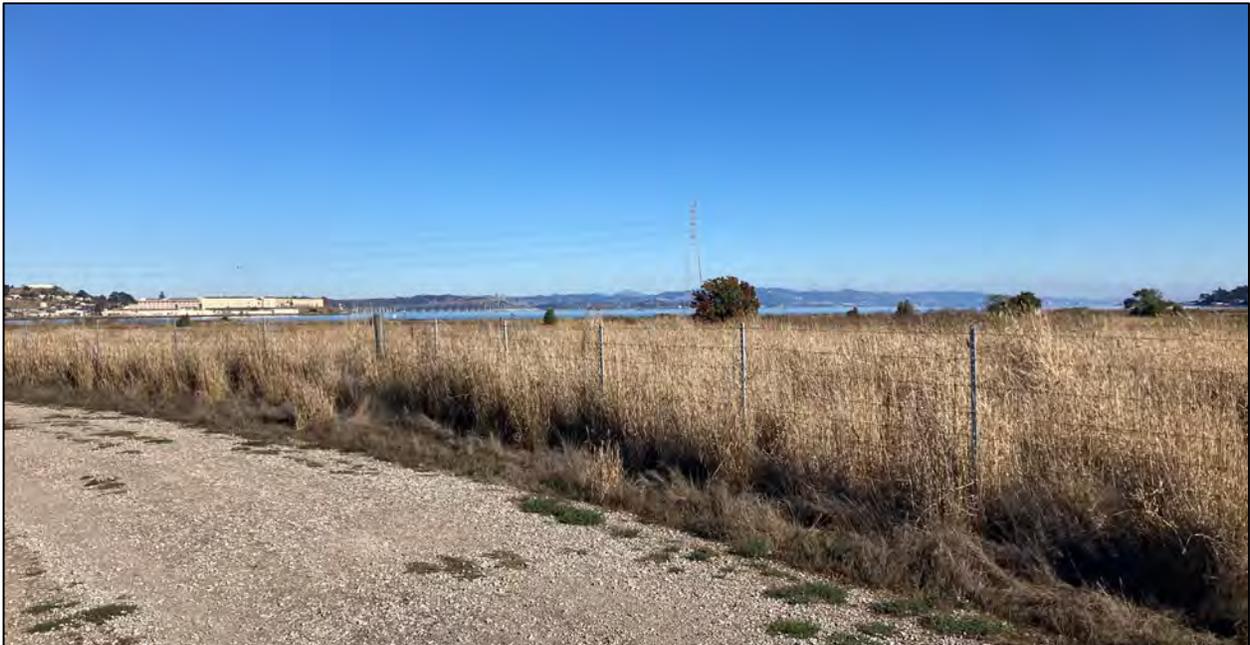
Photograph 4. Photo-monitoring Location 4. View from trail and exclusion fence, facing east. Photo taken October 17, 2025.

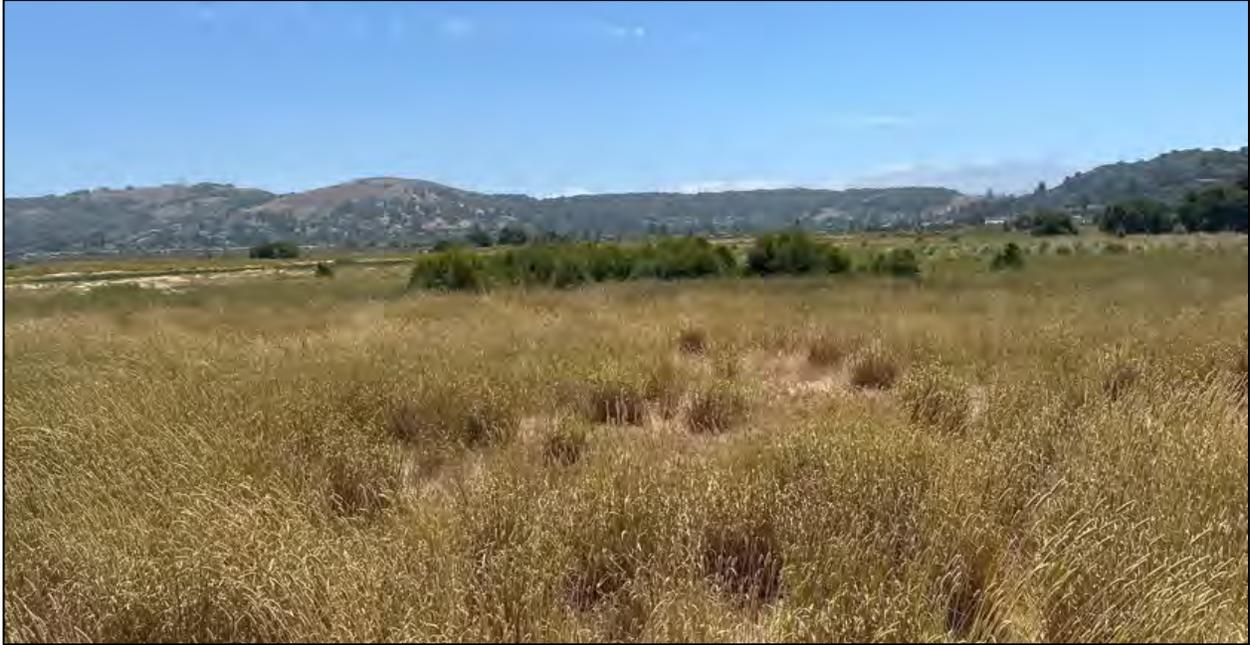
Photograph 5. Photo-monitoring Location 5. View of upland disposal area with seasonal wetland in background, facing south. Photo taken June 13, 2025.

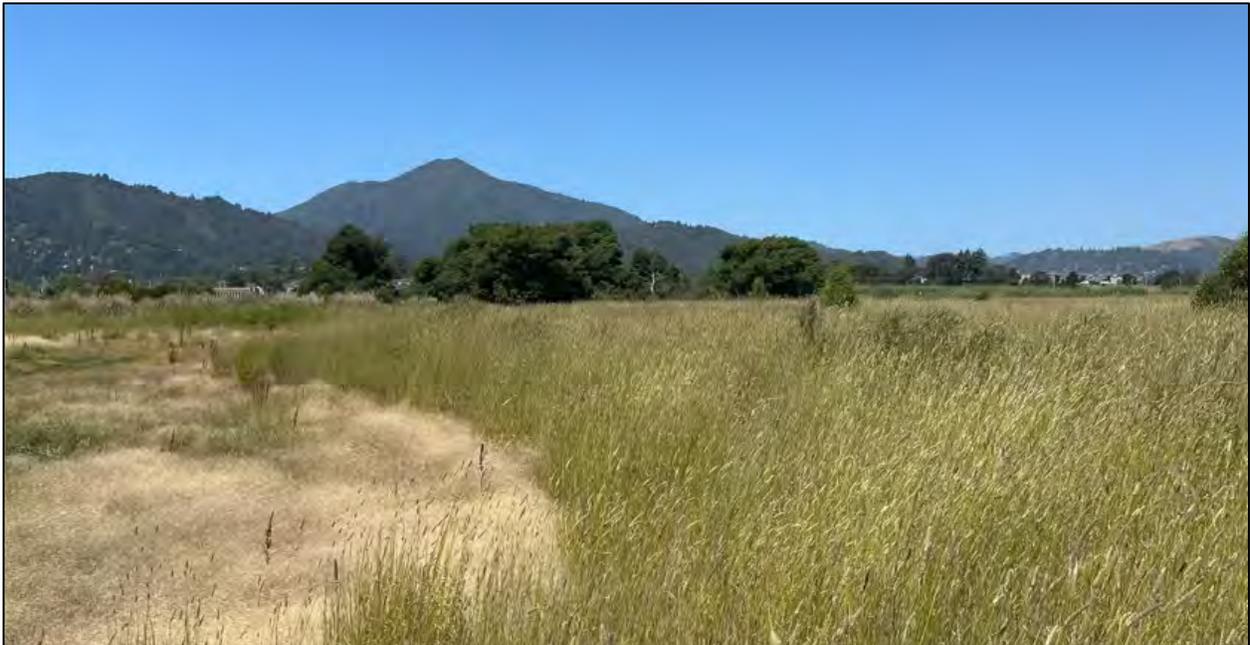
Photograph 6. Photo-monitoring Location 6. View of restored seasonal wetland, facing west. Photo taken June 13, 2025.

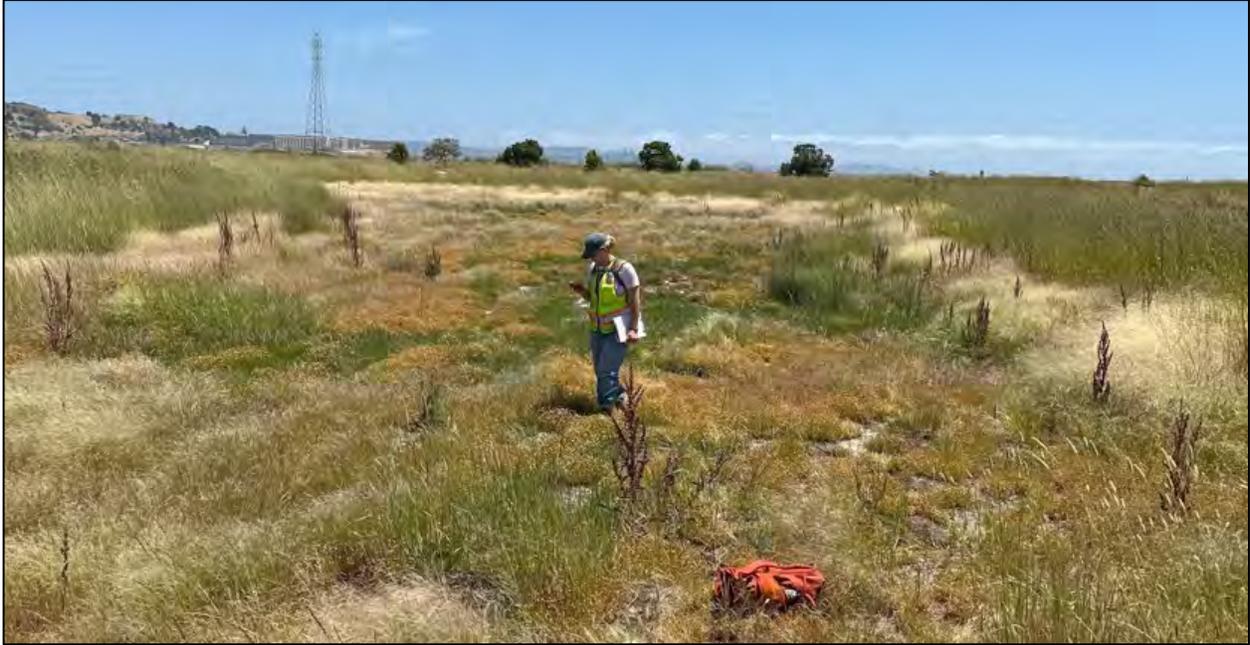
Photograph 7. Photo-monitoring Location 7. View of restored seasonal wetland, facing east. Photo taken June 13, 2025.

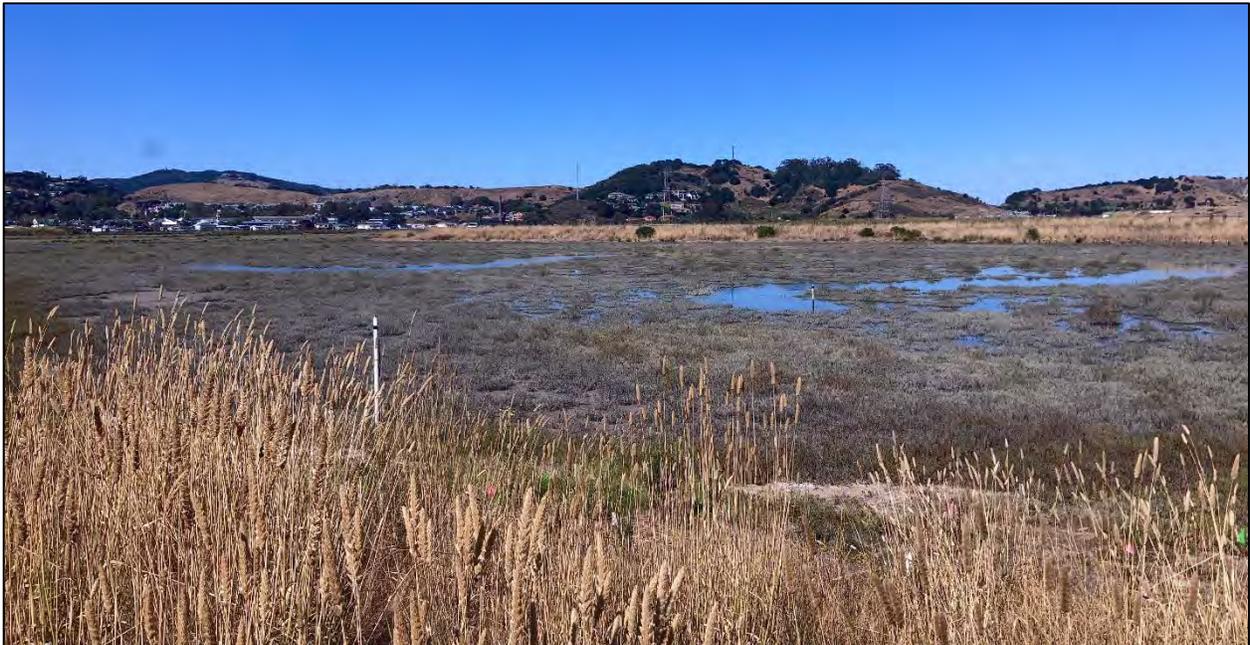
Photograph 8. Photo-monitoring Location 8. View of transition zone and tidal marsh, facing northeast. The tidal marsh vegetation in view is pickleweed (*Salicornia pacifica*) and the transition zone vegetation is blocked in the foreground by emerging Harding grass (*Phalaris aquatica*). Photo was taken at high tide – predicted at 5.82 ft MLLW at 4:05 pm. Photo taken August 13, 2025.

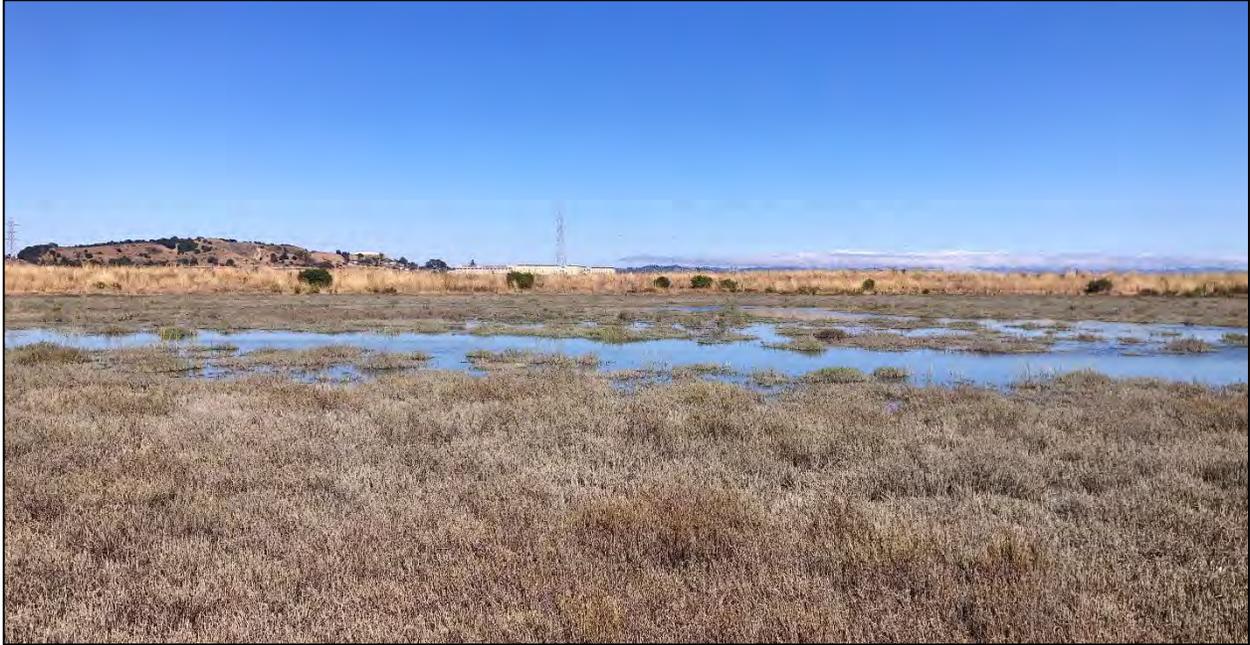
Photograph 9. Photo-monitoring Location 9. View of tidal marsh, facing east. Tidal marsh vegetation in view is dominated by pickleweed. Photo was taken at high tide – predicted at 5.82 ft MLLW at 4:05 pm. Photo taken August 13, 2025.

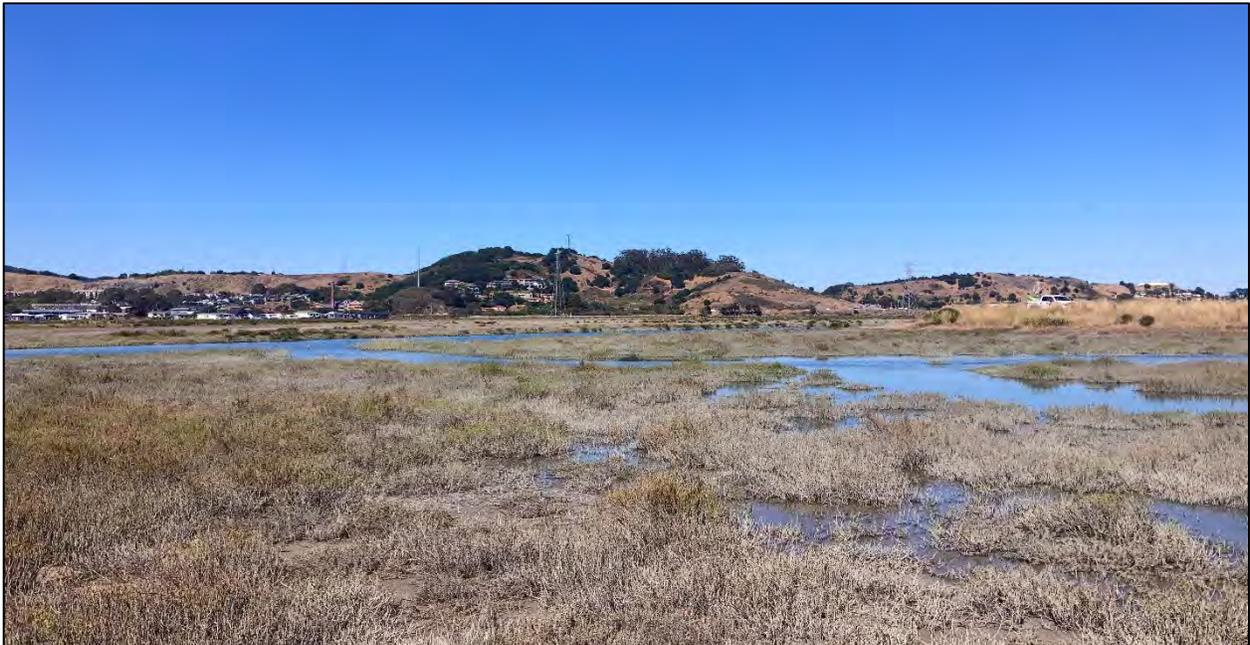
Photograph 10. Photo-monitoring Location 10. View of restored tidal marsh and adjacent previously existing marsh, facing north. Tidal marsh vegetation is dominated by pickleweed. Photo was taken at high tide – predicted at 5.82 ft MLLW at 4:05 pm. Photo August 13, 2025

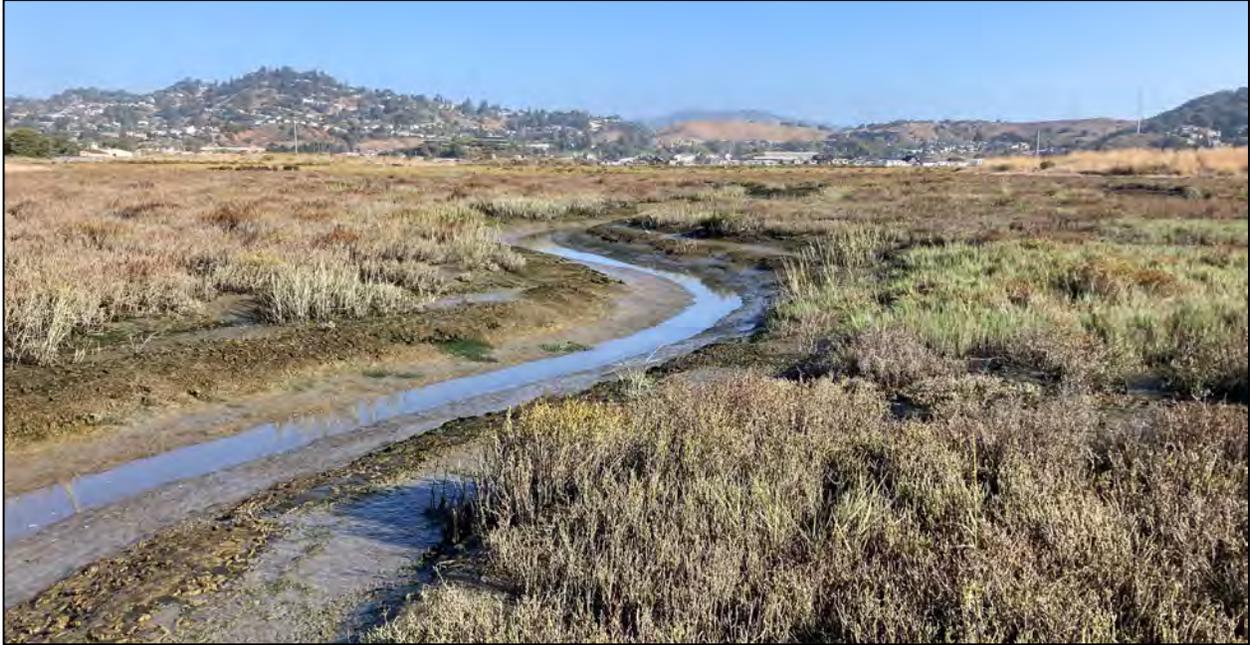
Photograph 11. View of the high marsh in the restored tidal marsh. Image shows expanding native plantings, primarily a robust population of pickleweed, as well as natural native species recruits. Photo taken September 26, 2025.

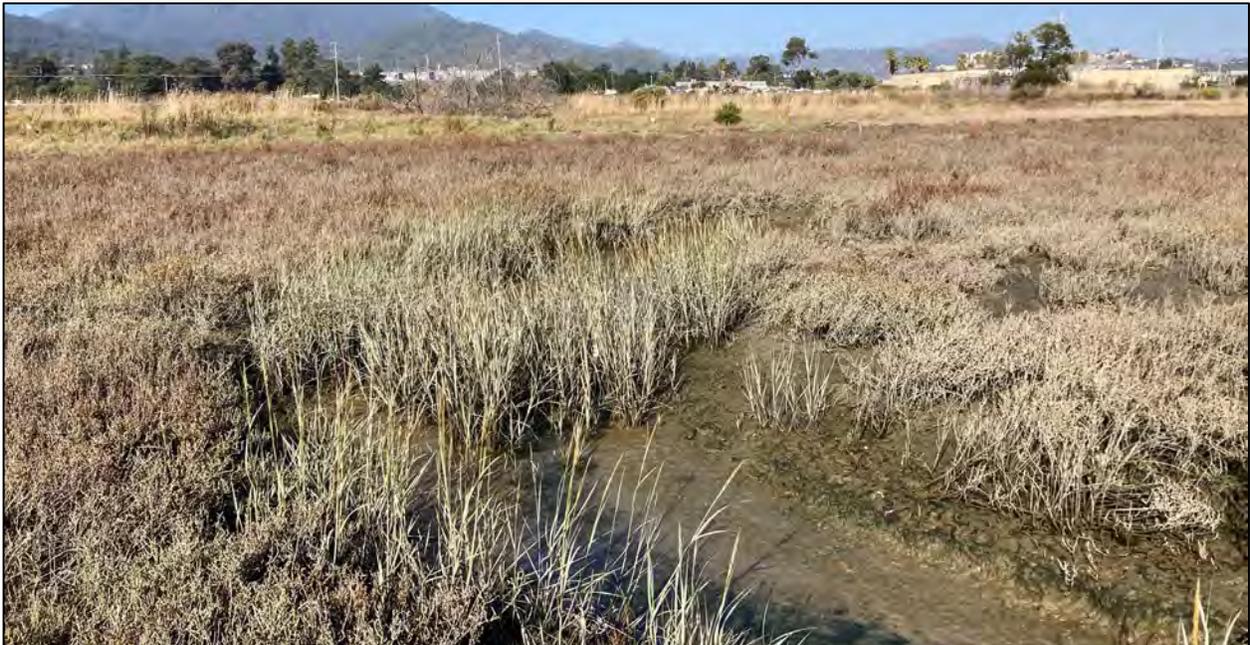
Photograph 12. View of the low marsh (channel) and high marsh in the restored tidal marsh, facing west. Image shows expanding native plantings as well as natural native species recruits, primarily cordgrass. Photo taken September 26, 2025.

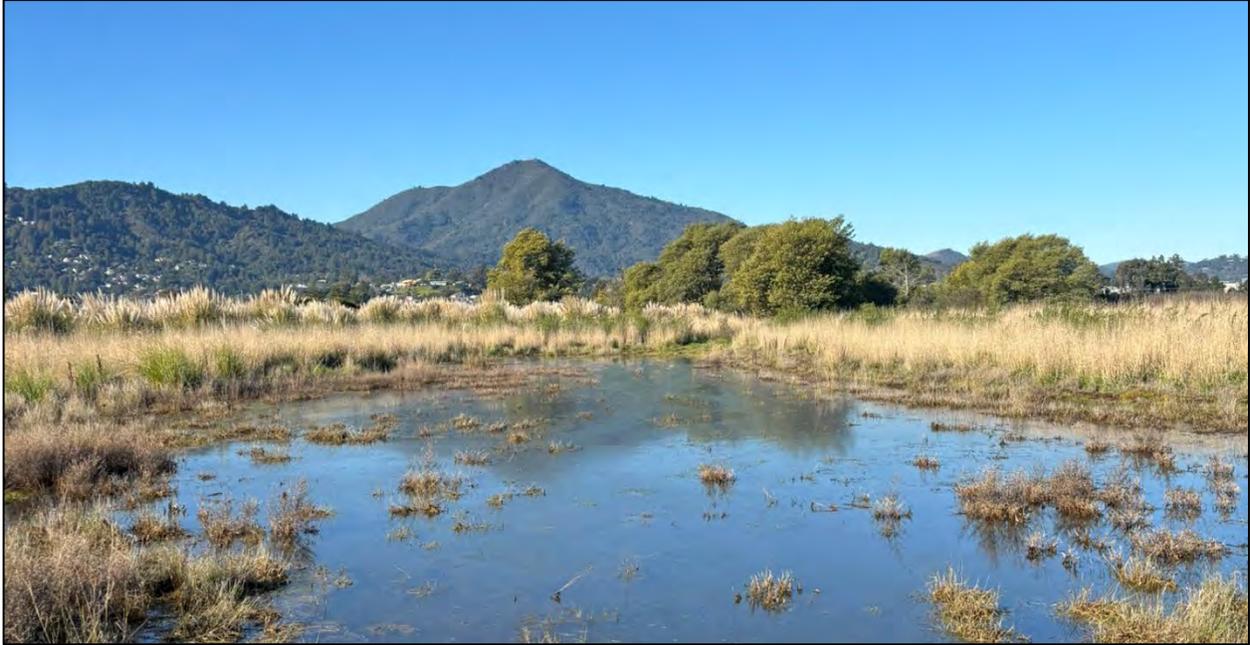
Photograph 13. View of the restored seasonal wetland, facing west. Image shows the wetland fully inundated. Photo taken January 23, 2025.

In Year 5, inundation was observed in the seasonal wetland on January 23, February 13, and February 28. Images of inundation during Year 5 are included in Appendix C – Photos 13, 14, and 15.

The restored seasonal wetland was directly observed on the ground on January 23, February 13, February 28, May 2, and May 28 of 2025. On January 23, the restored seasonal wetland was fully inundated and saturated (Appendix C – Photo 13). On February 13 and February 28, the restored

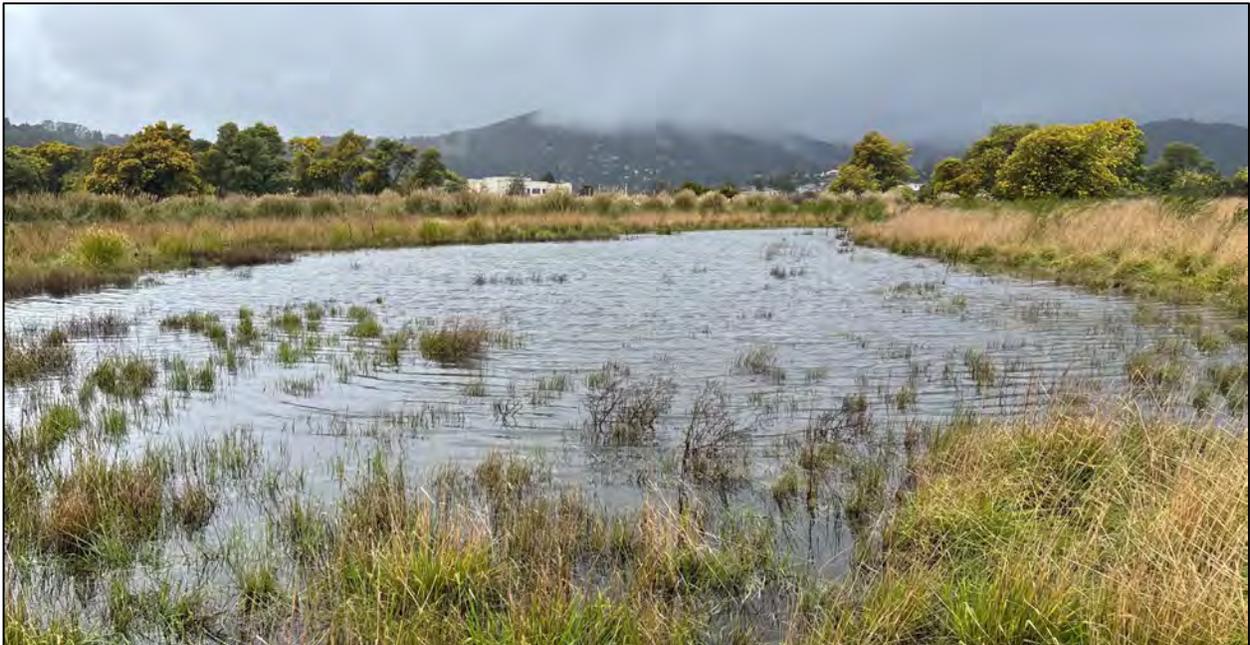
Photograph 14. View of restored seasonal wetland, facing southwest. Image shows the wetland fully inundated. Photo taken on February 13, 2025.

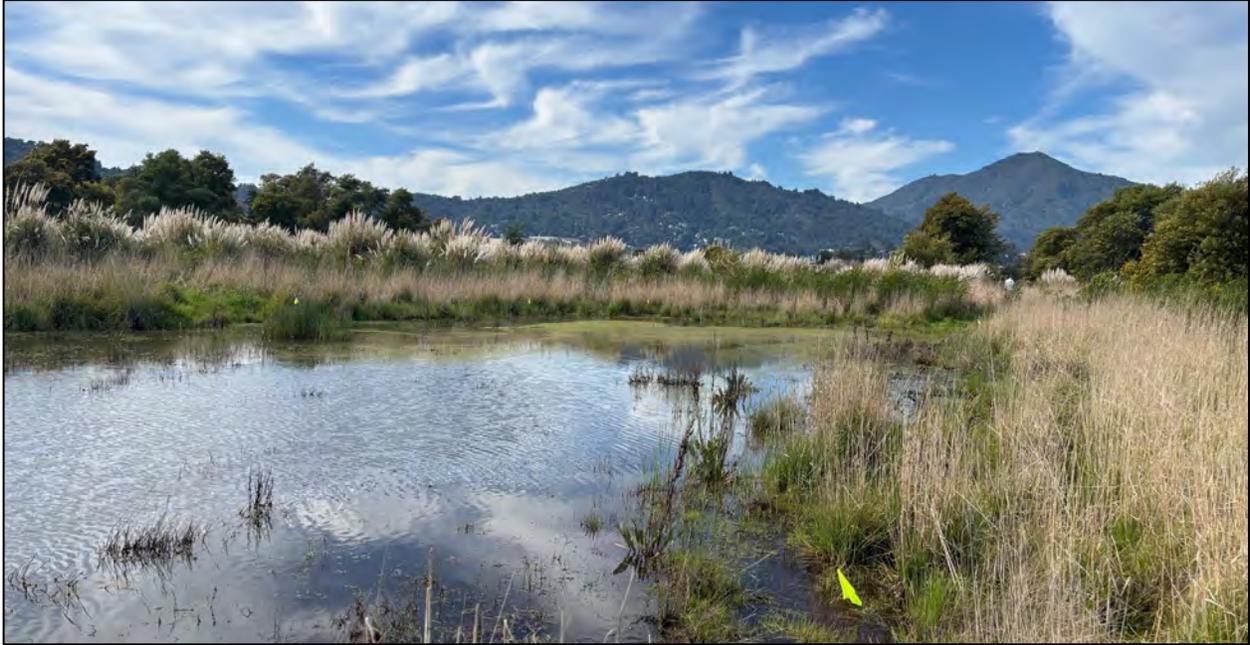
Photograph 15. View of restored seasonal wetland, facing southwest. Wetland was fully inundated. Photo taken on February 28, 2025.

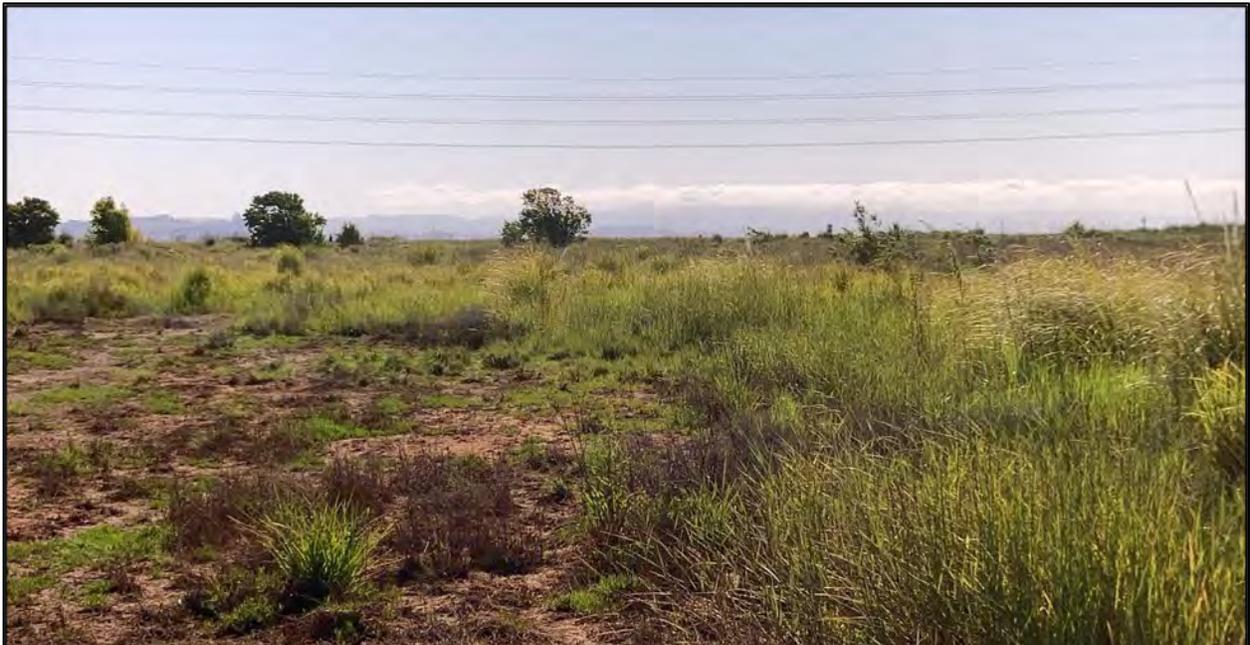
Photograph 16. View of the restored seasonal wetland, facing east. Wetland soils were damp but no longer saturated at the time of the visit. Photo taken May 02, 2025.

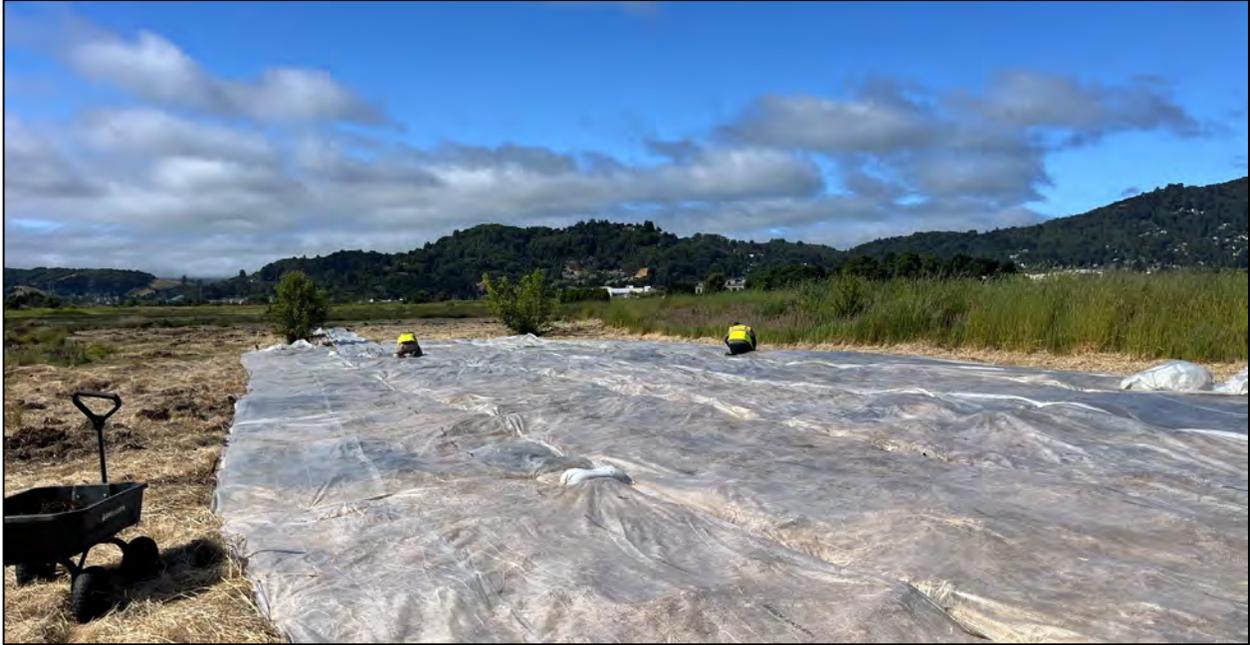
Photograph 17. Harding grass (*Phalaris aquatica*) plastic solarization sheeting at the northeast end of the restored season wetland area. View facing southwest. Photo taken May 28, 2025.

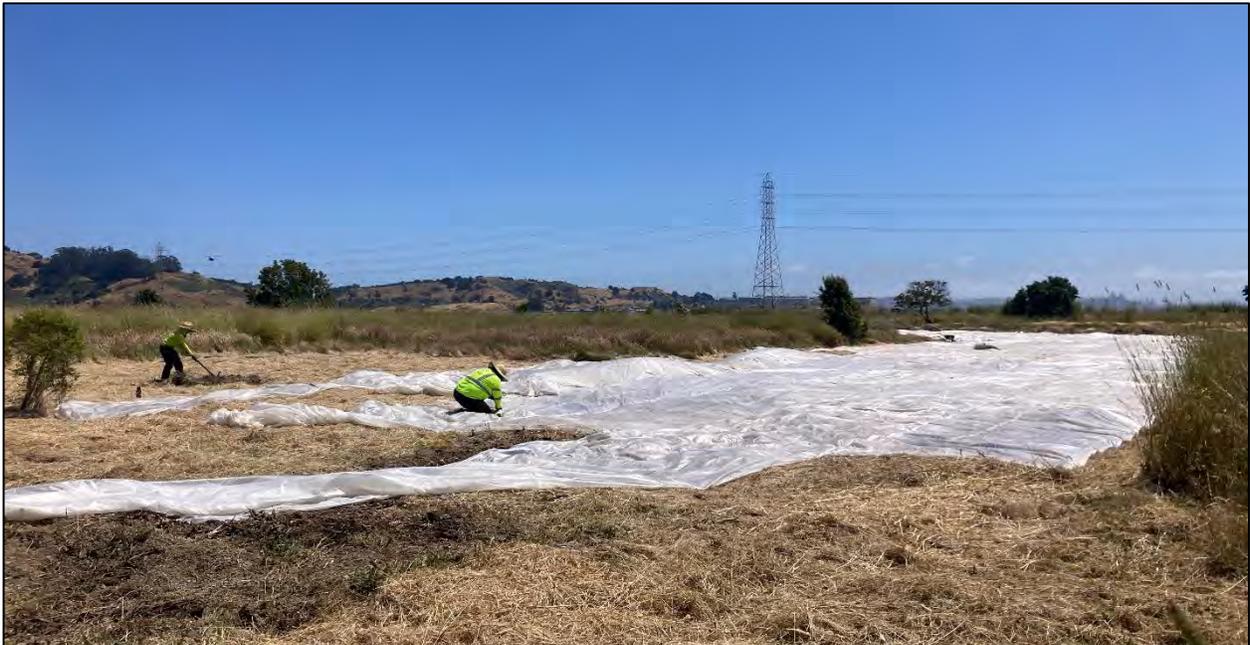
Photograph 18. Harding grass plastic solarization sheeting at the northeast end of the restored seasonal wetland area. View facing northeast. Photo taken June 13, 2025.

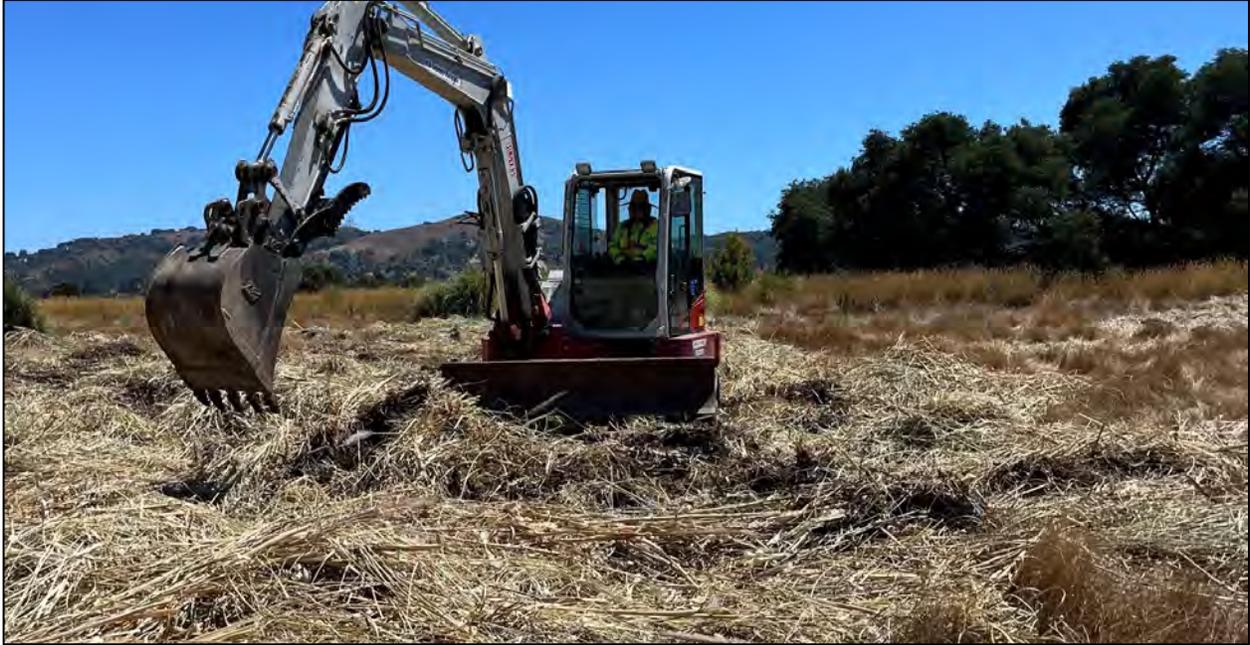
Photograph 19. Excavator digging up pampas grass (*Cortaderia selloana*) north of the restored seasonal wetland. Photo taken on August 6, 2025.

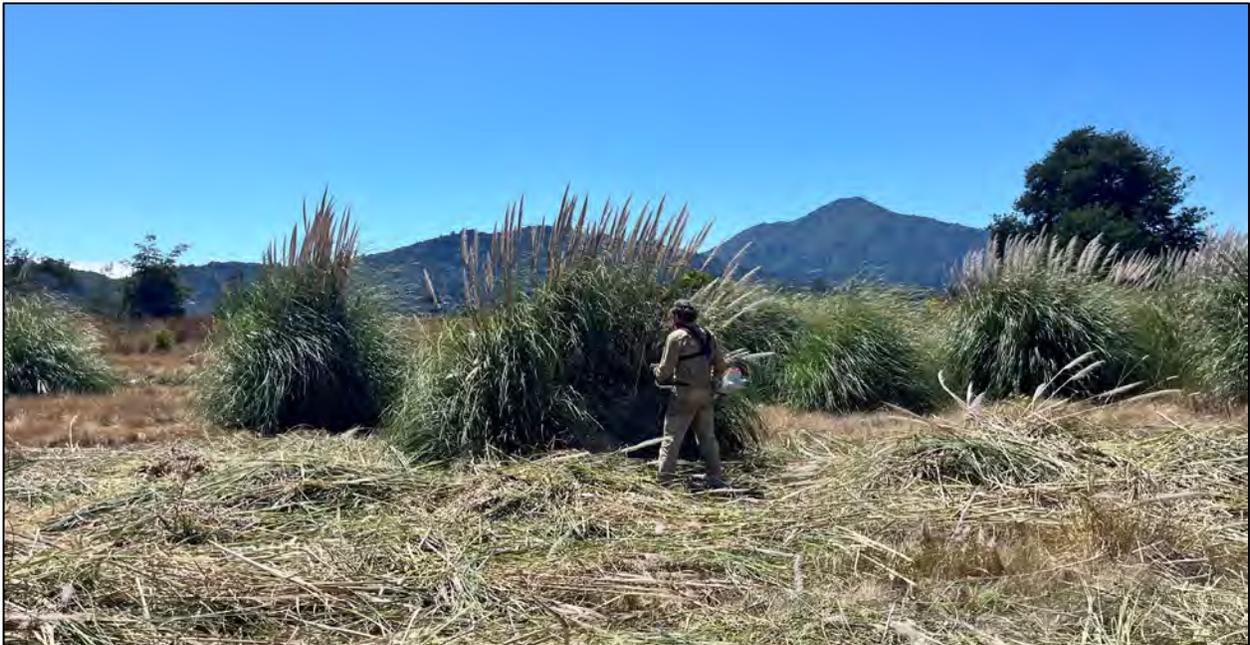
Photograph 20. Trimming leaves from pampas grass to prep it for excavation. Photo taken August 1, 2025.

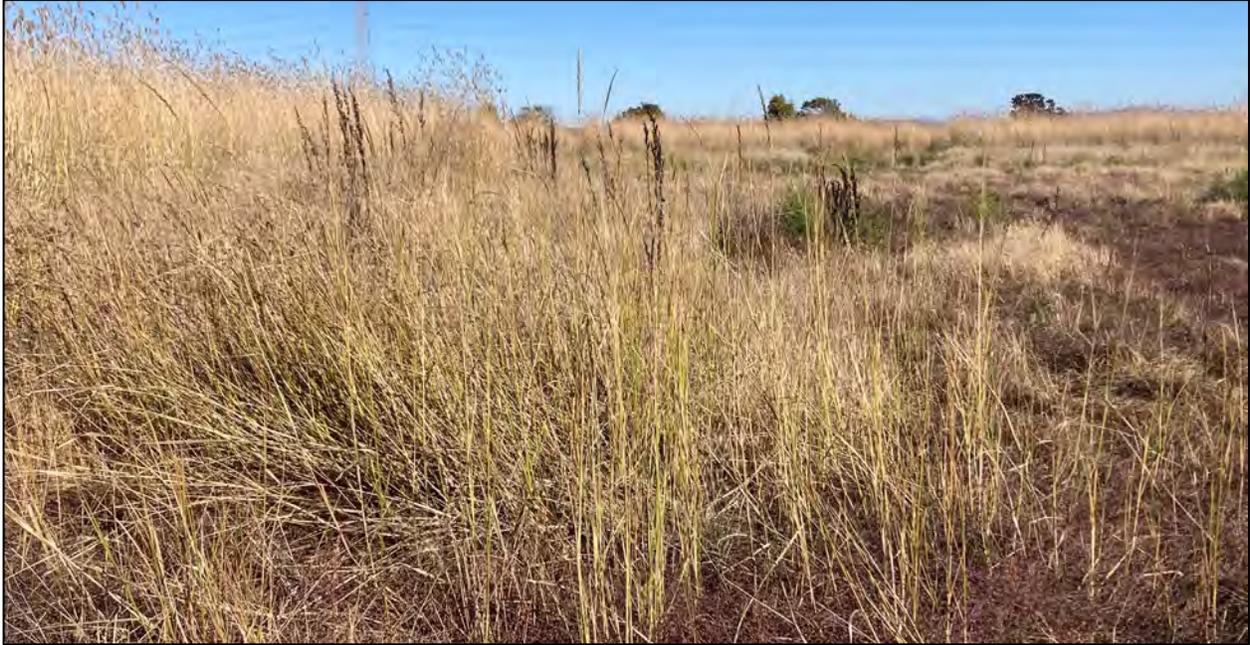
Photo 21: Photo of *Elymus triticoides* patches throughout the restored seasonal wetland. Photo taken facing east from the west terminus of the restored seasonal wetland. Robust patches were not present during annual vegetation monitoring in June 2025 (See Photo 7). Photograph taken on October 17, 2025.
