Corte Madera Four-Acre Tidal Marsh Restoration Project

Year 5 (2025) Annual Monitoring Report

Corte Madera, Marin County, California

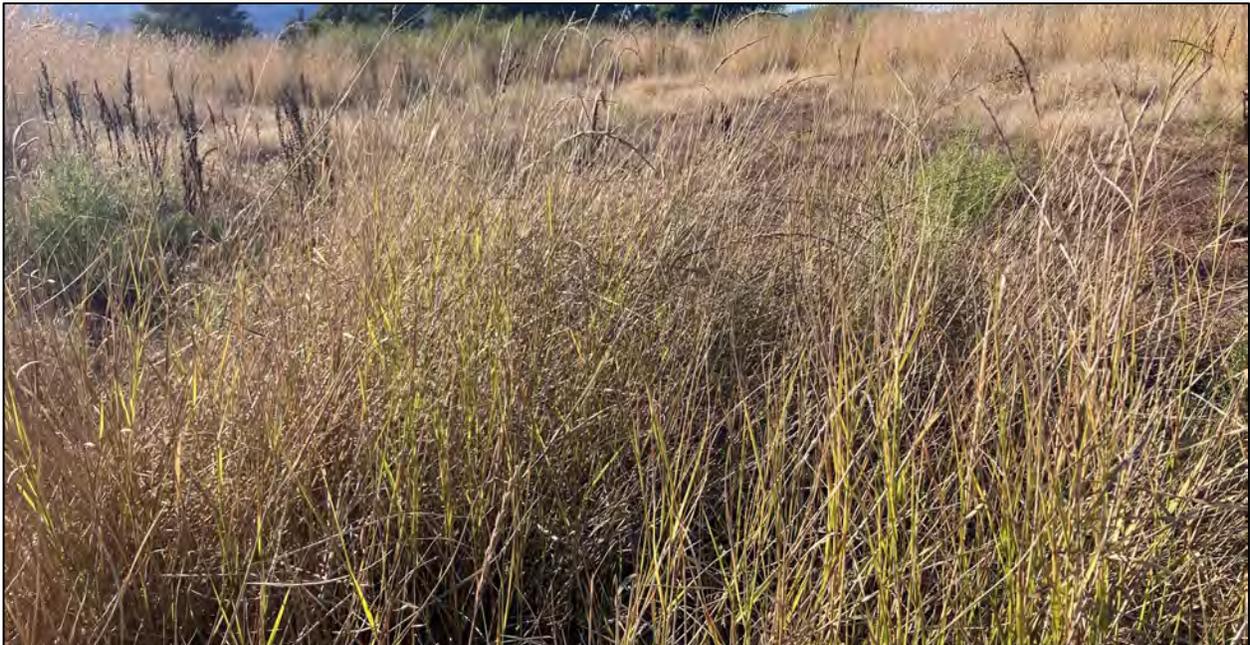
Photo 22: Photo of *Elymus triticoides* patches throughout the restored seasonal wetland. Photo taken facing west from the east terminus of the restored seasonal wetland. Robust patches were not present during annual vegetation monitoring in June 2025 (See Photo 7). Photograph taken on October 17, 2025.

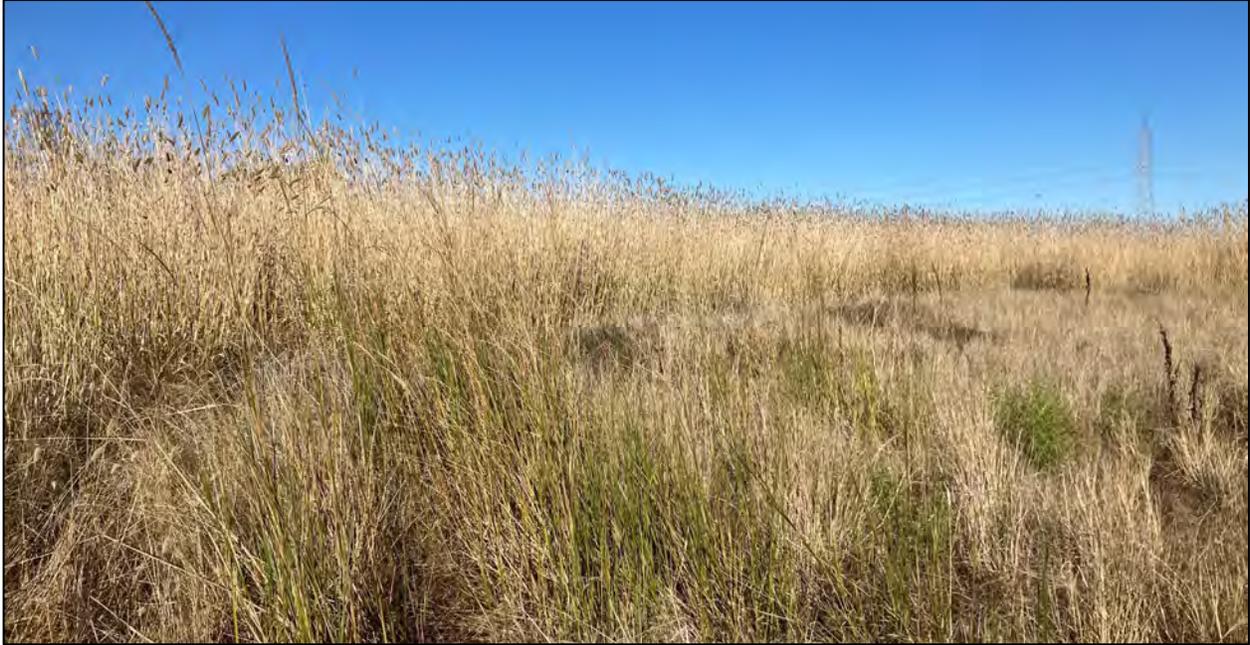
Photo 23: Photo of *Elymus triticoides* patches throughout the restored seasonal wetland. Photo taken facing east from the middle of the northern border of the restored seasonal wetland. Robust patches were not present during annual vegetation monitoring in June 2025 (See Photo 7). Photograph taken on October 17, 2025.

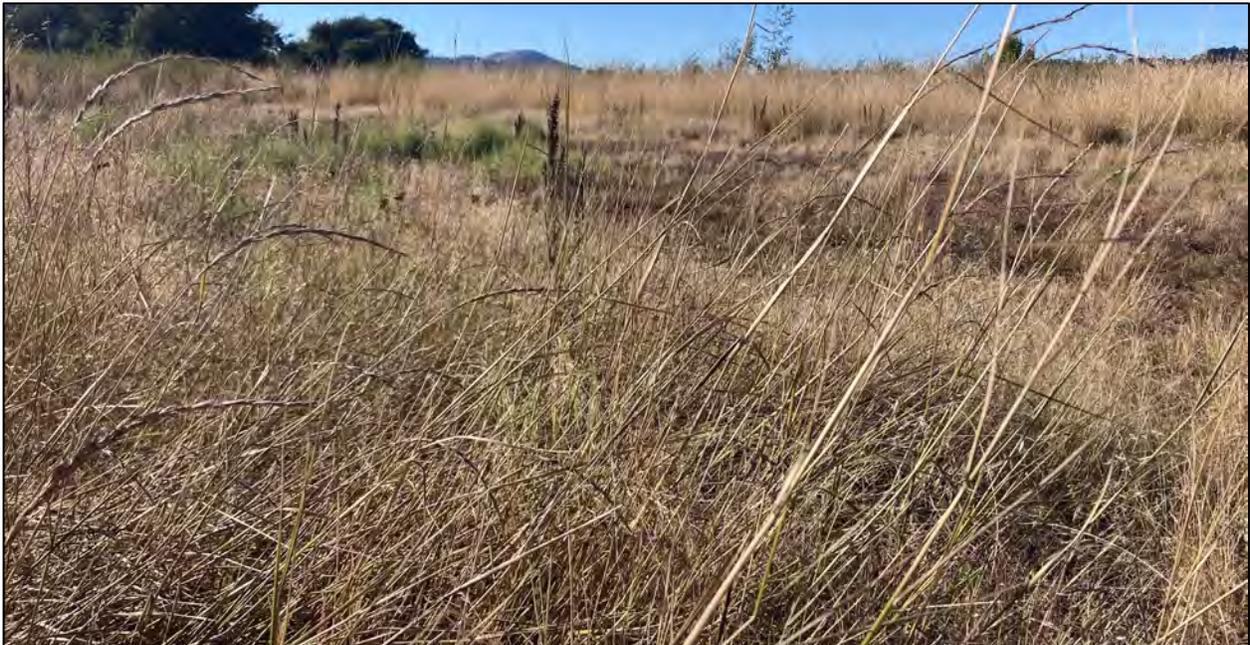
Photo 24: Photo of *Elymus triticoides* patches throughout the restored seasonal wetland. Photo taken facing north from the middle of the southern border of the restored seasonal wetland. Robust patches were not present during annual vegetation monitoring in June 2025 (See Photo 7). Photograph taken on October 17, 2025.

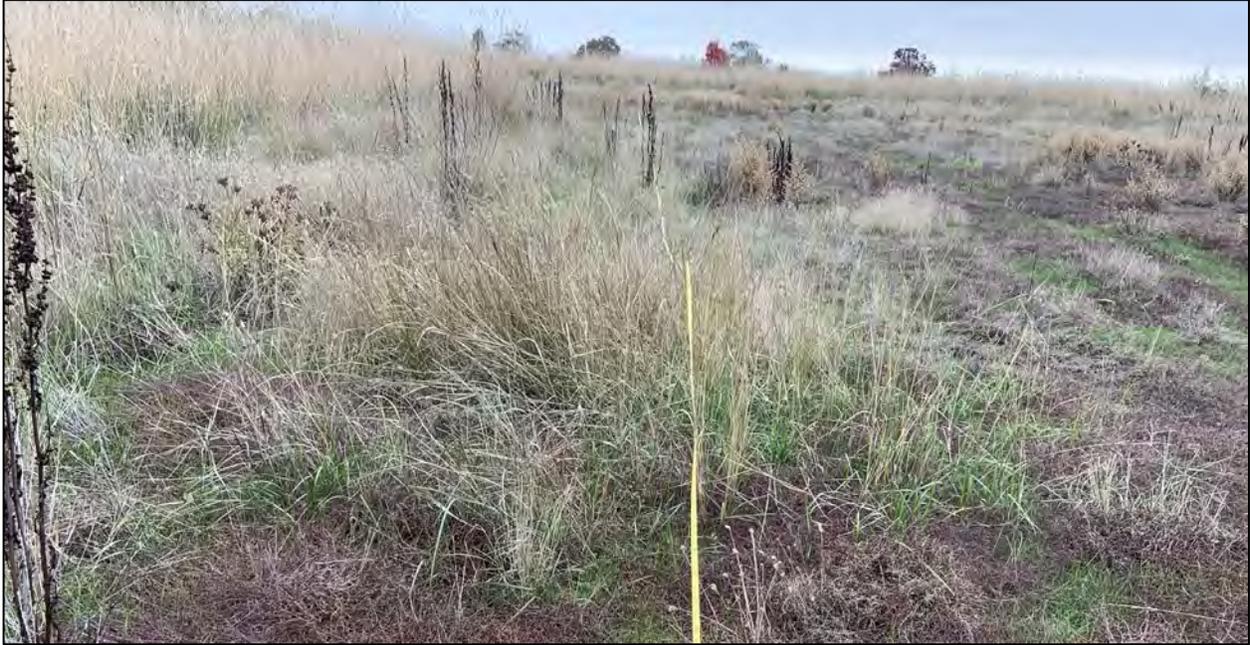
Photo 25: Large, dense patches of *Elymus triticoides* shown growing in the north margin of the seasonal wetland. Photo taken December 10, 2025.

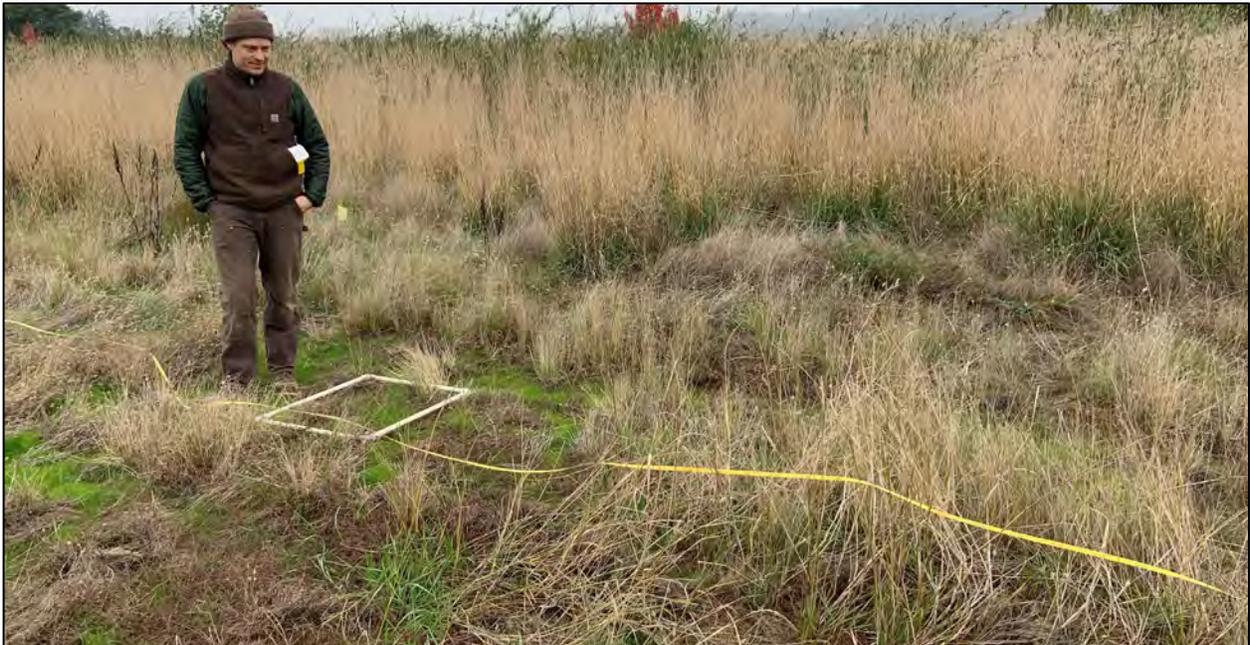
Photo 26: Large, dense patches of *Elymus triticoides* shown growing in the south margin of the seasonal wetland. Photo taken December 10, 2025.

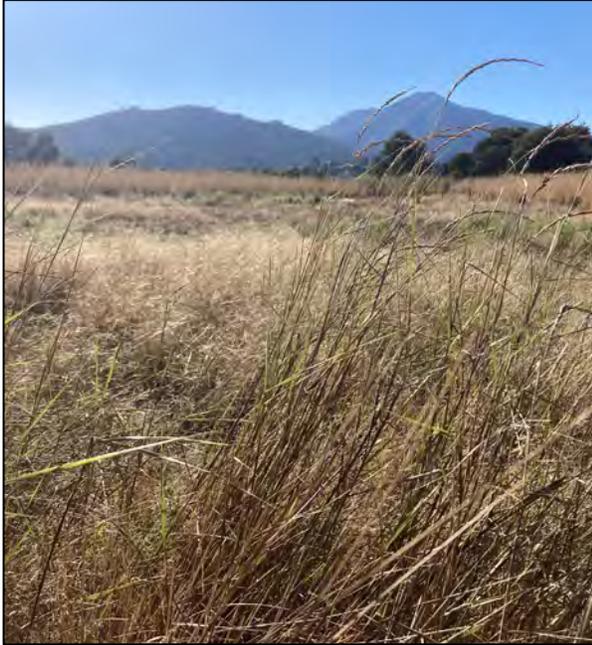
Photograph 27. *Elymus triticoides* successfully colonizing areas reseeded in restored seasonal wetland. Photo taken on October 17, 2025.

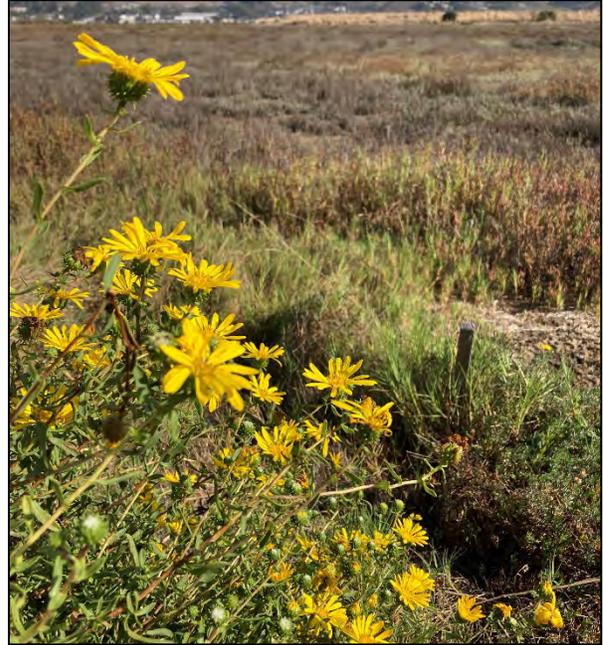
Photograph 29. *Grindelia stricta* plantings growing in the transition zone. Photo taken on September 26, 2025.

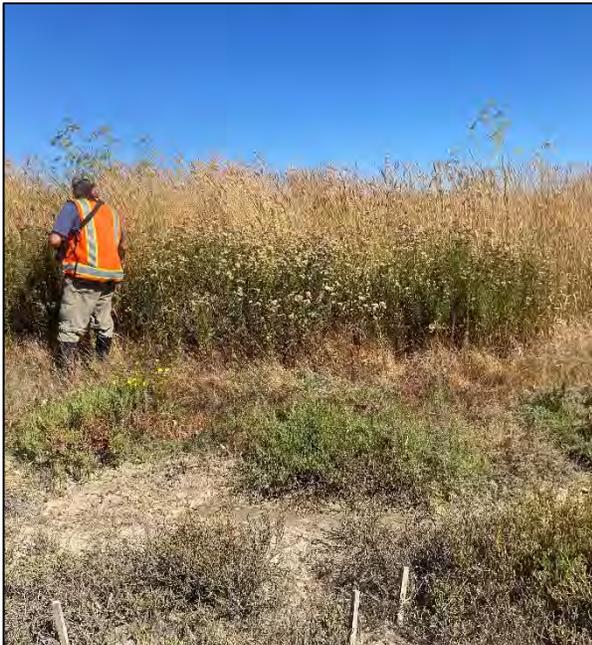
Photograph 28. *Baccharis glutinosa* growing vigorously in the transition zone, growing interspersed with Harding grass. Photo taken on September 3, 2025.

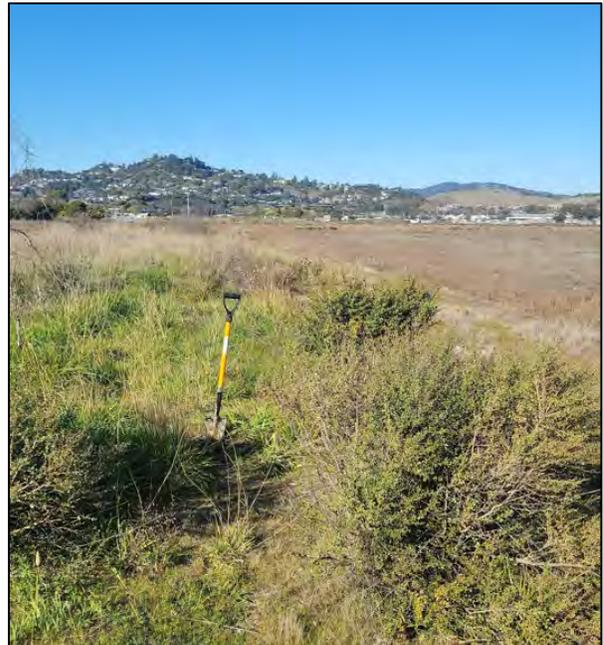
Photograph 30. Representative photograph of the transition zone. *Baccharis pilularis* grows robustly in the transition zone. Photo taken on January 23, 2025.
