# Larkspur Ferry Terminal Sea Level Rise Impact Assessment

Larkspur Ferry Service Expansion and Parking Project

Golden Gate Bridge, Highway and Transportation District

October 6, 2026

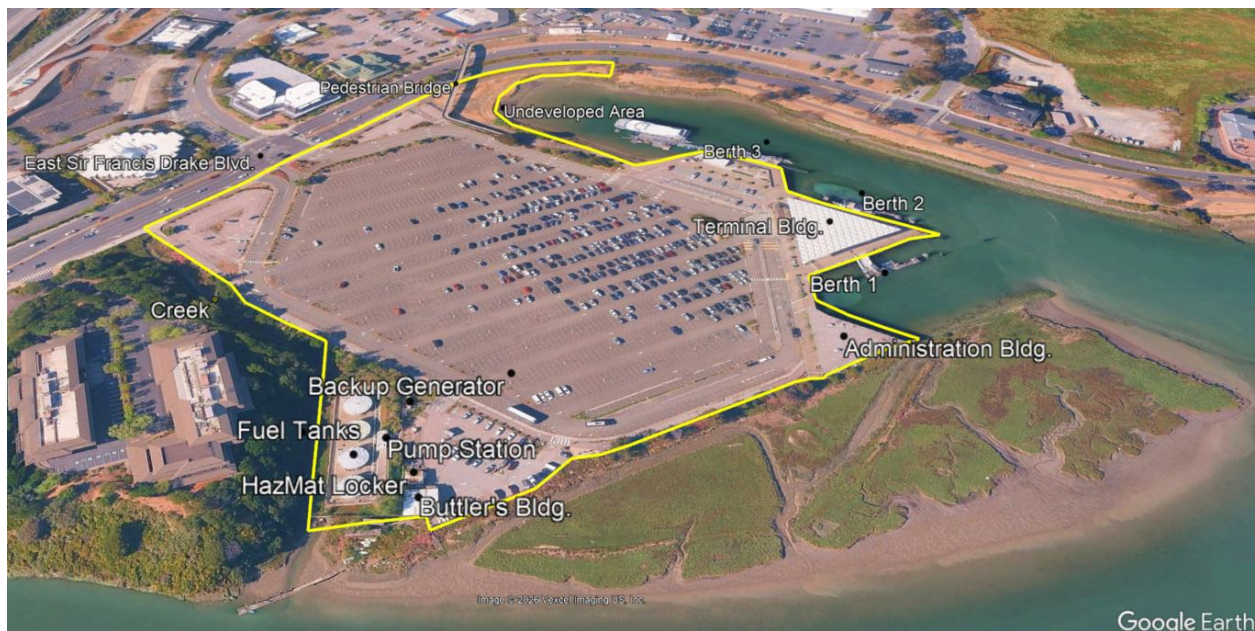
**Figure ES-1. Aerial view of the Larkspur Ferry Terminal, key locations and perimeter inspected (image source: Google Earth Landsat/Copernicus)**

The perimeter inspection started at Berths 2 and 3 and proceeded counterclockwise along a paved pathway that forks toward a pedestrian bridge over East Sir Francis Drake Boulevard (SFD Boulevard) and an undeveloped, low elevation area vulnerable to flooding. Moving west along the SFD Boulevard and onto a bike path, the inspection noted an unnamed Creek, equipped with gates at the SFD Boulevard to prevent upstream high-water propagation. In the relatively low and vulnerable southwest corner, a 4-foot engineered concrete levee surrounds four Fuel Tanks, while the Butler Building, Hazardous Materials (HazMat) Locker, and Backup Generator are elevated on concrete pads above grade. Continuing east along the southern boundary, a low vegetated berm separates the LFT from the marsh and Corte Madera Creek, where an underground stormwater outfall provides a floodwater pathway to the main parking lot. The inspection ended at the Administration Building.

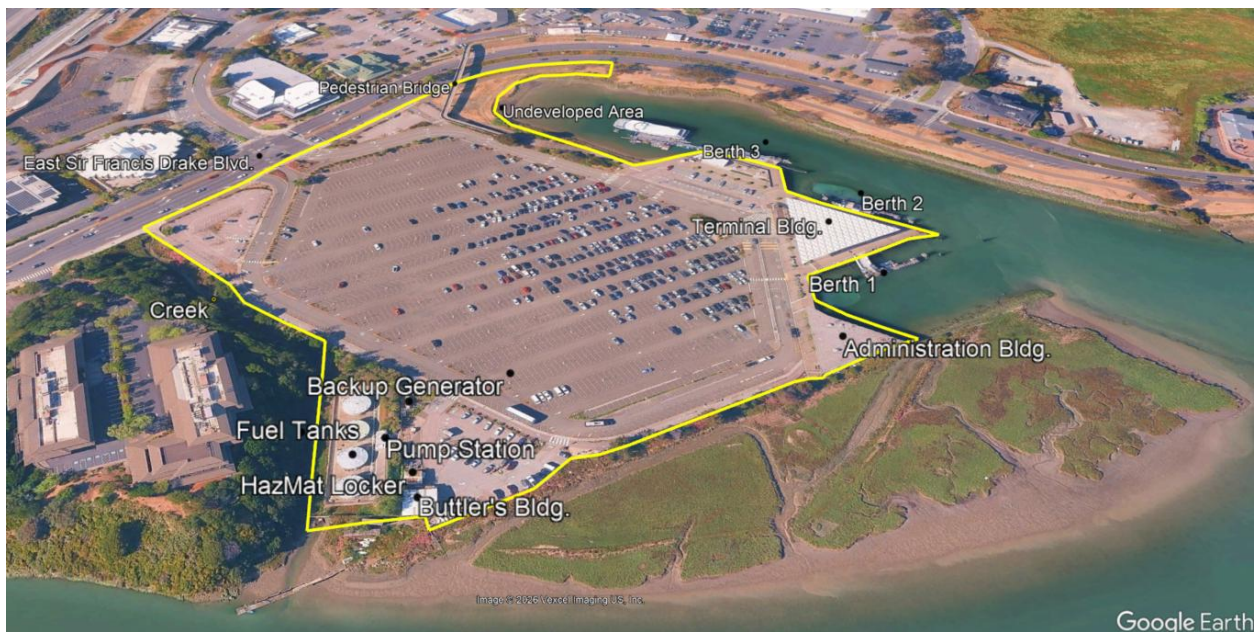
Figure 1. Aerial view of the Larkspur Ferry Terminal, key locations and perimeter inspected (image source: Google Earth Landsat/Copernicus)

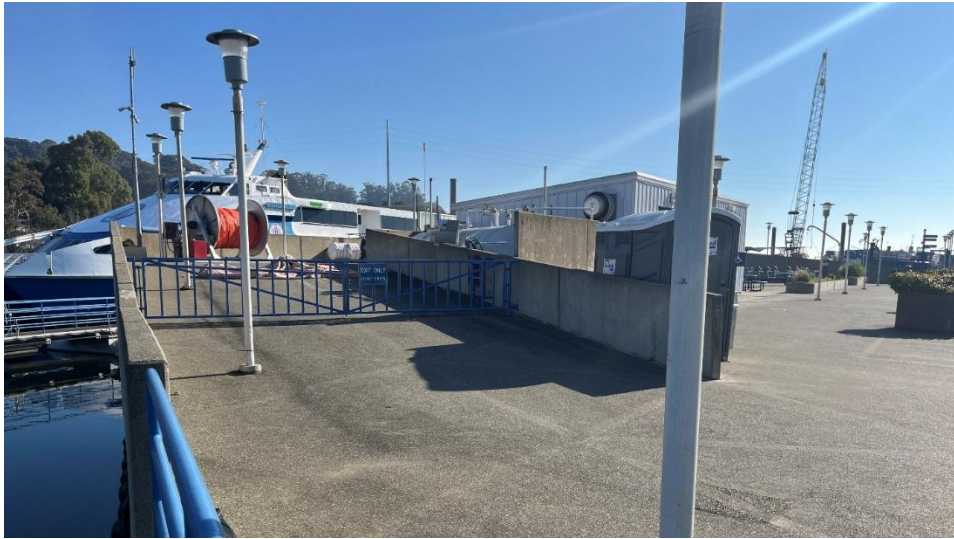
**Figure 2. East view of Berth 3**

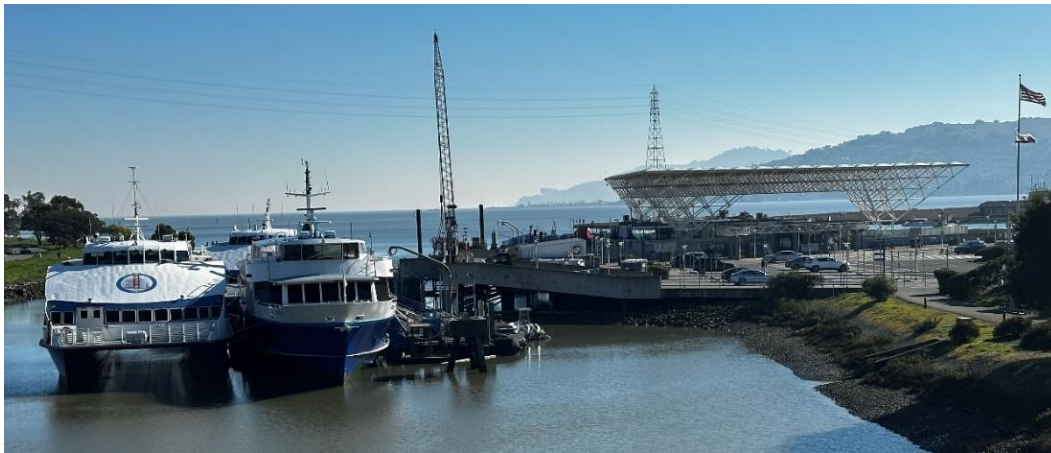
**Figure 3. South view of Berth 3, Berth 2 and the Larkspur Ferry Terminal Building in the background**

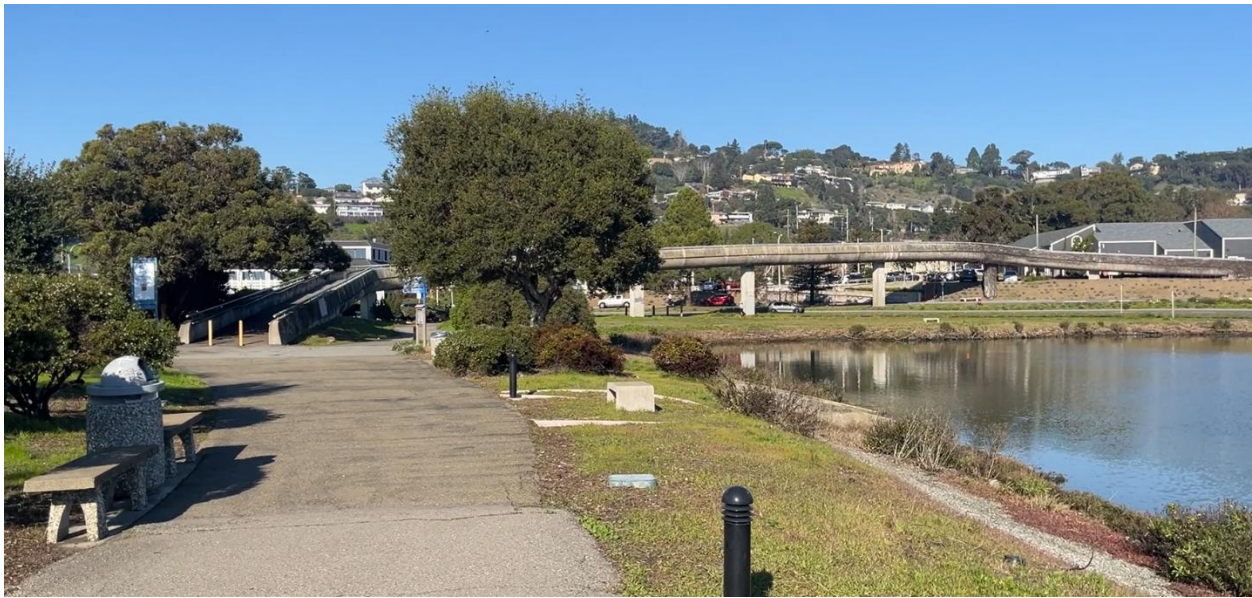
After Berths 2 and 3, the inspection proceeded along the mostly natural waterfront to the north of Berth 3. A pedestrian paved pathway extends to the north as shown in Figure 4. The pathway forks to the west into a pedestrian bridge over East Sir Francis Drake Boulevard (SFD Boulevard) and to the east to an undeveloped, low elevation area vulnerable to flooding. To the west of the pathway, an approximately 5-foot-high above-grade vegetated berm separates the pathway from the main parking lot.

**Figure 4. Pedestrian pathway to the north of Berth 3, bridge over the Sir Francis Drake Boulevard and undeveloped, low elevation area (background and right)**

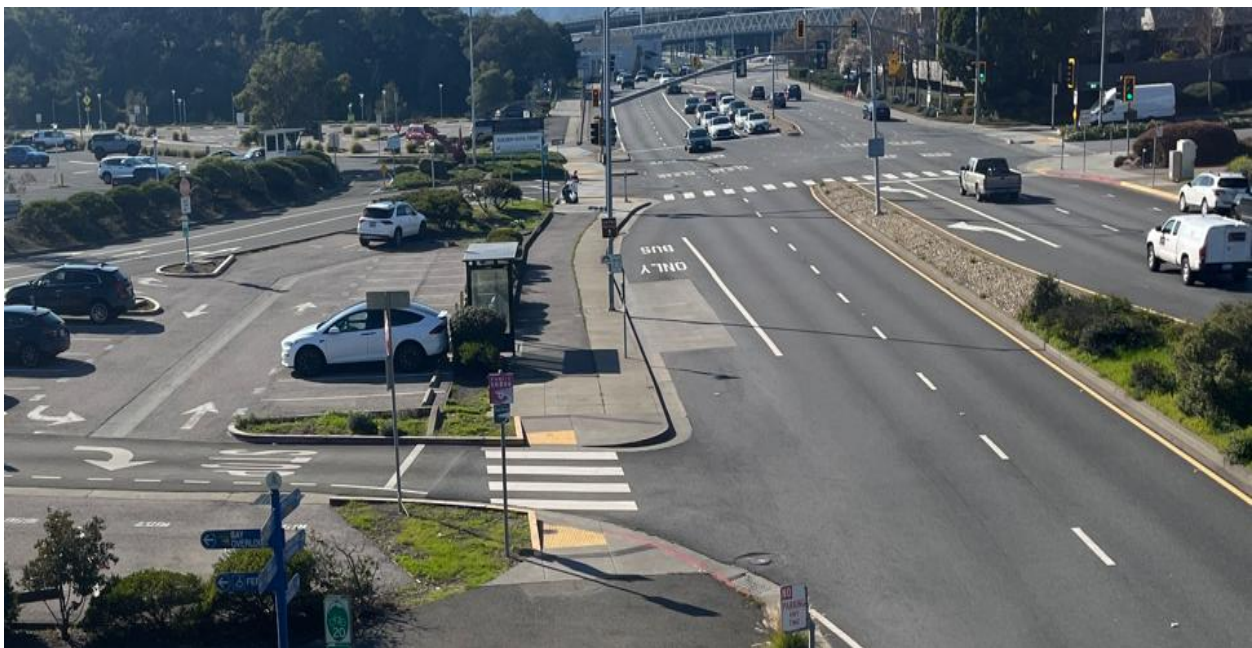
From the pedestrian bridge and SFD Boulevard, the inspection proceeded west along SFD Boulevard, which bounds the LFT to the north. This section is approximately 560 feet long and consists of a sidewalk and planters that separate the LFT from SFD Boulevard. Immediately west of the pedestrian bridge, there is a one-lane main parking lot exit road. Near the midpoint, at the intersection with Larkspur Landing Court, a three-lane exit and a two-lane entrance connect to the LFT access road that runs counterclockwise around its perimeter. Figure 5 shows a west view from the pedestrian bridge of SFD Boulevard and the northern area of the main parking lot.

**Figure 5. West view of the Sir Francis Drake Boulevard (right), main parking lot (left)**

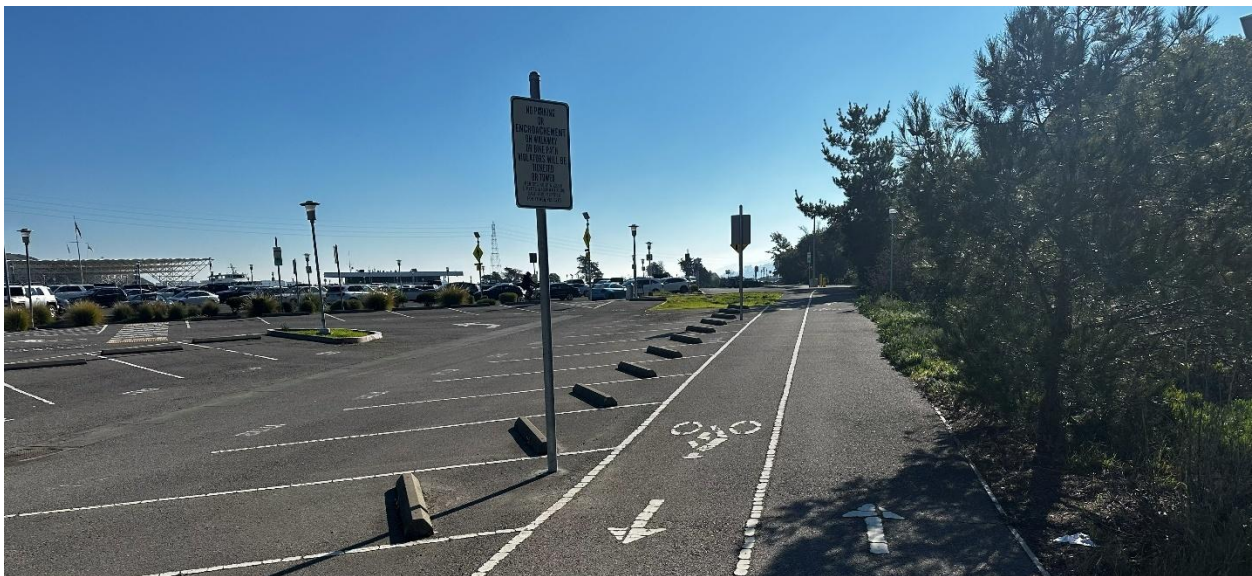
**Figure 7. South view of the bike path by the Creek**

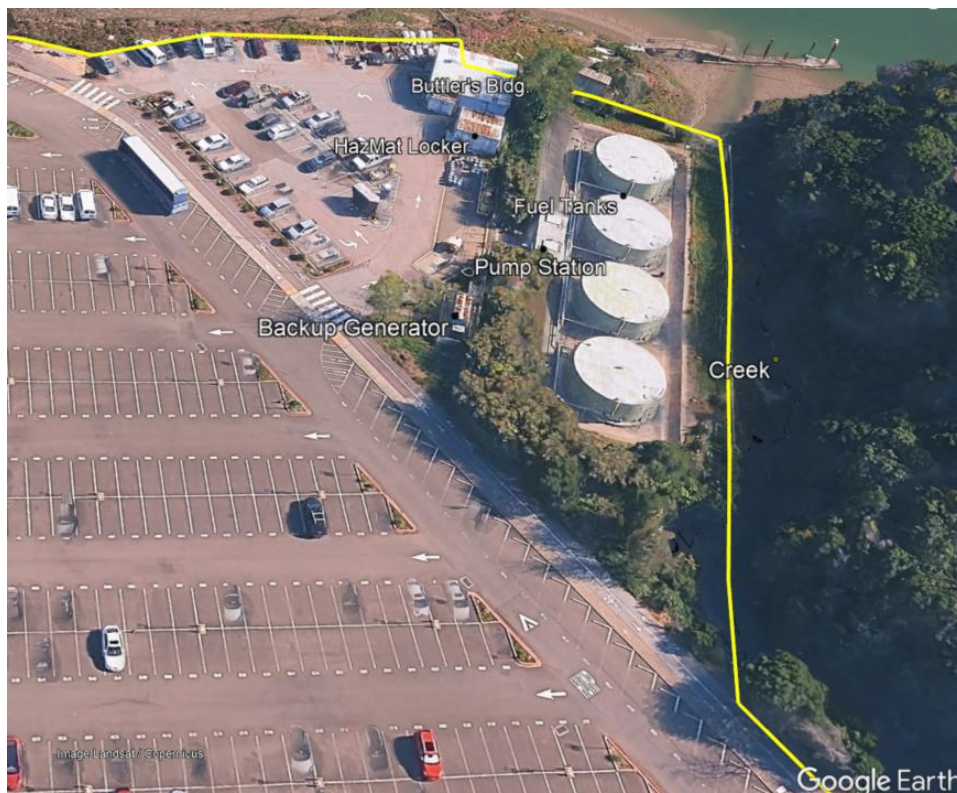
Approximately 400 feet from SFD Boulevard the Creek turns to the south. From that location, the bike path extends until it reaches the marsh at the Corte Madera Creek to then turn east. On the west side, the bike path borders four Fuel Tanks, an employee parking lot and ancillary facilities and, on the east side, the main parking lot. Figure 8 shows an aerial view to the south of the Creek, LFT perimeter, Fuel Tanks and ancillary facilities.

This area, in the southwest corner of the LFT, is relatively low and, as relayed by District's staff, vulnerable to flooding. An about 4-foot-high engineered concrete levee surrounds the Fuel Tanks in a containment area which protects the LFT and Creek from accidental spills and the tanks from flooding. Rainwater collected within the containment area is conveyed with ditches to a sump in the southwest corner where is pumped out into the Corte Madera Creek.

**Figure 8. Aerial view to the south of the southwest corner of the Larkspur Ferry Terminal, perimeter (yellow), Fuel Tanks and ancillary facilities (Google Earth Landsat/Copernicus n.d.)**

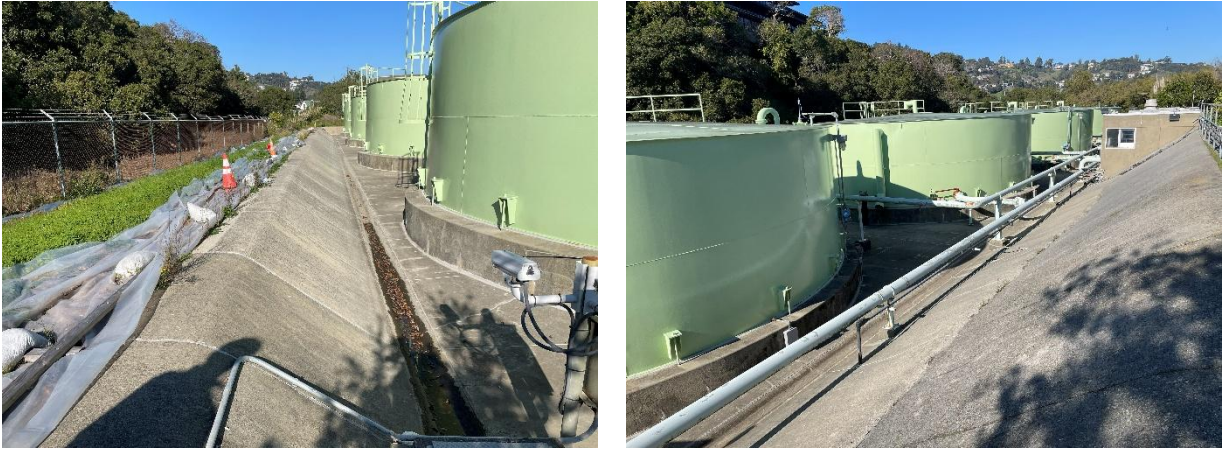
Figure 9. North views of Fuel Tanks, west side (left) and east side and Pump Station (right)

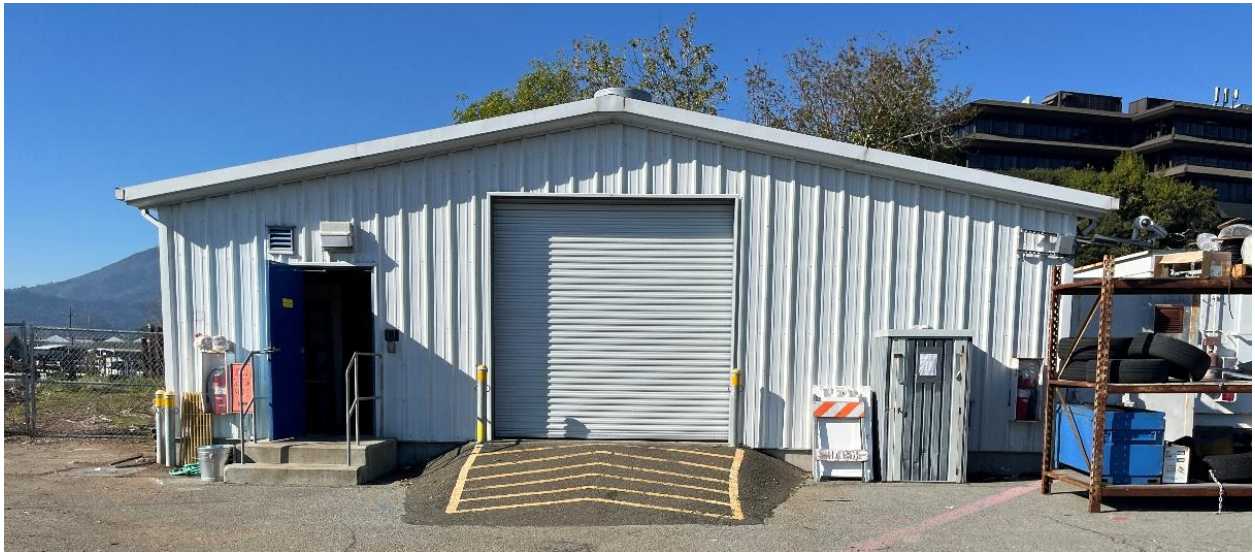
Figure 10. Butler Building

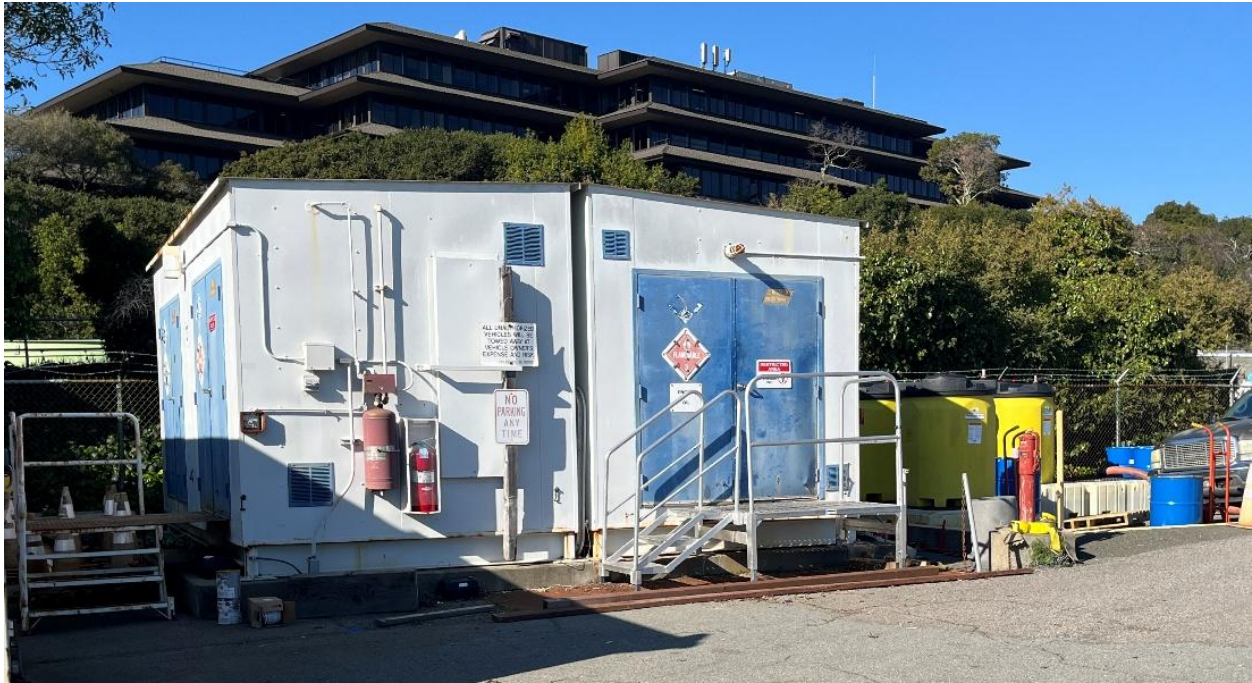
Figure 11. HazMat Locker

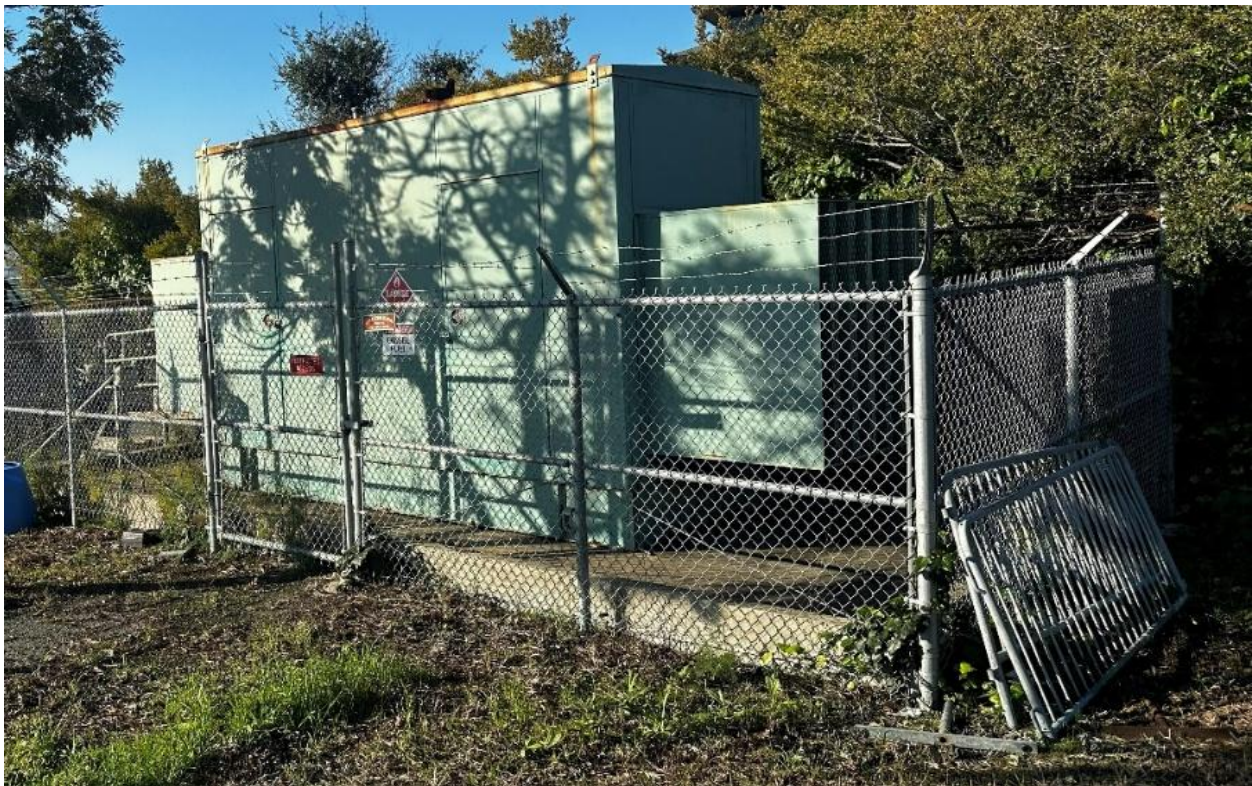
Figure 12. Backup Generator

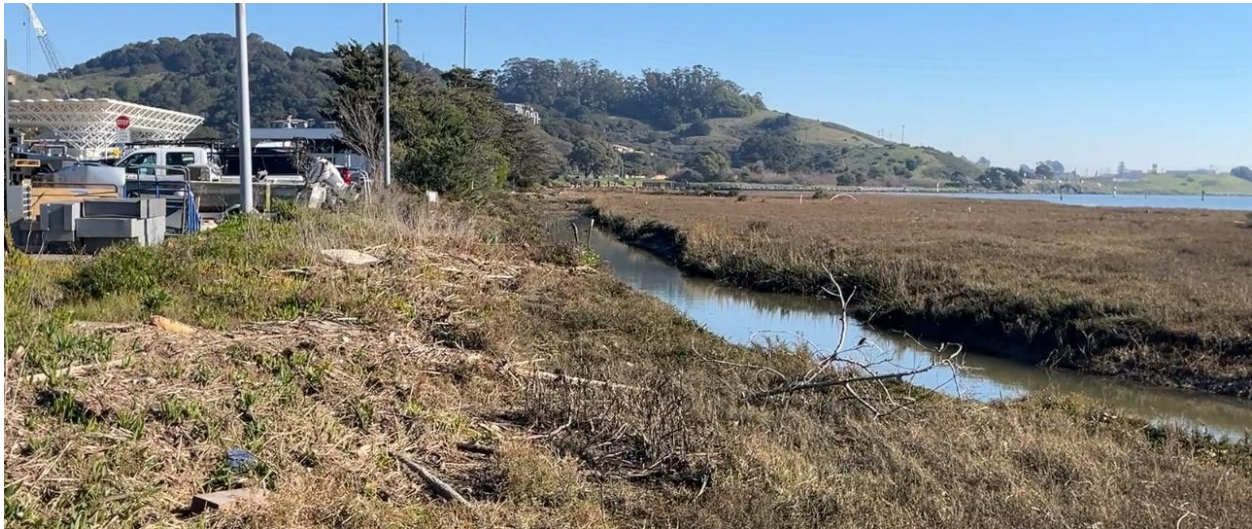
**Figure 13. East view of the marsh from the Butler Building**

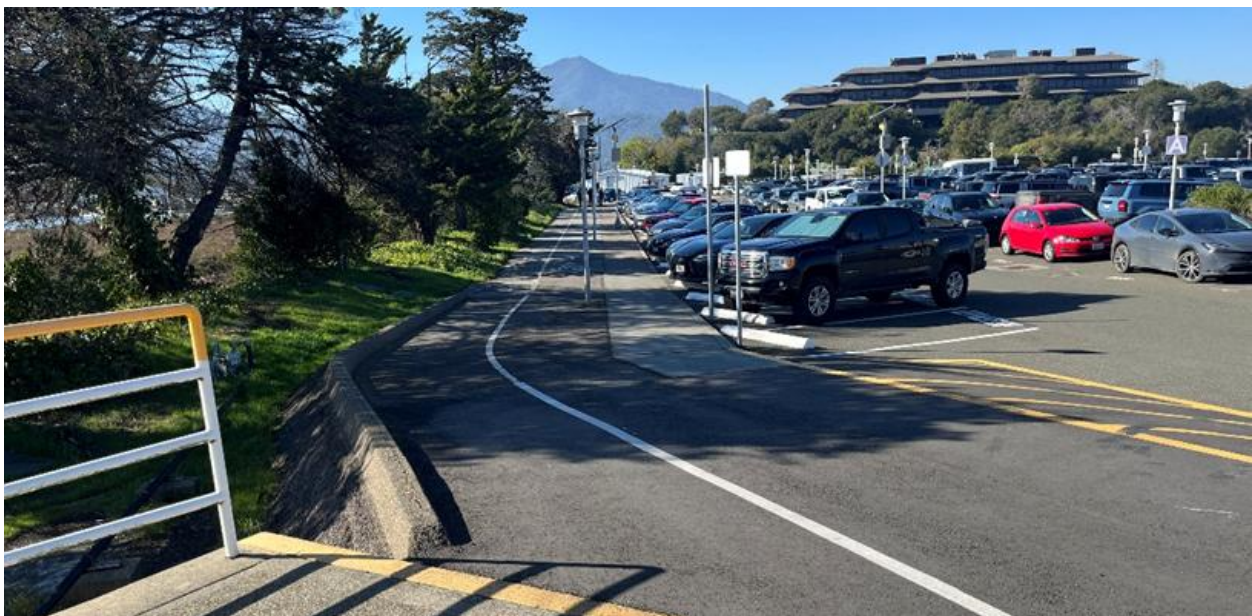
From the Butler Building, the inspection continued east along the bike path that borders the marsh and which fronts the LFT along its approximately 550-foot southern boundary. The bike path is generally level and has an elevation consistent with the adjacent main parking lot. A low, vegetated berm about 3-foot-high above-grade separates the bike path from the marsh and Corte Madera Creek. This waterfront area is relatively low and, as relayed by District's staff, vulnerable to flooding. Stormwater collected in an approximately 120-foot-long drain in the LFT access road adjacent to the bike path is conveyed through an underground outfall to the Corte Madera Creek. The outfall constitutes a path for the Corte Madera Creek seawater to flood the main parking lot in high water events. Figure 13 shows a general view of the marsh to the east from the Butler Building. Figure 14 shows a west view of the bike path along the LFT southern boundary.

**Figure 14. West view of the bike path and vegetated berm along the southern boundary of the Larkspur Ferry Terminal**

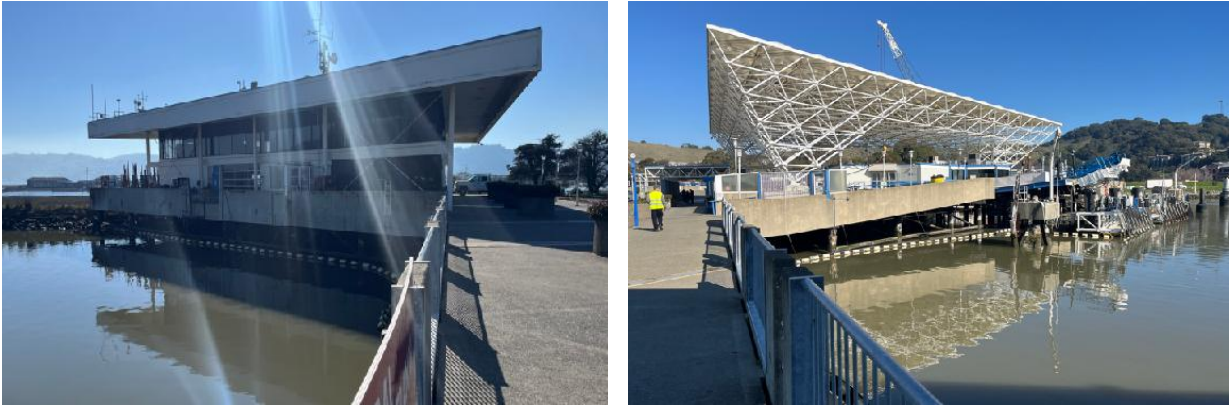
The inspection ended at the Administration Building located at the southeast corner of the LFT (Figure 15). Like the passenger boarding pier where Berths 1 and 2 are located, the Administration Building is built on a pile-supported concrete deck. The perimeter of both is protected by approximately 44-inch-high concrete parapets and steel railings.

Figure 15. Southwest view the Administration Building (left) and northeast view of Larkspur Ferry Terminal Building Berth 1

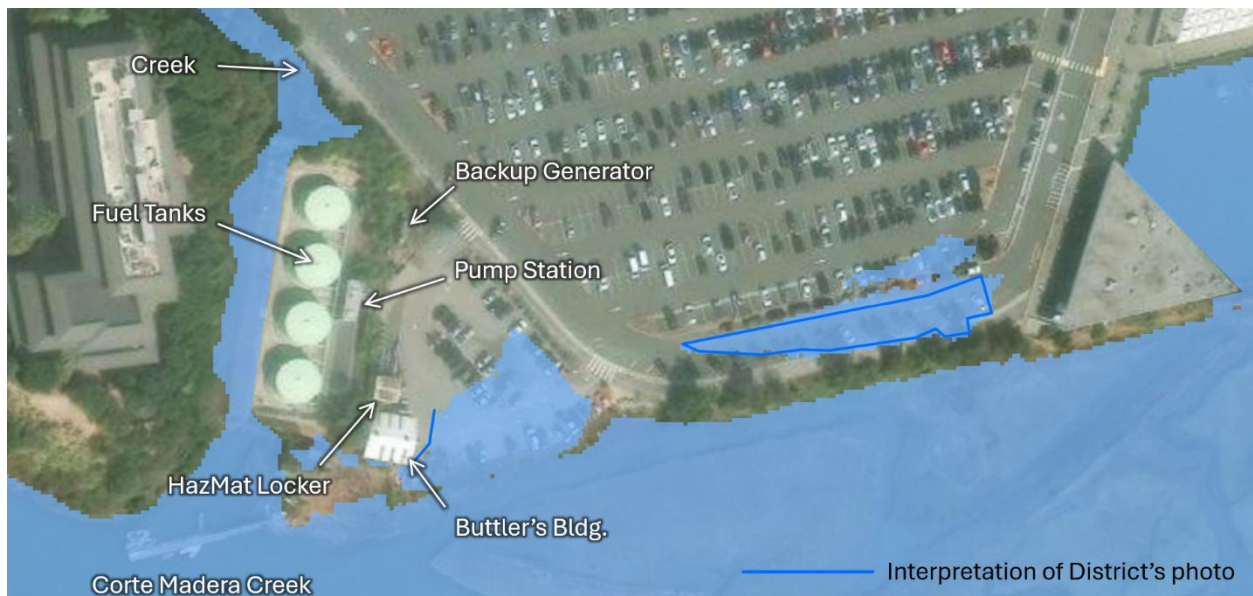
Figure 18 and Figure 19 show District's photos taken on January 2, 2026, at 9:39 AM when the TWL was 8.31 feet NAVD88 (NOAA 2025b). Figure 18 shows the flooded area in front of the Butler Building and Figure 19 shows the flooded area in the southern section of the LFT access road. Figure 20 shows a very good correlation between the flooded area according to the NOAA DEM and the extent of flooding from

**Figure 20. Flooded area in the Butler Building area and southern section of the Larkspur Ferry Terminal access road according to the NOAA DEM on January 2, 2026, at 9:39 AM, TWL = 8.31 feet NAVD88 (NOAA 2025b)**

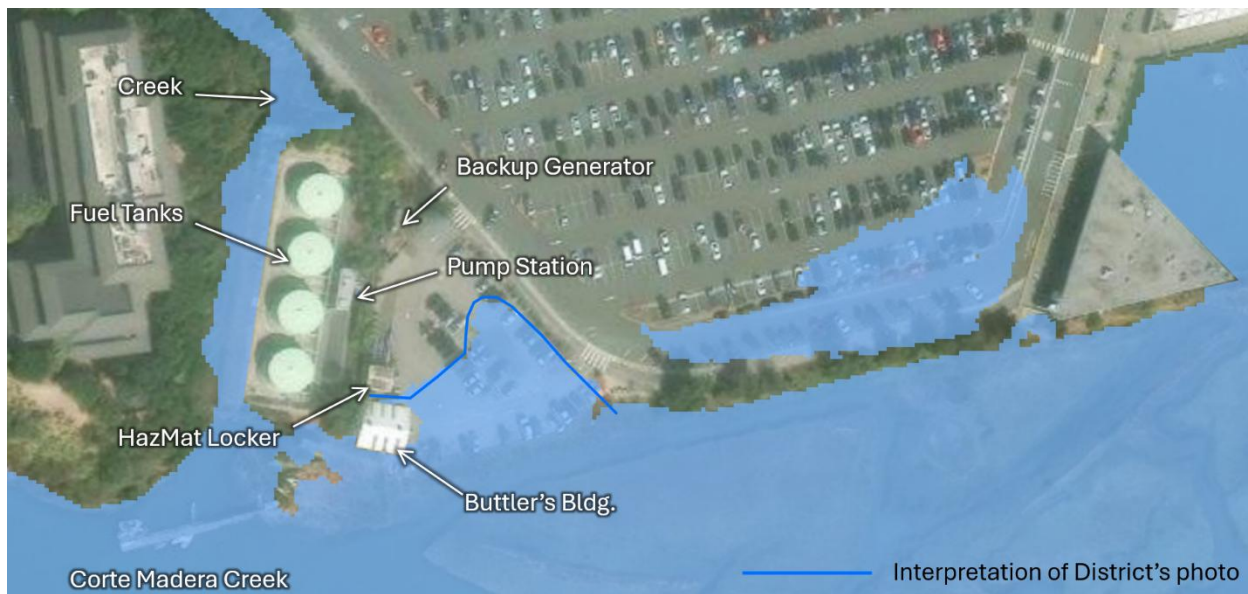
Figure 21 shows a District's photo of the debris in the employee parking lot in the Butler Building area marking the edge of the highest floodwater elevation on January 3, 2026, at 10:36 AM when the TWL was 8.73 feet NAVD88 (NOAA 2025b). Figure 22 shows a very good correlation between the flooded area according to the NOAA DEM and the extent of flooding from the interpretation of the District's photo; the edge of the floodwater is close to the entrance of the Butler Building and covers a significant area of the employee parking lot.

**Figure 22. Flooded area in the Butler Building area and southern section of the Larkspur Ferry Terminal access road according to the NOAA DEM on January 3, 2026, at 10:36 AM, TWL = 8.73 feet NAVD88 (NOAA 2025b)**

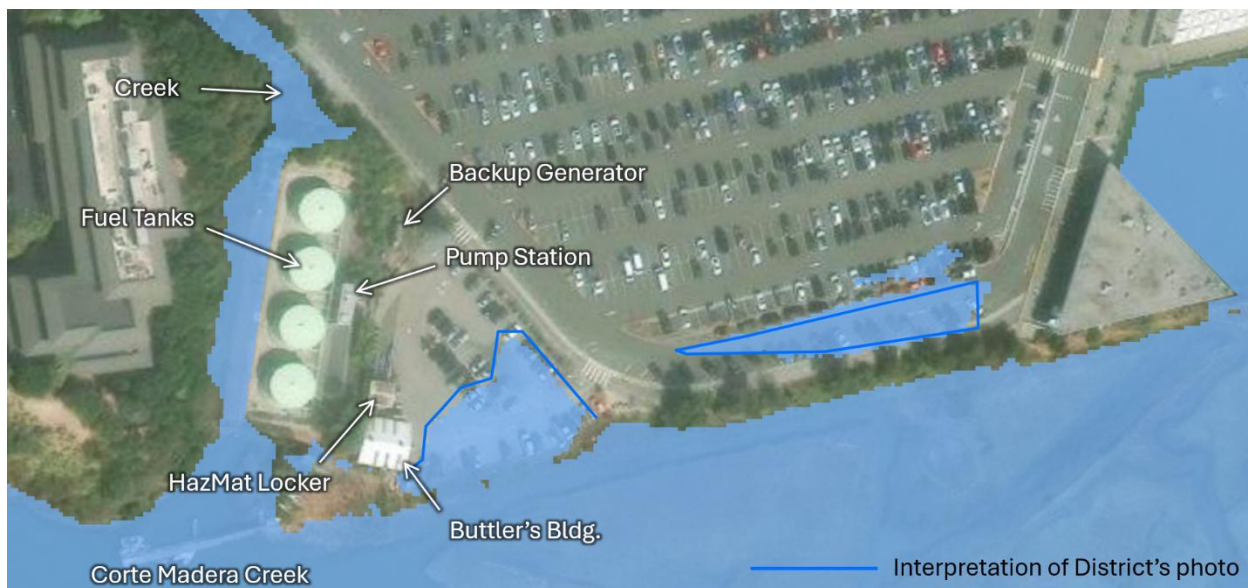
Figure 23 (same as Figure 21) shows the edge of the floodwater and flooded area in the employee parking lot in the Butler Building area on January 4, 2026, at 12:09 PM when the TWL was 8.23 feet NAVD88 (NOAA 2025b). Figure 24 shows the flooded area in the southern section of the LFT access road. Figure 25 shows a very good correlation between the flooded area according to the NOAA DEM and the extent of flooding from the interpretation of the District's photos; the edge of the floodwater is close to the entrance of the Butler Building, and the HazMat Locker is above water. Furthermore, the southern section of the LFT access road is partially flooded due to the intrusion of seawater through the outfall under the bike path and vegetated berm and drain along the road.

**Figure 25. Flooded area in the Butler Building area and southern section of the Larkspur Ferry Terminal access road according to the NOAA DEM on January 4, 2026, at 12:12 PM, TWL = 8.23 feet NAVD88 (NOAA 2025b)**

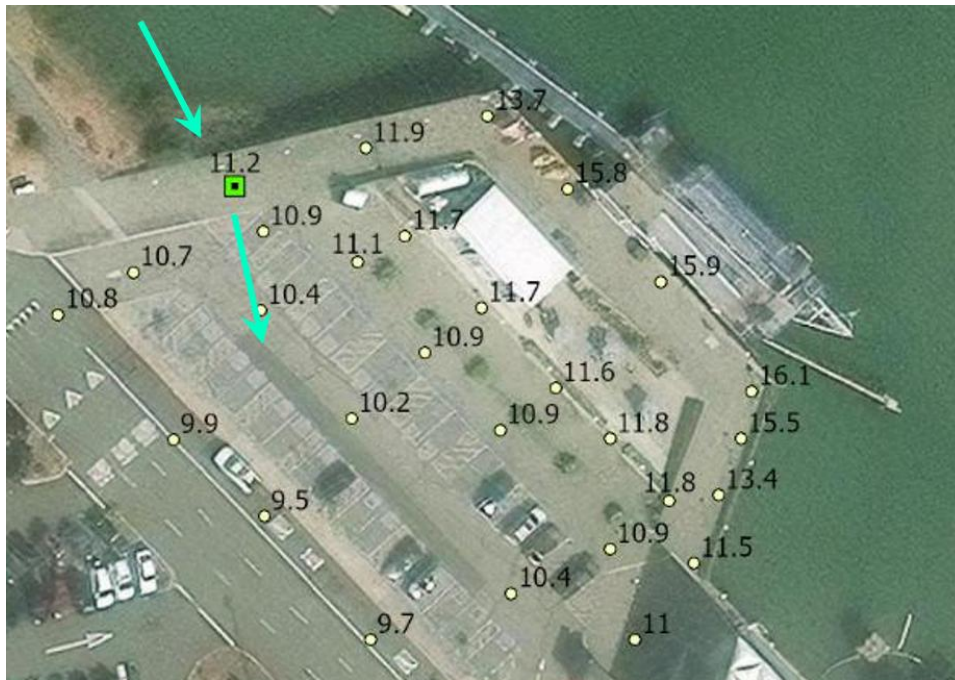
The lowest elevation, and potential floodwater breaching point, in the LFT Buildings area is **11.2 feet NAVD88** at the northern end Berth 3. Figure 30 shows the location of the floodwater breaching point and the elevations in the vicinity.

Figure 30. Location and elevation of the floodwater breaching point (■) in the Larkspur Ferry Terminal Buildings area at the northern end of Berth 3 and elevations in the vicinity

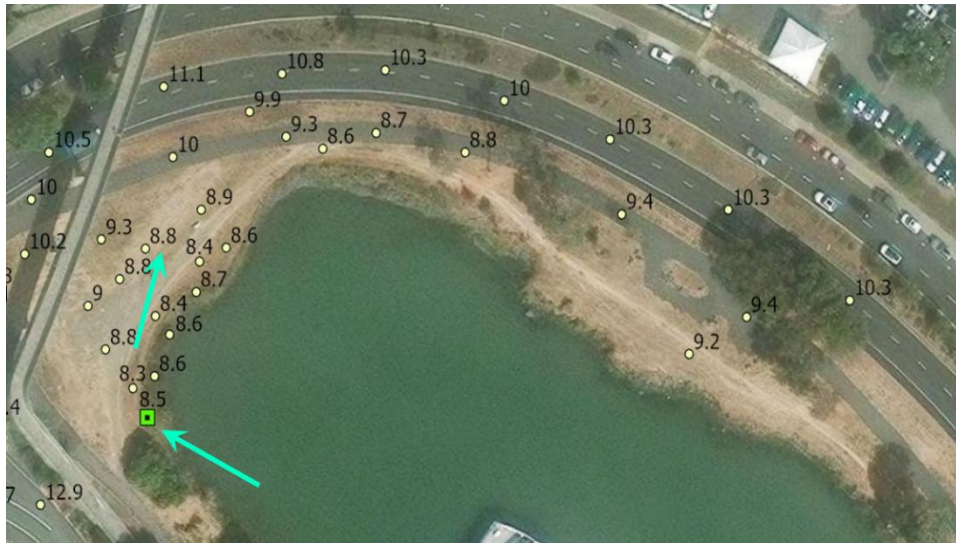
The lowest elevation, and potential floodwater breaching point, in the Undeveloped area is **8.5 feet NAVD88** at the northwest corner of the LFT basin. Figure 31 shows the location of the floodwater breaching point and the elevations in the vicinity.

Figure 31. Location and elevation of the floodwater breaching point (■) in the Undeveloped area at the northwest corner of the Larkspur Ferry Terminal basin and elevations in the vicinity

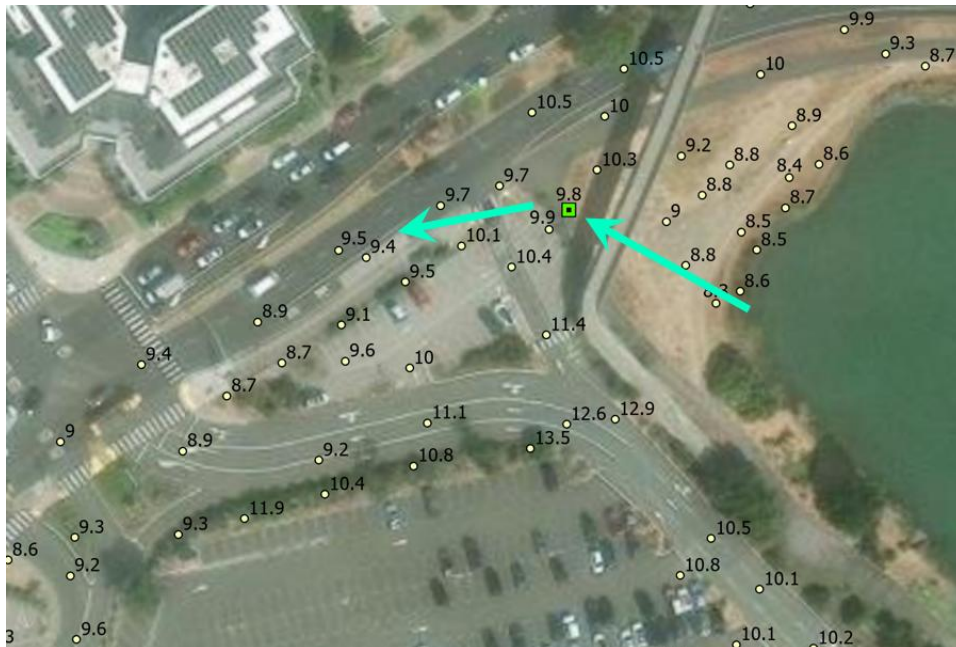
The lowest elevation, and potential floodwater breaching point, in the SFD Boulevard area is **9.8 feet NAVD88** at the eastern end of SFD Boulevard by the pedestrian bridge. Figure 32 shows the location of the floodwater breaching point and the elevations in the vicinity.

Figure 32. Location and elevation of the floodwater breaching point (■) in Sir Francis Drake Boulevard area at the eastern end of Sir Francis Drake Boulevard by the pedestrian bridge and elevations in the vicinity

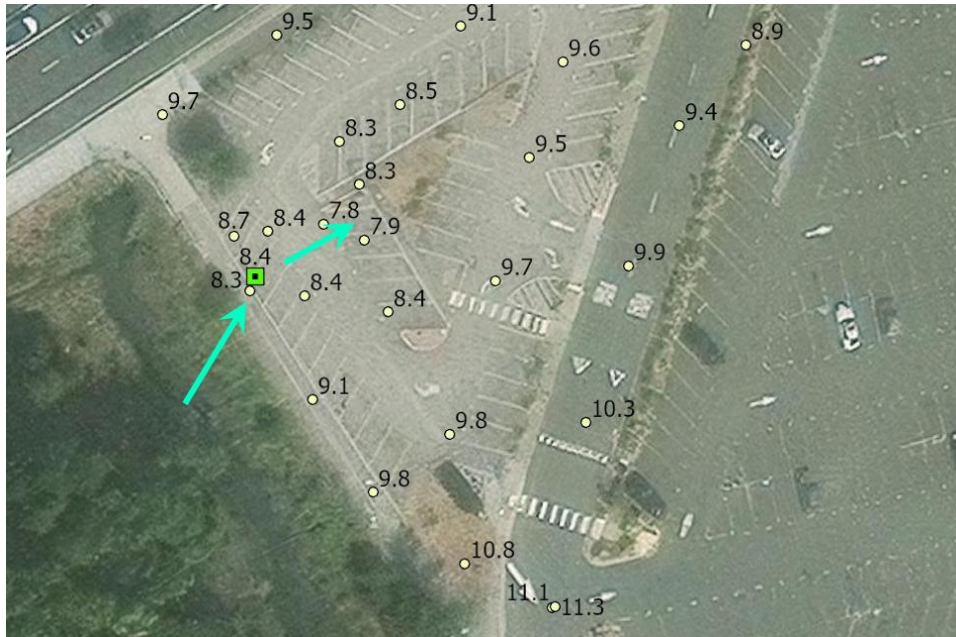
The lowest elevation, and potential floodwater breaching point, in the Creek area is **8.4 feet NAVD88** near the northern end of the Creek. Figure 33 shows the location of the floodwater breaching point and the elevations in the vicinity.

Figure 33. Location and elevation of the floodwater breaching point (■) in the Creek area near the northern end of the Creek and elevations in the vicinity

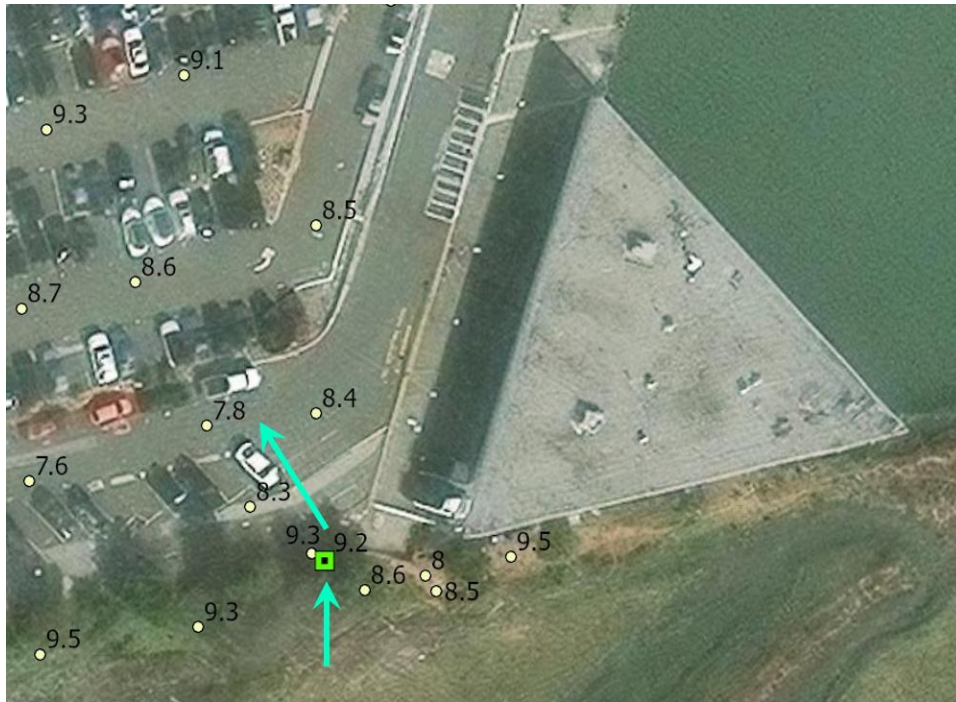
The lowest elevation, and potential floodwater breaching point, in the Marsh area is **9.3 feet NAVD88** at the eastern landward edge of the marsh close to the Administration Building. Figure 36 shows the location of the floodwater breaching point and the elevations in the vicinity.

Figure 36. Location and elevation of the floodwater breaching point (■) in the Marsh area at the eastern landward edge of the marsh close to the Administration Building and elevations in the vicinity

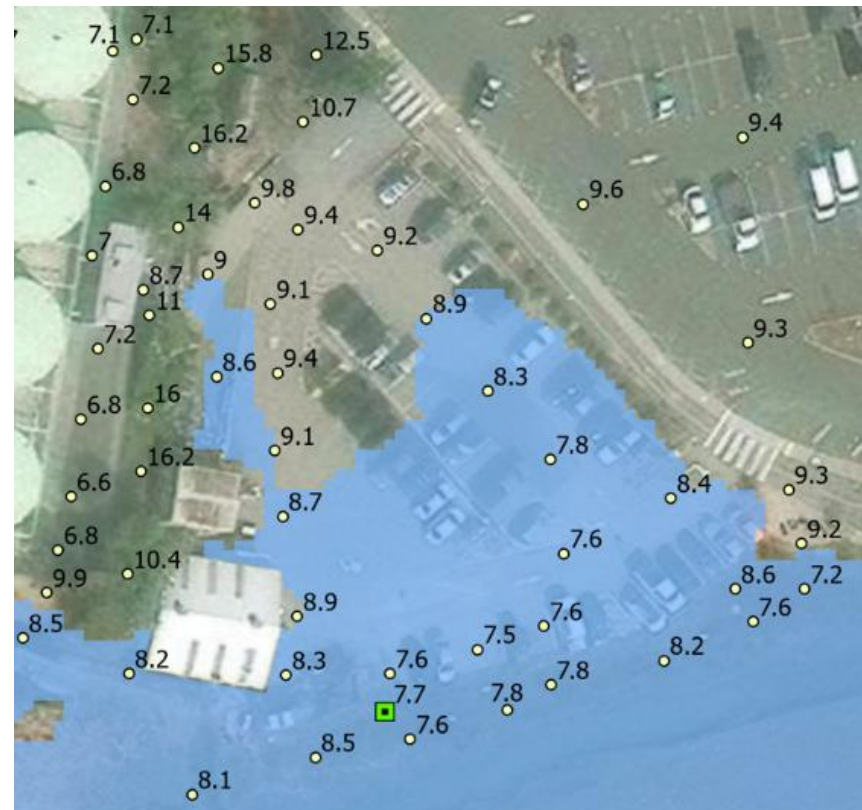
Figure 41. Potential extent of flooding in the Butler Building area assuming infinite duration of the projected 8.9 feet NAVD88 TWL by 2030 (intermediate risk aversion) overtopping the 7.7 feet NAVD88 breaching point and low-lying areas

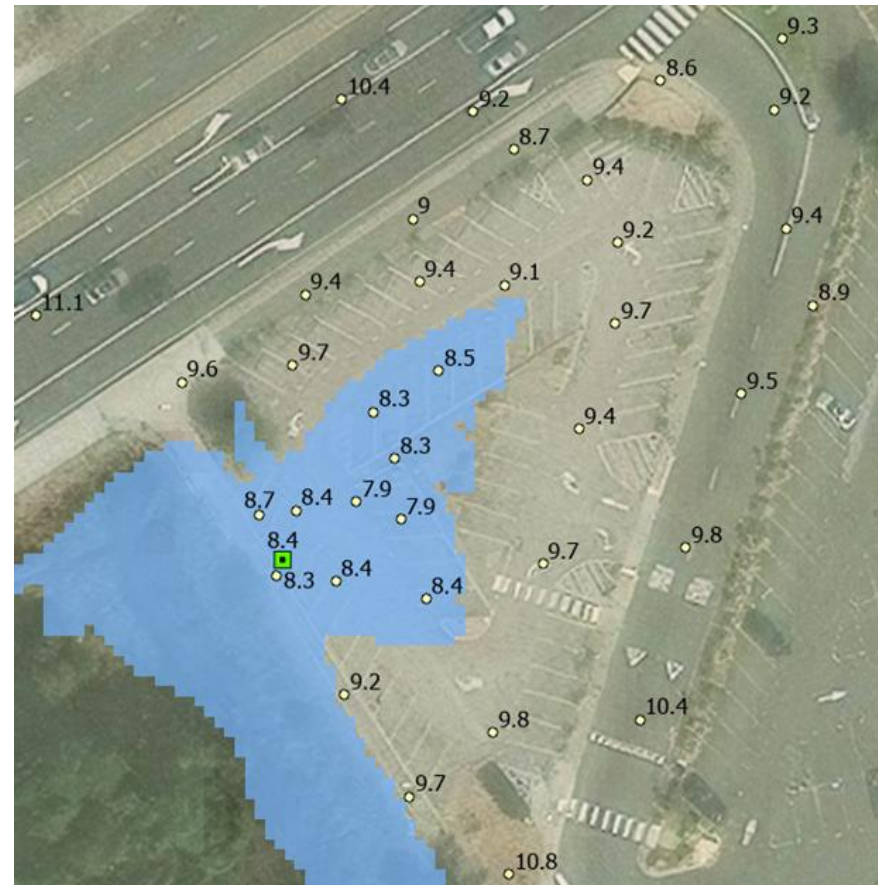
Figure 44. Potential extent of flooding in the Creek area assuming infinite duration of the projected 8.9 feet NAVD88 TWL by 2030 (intermediate risk aversion) overtopping the 8.4 feet NAVD88 breaching point and adjacent low-lying areas

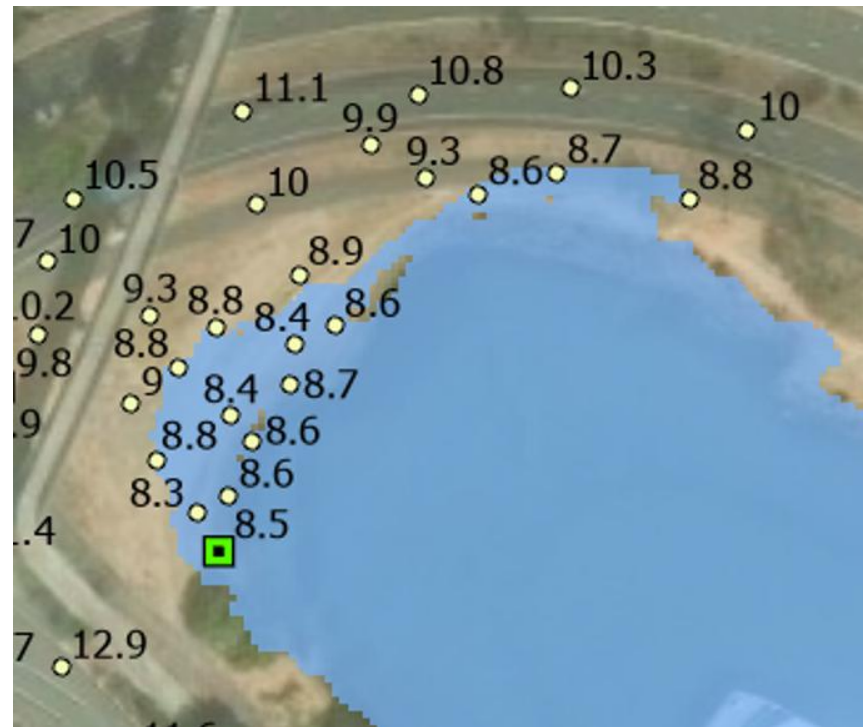
Figure 47. Potential extent of flooding in the Undeveloped area assuming infinite duration of the projected 8.8 feet NAVD88 TWL by 2030 (low risk aversion) overtopping the 8.5 feet NAVD88 breaching point and adjacent low-lying areas

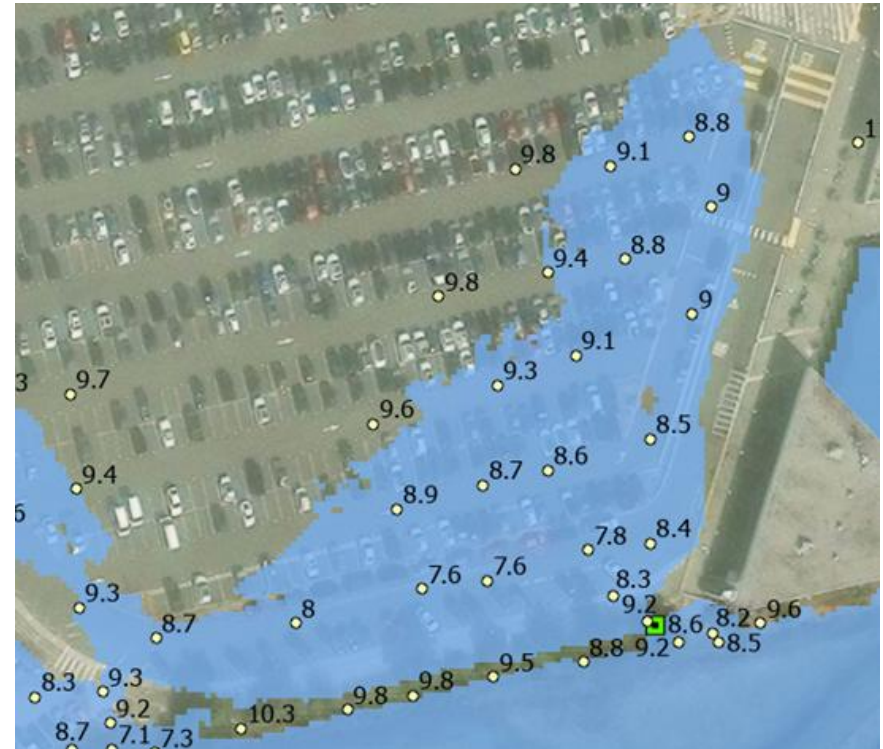
Figure 50 shows the potential extent of flooding (i.e., the area with elevations below the projected TWL) when the 9.3 feet NAVD88 TWL by 2050 (intermediate risk aversion) overtops the breaching point and adjacent low-lying areas for an infinite duration. This extent of flooding is unlikely to occur, as the duration of the TWL above the breaching point elevation and adjacent low-lying areas will be limited. Furthermore, the extent of flooding will be controlled not only by the duration of overtopping but also by site-specific factors affecting floodwater propagation, such as topography, surface permeability, existing structures, flow pathways, and drainage characteristics. Hydrodynamic flood modeling accounting for these factors would be needed to accurately quantify the spatial extent and depth of flooding.

Figure 50. Potential extent of flooding in the Marsh area assuming infinite duration of the projected 9.3 feet NAVD88 TWL by 2050 (intermediate risk aversion) overtopping the 9.2 feet NAVD88 breaching point and adjacent low-lying areas

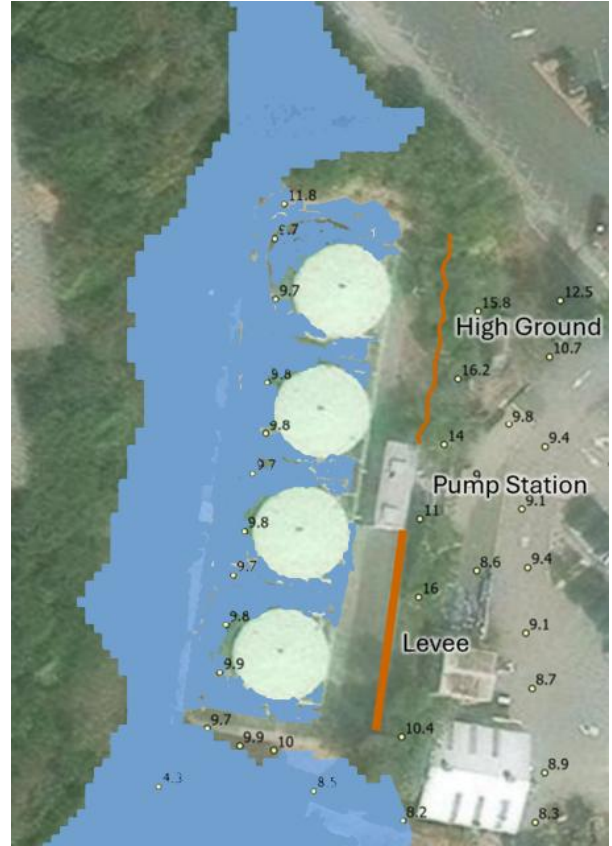
Figure 53 shows the potential extent of flooding (i.e., the area with elevations below the projected TWL) when the 9.8 feet NAVD88 TWL by 2070 (intermediate risk aversion) overtops the engineered levee. Hydrodynamic flood modeling would be needed to determine the volume and depth of floodwater in the containment area.

Figure 53. Potential extent of flooding of the Fuel Tanks area and tanks containment area assuming infinite duration of the projected 9.8 feet NAVD88 TWL by 2070 (intermediate risk aversion) overtopping the 9.7-foot NAVD88 high engineered levee and adjacent low-lying areas
