# Larkspur Ferry Terminal Sea Level Rise Impact Assessment

Larkspur Ferry Service Expansion and Parking Project

Golden Gate Bridge, Highway and Transportation District

October 6, 2026

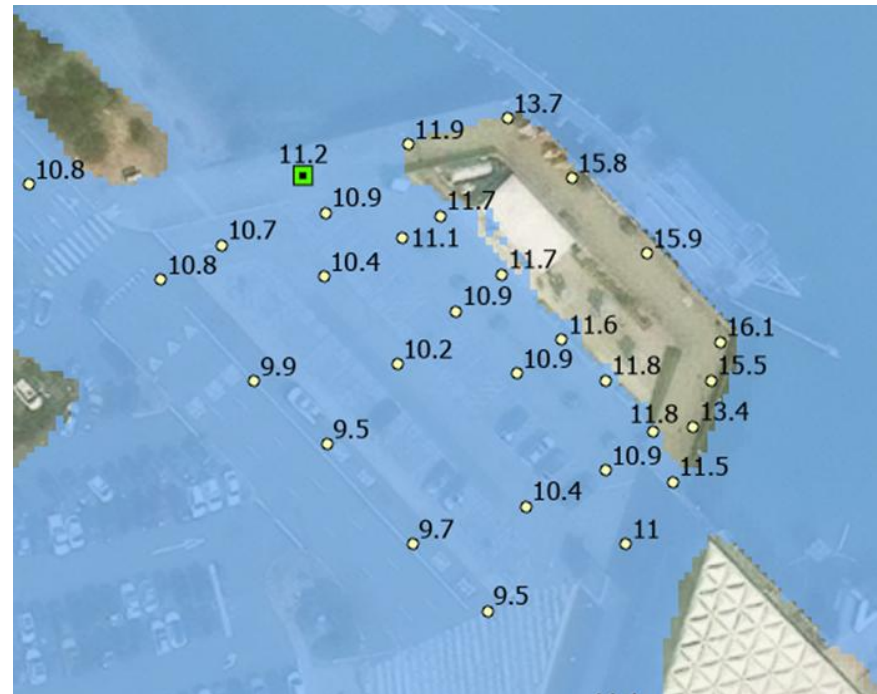
Figure 56 shows the potential extent of flooding (i.e., the area with elevations below the projected TWL) when the 11.3 feet NAVD88 TWL by 2070 (high risk aversion) overtops the breaching point and adjacent low-lying areas for an infinite duration. This extent of flooding is unlikely to occur, as the duration of the TWL above the breaching point elevation and adjacent low-lying areas will be limited. Furthermore, the extent of flooding will be controlled not only by the duration of the overtopping but also by site-specific factors affecting floodwater propagation, such as topography, surface permeability, existing structures, flow pathways, and drainage characteristics. Hydrodynamic flood modeling accounting for these factors would be needed to accurately quantify the spatial extent and depth of flooding.

Figure 56. Potential extent of flooding in the Larkspur Ferry Terminal Buildings Berth 3 assuming infinite duration of the projected 11.3 feet NAVD88 TWL by 2070 (high risk aversion) overtopping the 11.2 feet NAVD88 breaching point and low-lying areas

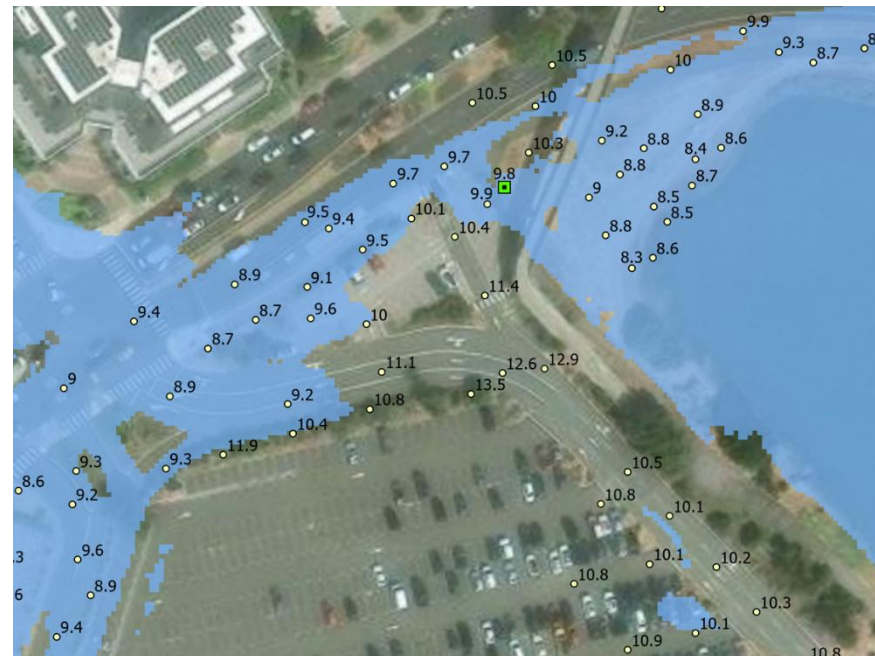
**Figure 59. Potential extent of flooding in the Sir Francis Drake Boulevard area assuming infinite duration of the projected 10.2 feet NAVD88 TWL by 2080 (intermediate risk aversion) overtopping the 9.8 feet NAVD88 breaching point and adjacent low-lying areas**

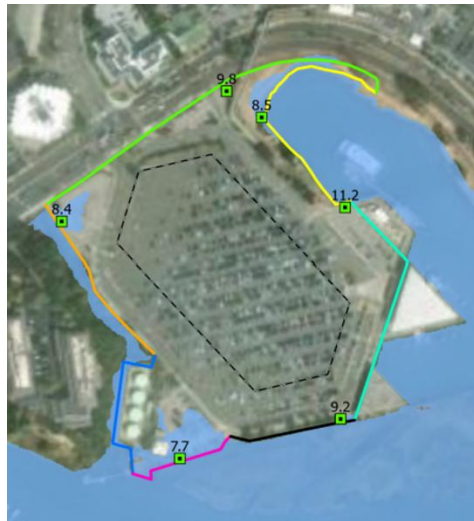
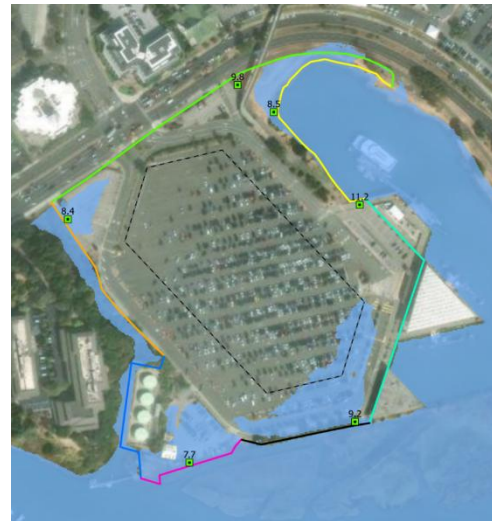
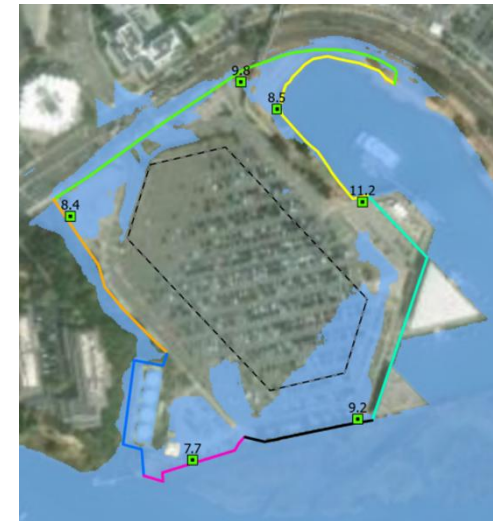
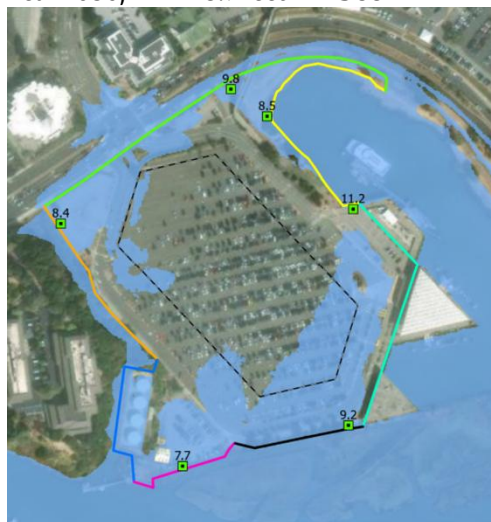
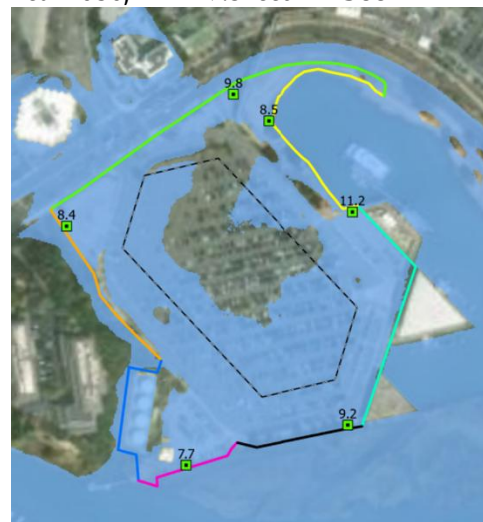
Figure 63. Breaching points and potential extent of flooding from 2030 to 2080 assuming no adaptation measures are implemented, year 2030 low and intermediate risk aversion scenarios, years 2050 and 2070 intermediate, and year 2080 high risk aversion scenario
